**NDCRS SITE FORM  
ARCHITECTURAL SITES**

Manuscript/Report Title: 03-001-064 Cultural Resources Inventory, Adams County, North Dakota

NDCRS ARCHITECTURAL SITE FORM

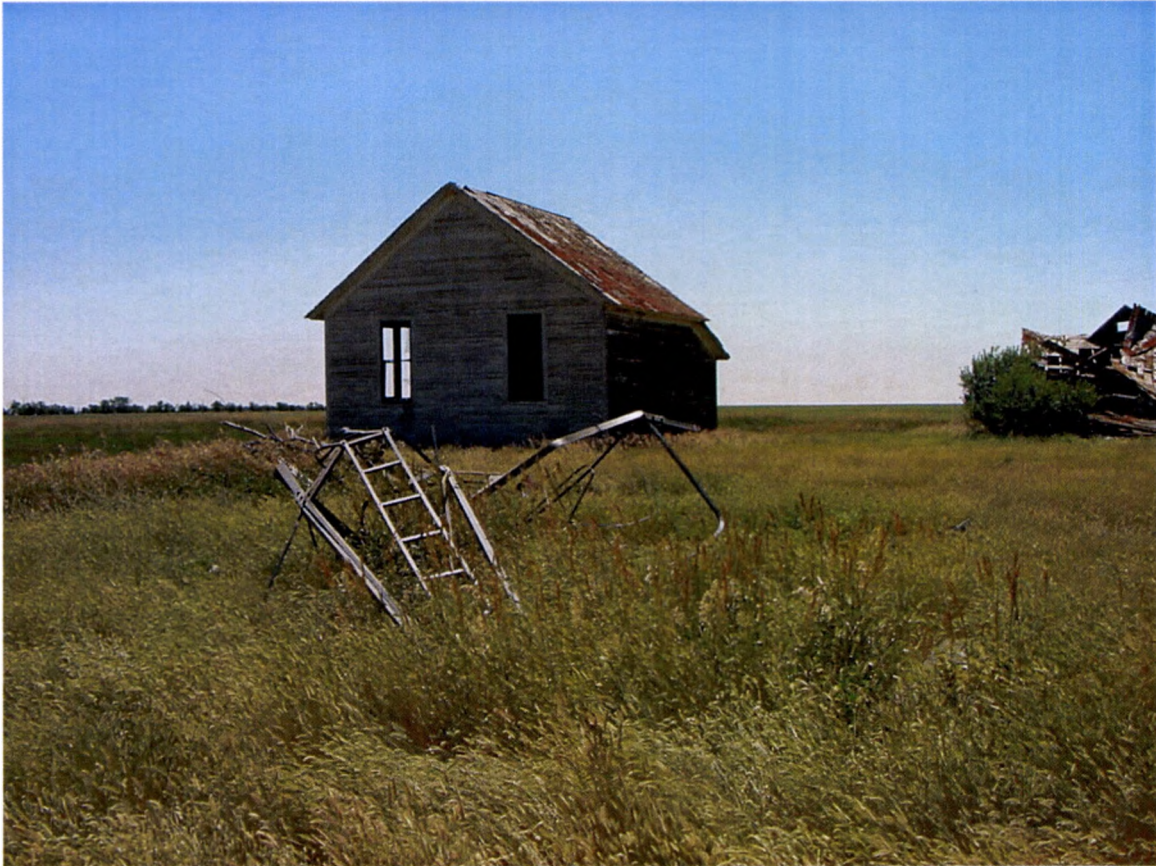
DESCRIPTION/INTEGRITY/ELIGIBILITY The school is not on its original foundation, it is raised on concrete blocks. Its condition is poor. The glass windows are broken and frames are damaged. The entrance lean-to appears to have been added after original construction but before moving to this location. The landowner mentioned that one school had been moved to the ranch headquarters around the 1950s so family and neighboring kids would have a closer school, but no teacher was found to teach there and the school was left empty. The 6 missing, double-hung sash, vertical, parallel, east-facing windows are the most noticeable characteristic of this historic school. The windows are characteristic of many similar one room schools that would need as much natural light as possible for regular school activities. The building currently does not have a solid foundation.

Integrity: poor (moved, damaged, lack of maintenance) Eligibility: No

**View of school with dump in foreground. Note the twisted metal of a windmill.**  
**View to the southeast.**  
**See description of feature #3 on page 2B of this form for further details.**

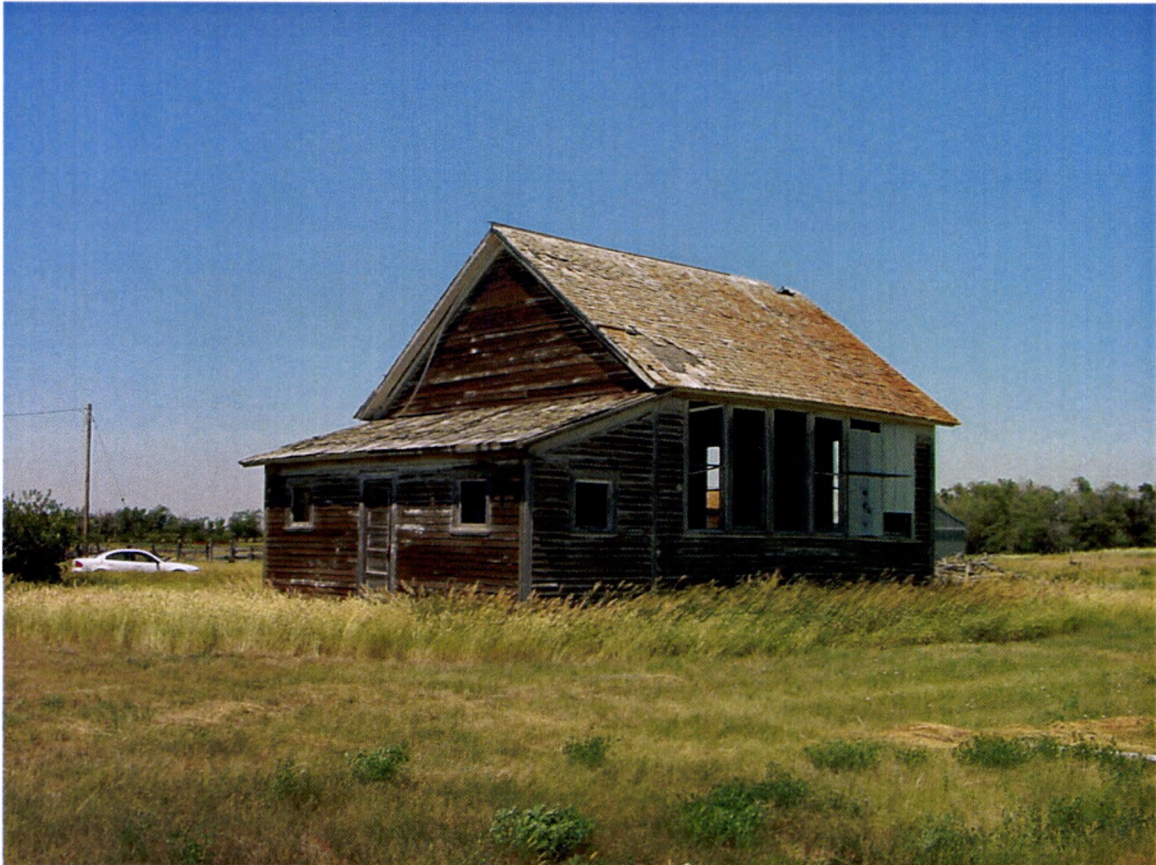
View of school from front with entryway and large window frames.  
View to the northwest.  
See description of feature #3 on page 2B of this form for further details.

This school house is not on its original foundation and its condition is poor. All windows are broken and missing. Pieces of window frames remain. The enclosed front entryway appears to have been added as a lean-to after original construction. Its dimensions are 32 ft N/S x 28 ft E/W. The landowner mentioned to NRCS field office staff that one schoolhouse had been moved to the ranch headquarters around the 1950s so family and neighboring kids would have a closer school, but no teacher was found to teach there and the school was left empty. The now missing, large east-facing windows are one of the most noticeable characteristics of this historic school.
