NDCRS ARCHITECTURAL SITE FORM

Field Code KLJ-RDR-702

Reeder Telecom
Ryan Howell

Richardton and Reeder Telecom Exchanges in Bowman, Adams and Slope Counties, North Dakota: A Class III Cultural Resource Inventory, by Ryan J. Howell

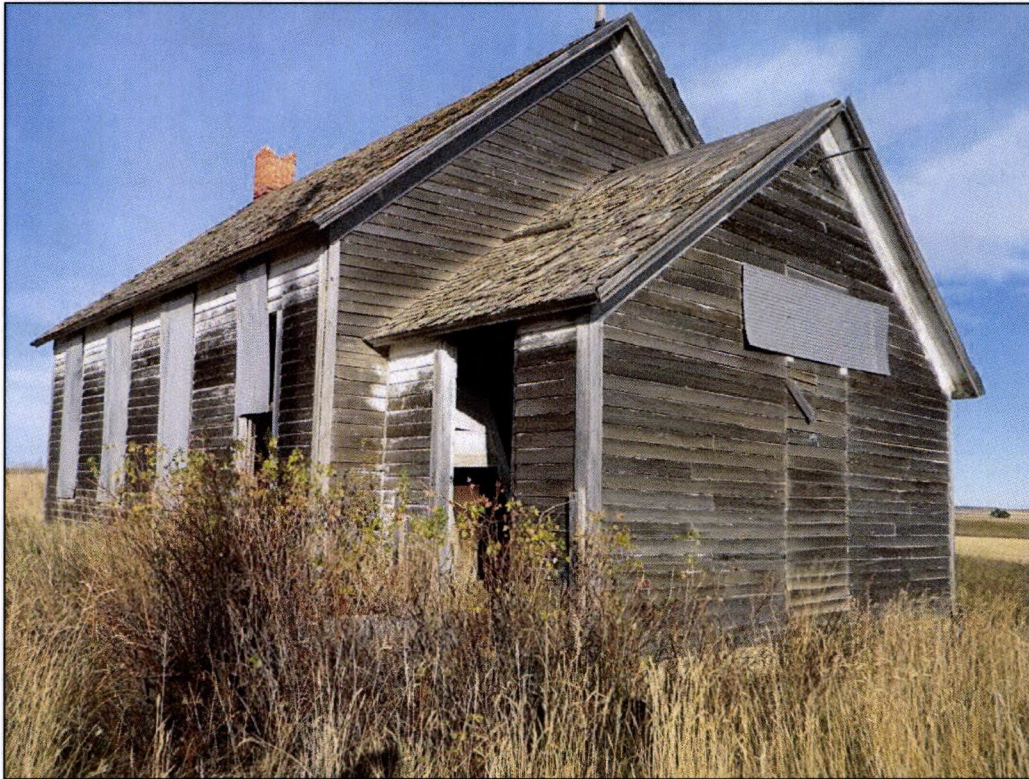
Feature 1 is a one-room school house. The building is oriented east-west. It is approximately 20' x 30'. The porch addition is approximately 6' x 12'. It is a small, wood frame, gabled front building with horizontal wood siding. There is a porch addition on the east end.

There are four windows on the south side and two on the west side. The porch addition has a small, high window on the east side above what appears to have once been a doorway, but which has been boarded over. The windows are double hung sash windows. None appear to contain glass. With one exception, they are covered with corrugated metal.

The building siding is narrow horizontal wood siding with traces of white paint. The foundation under the main part of the structure is constructed of cement slabs and field stone of Tongue River silicified sediment that had been at least partially mortared with cement. The foundation for the porch addition is concrete block.

The doorway is through the porch addition and faces south, with wooden steps leading to the doorway. The steps and railings are broken. The door is not intact.

The roof is gabled with open soffits. The shingles are wood. There is what appears to be a flagpole toward the east end of the roof. The chimney is at the west end and is of red brick. There is a metal finial on the west roof hip and another on the ground nearby the school.

Figure 3: Feature 1, schoolhouse, view to the northwest.

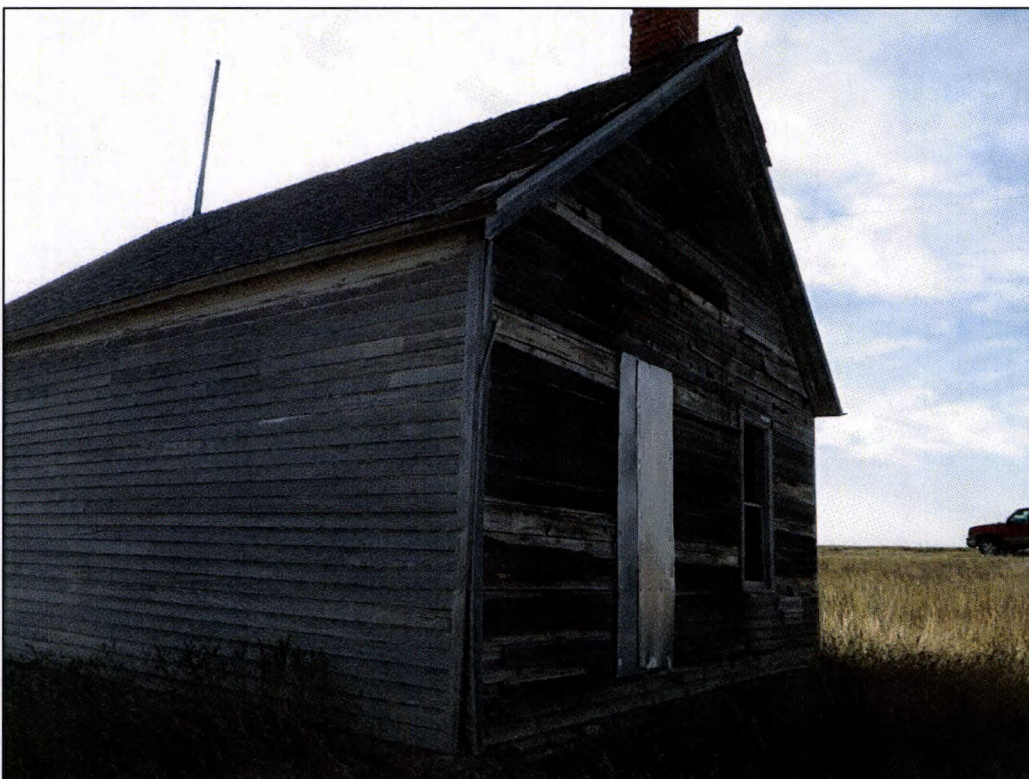
Feature 1 retains integrity of location, design, setting, materials, workmanship, feeling and association. The feature may be eligible for the NRHP under Criteria A and C, however at this time the feature is unevaluated.

Figure 4: Feature 1, view to the southeast

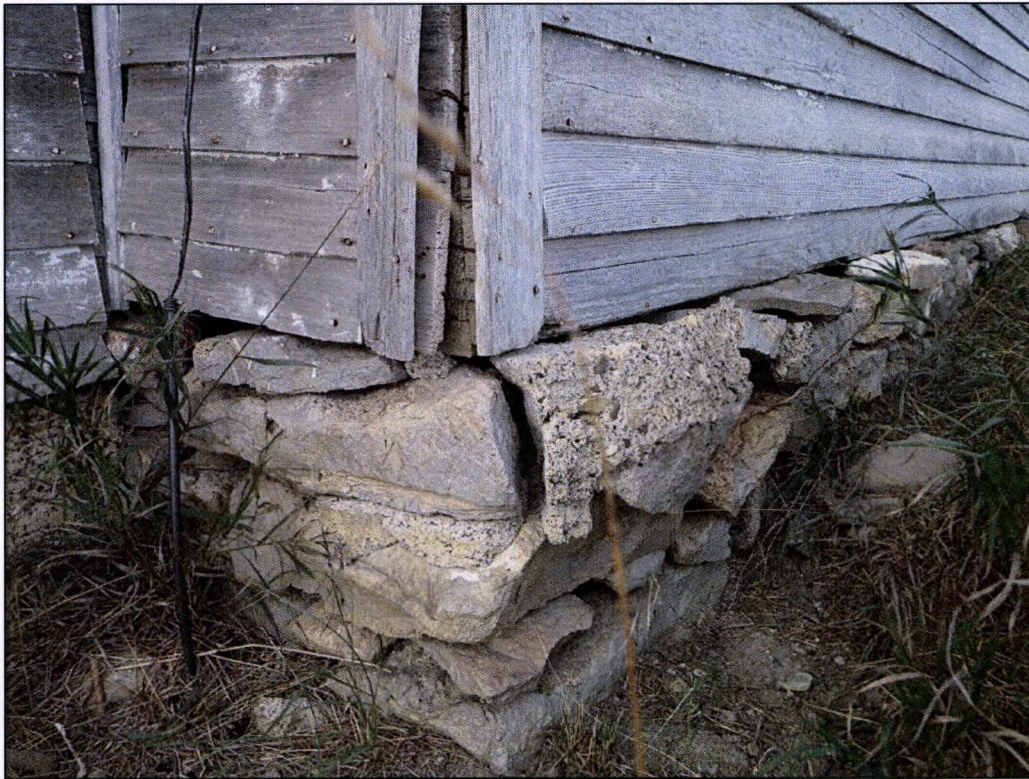
The foundation is poured concrete under the main building and the porch is supported with cinderblocks.

Figure 5: Feature 2, foundation, northeast corner.

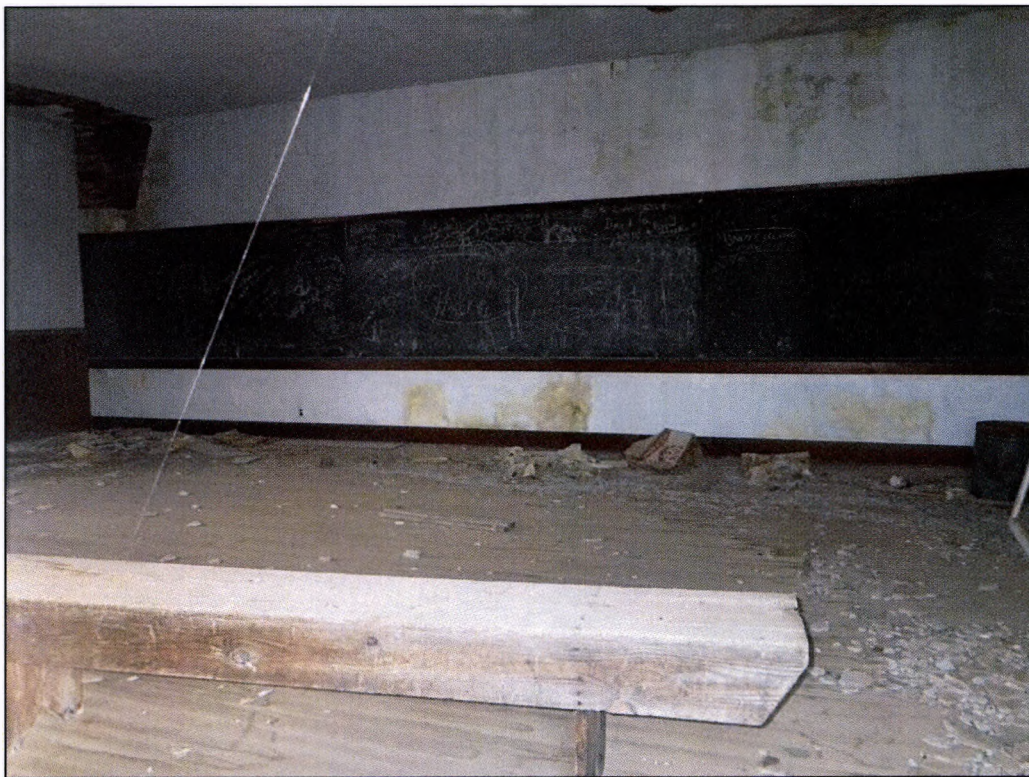
The limited interior view shows that the walls are plaster and lathe construction with wainscotting. The floor is wood plank. A wood bench is visible. Debris on the floor includes cardboard boxes, a can, a window sash, boards and plaster. A blackboard is inscribed with chalk writing and names dated from the 70s through the 90s. An interview with a neighbor revealed that young people have been entering the school over the years and autographing the chalkboard.

Figure 6: Feature 1, interior, view to the northwest.

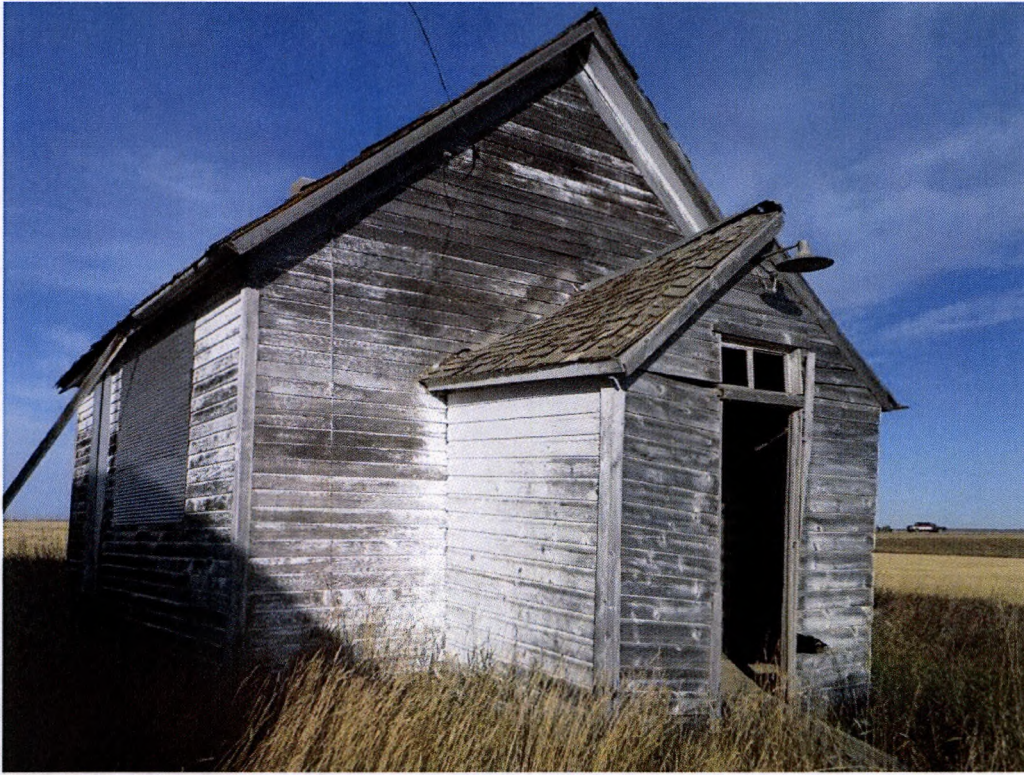
This is a one-room school house with a porch addition on the east end. It is the second school house on the site.

The building is a wooden structure with horizontal wood siding with traces of white paint. It has a gabled front and is approximately 12' x 22' and is oriented east and west.

There are three wood frame double hung sash windows on the south side of the building. All three are intact with glass and are covered on the exterior with corrugated sheet metal. There is a fourth window on the east end of the building north of the porch. It is uncovered and is not intact.

The doorway faces east and is through the porch addition. The door is missing. There is a small window opening above the doorway. It is partially intact.

Figure 7: Feature 2, view to the northwest.

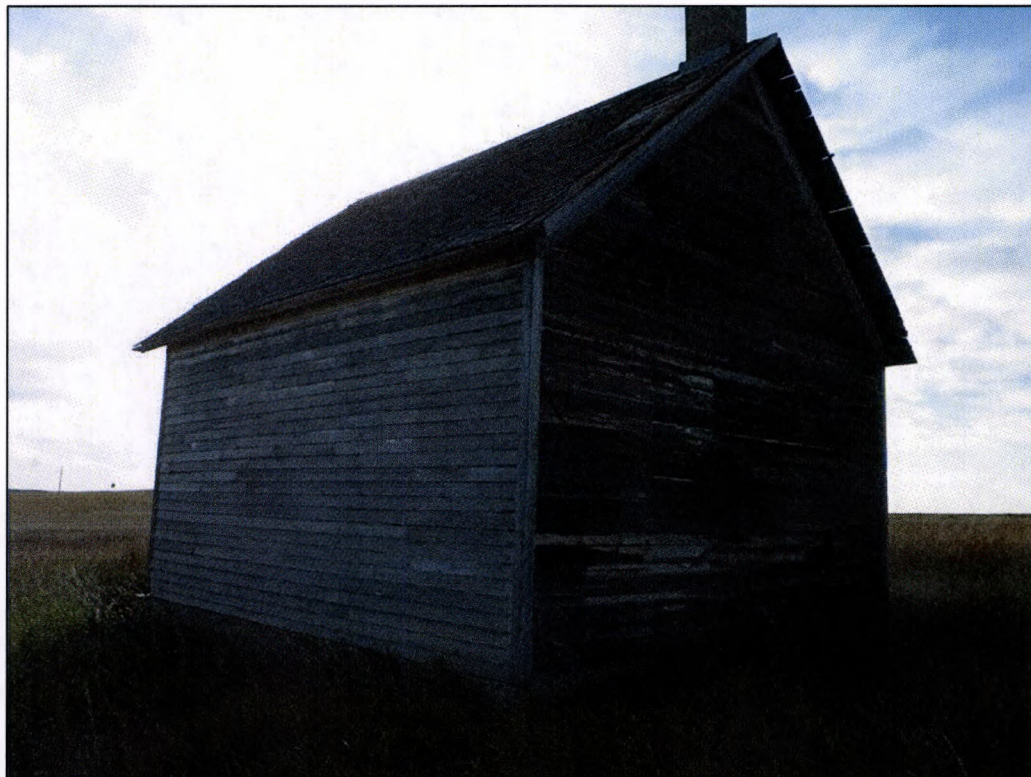
Feature 2 retains integrity of location, design, setting, materials, workmanship, feeling and association. The feature may be eligible for the NRHP under Criteria A and C, however at this time the feature is unevaluated.

Figure 8: Feature 2, view to the southeast.

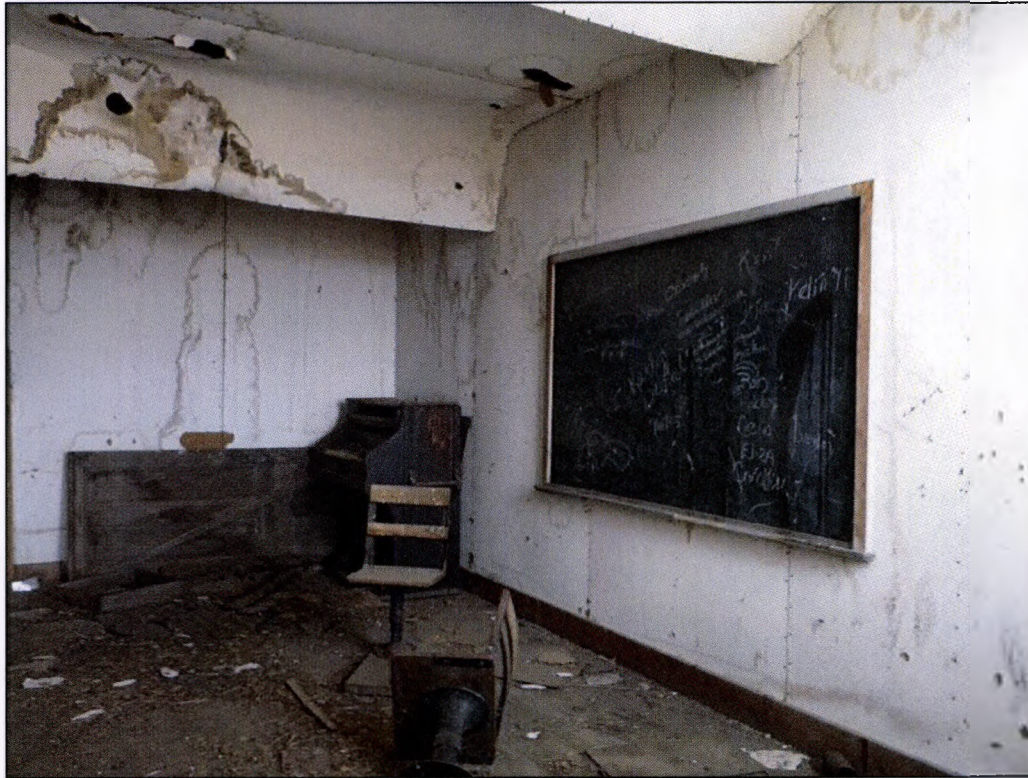
Interior views of the building indicate that the walls are paperboard or drywall and the floors, wood. There is a small blackboard inside the building. Numerous names are written there in chalk and one date: "2003". Other material inside the building includes two desk chairs, a complete desk, a door, a table and a small wooden table. Debris on the floor includes cans, board and fallen sheetrock or paperboard. An interview with a neighbor revealed that area youth have entered the schoolhouses over the years.

Figure 9: Feature 2, interior, view to the northwest.

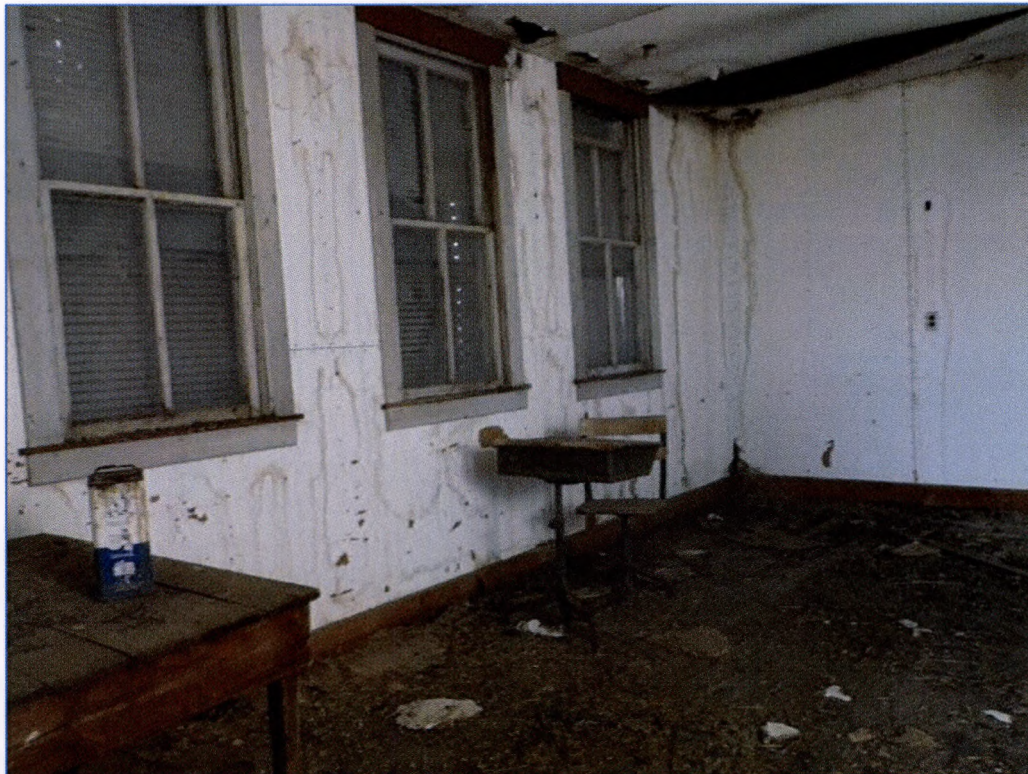
Figure 10: Feature 2, interior, view to the southwest.

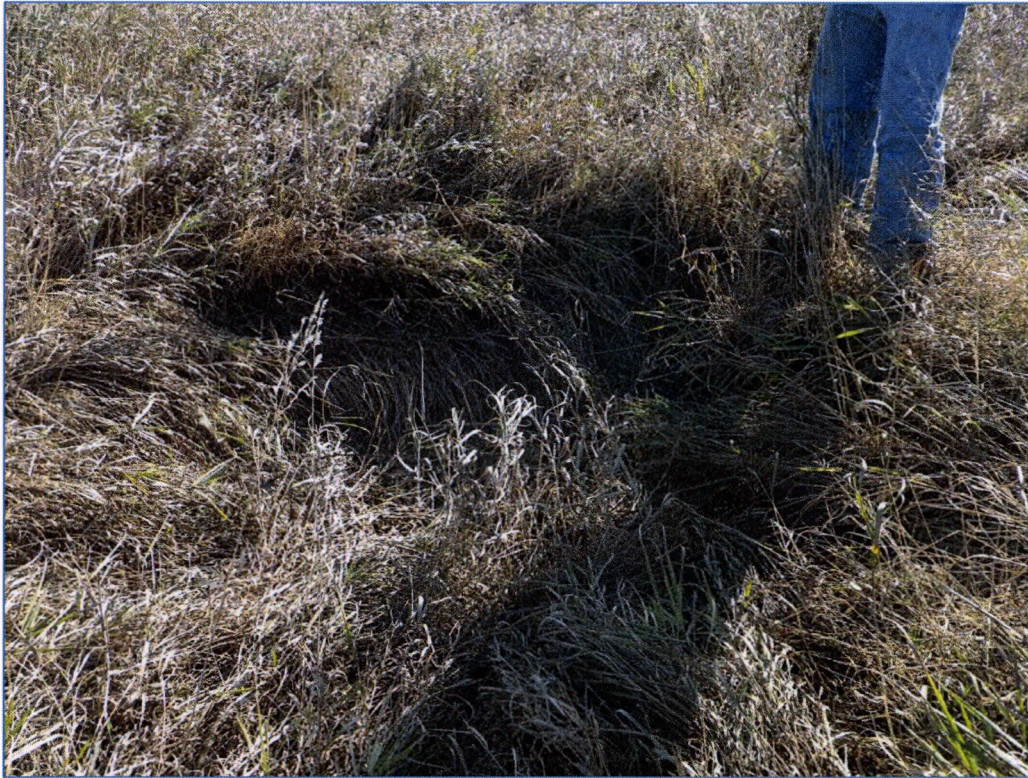
Feature 3 is a depression north of Feature 2. It is somewhat rectangular and approximately 2-3 m in diameter. It is thought to be a privy depression.

Figure 11: Feature 3, view to the northeast.

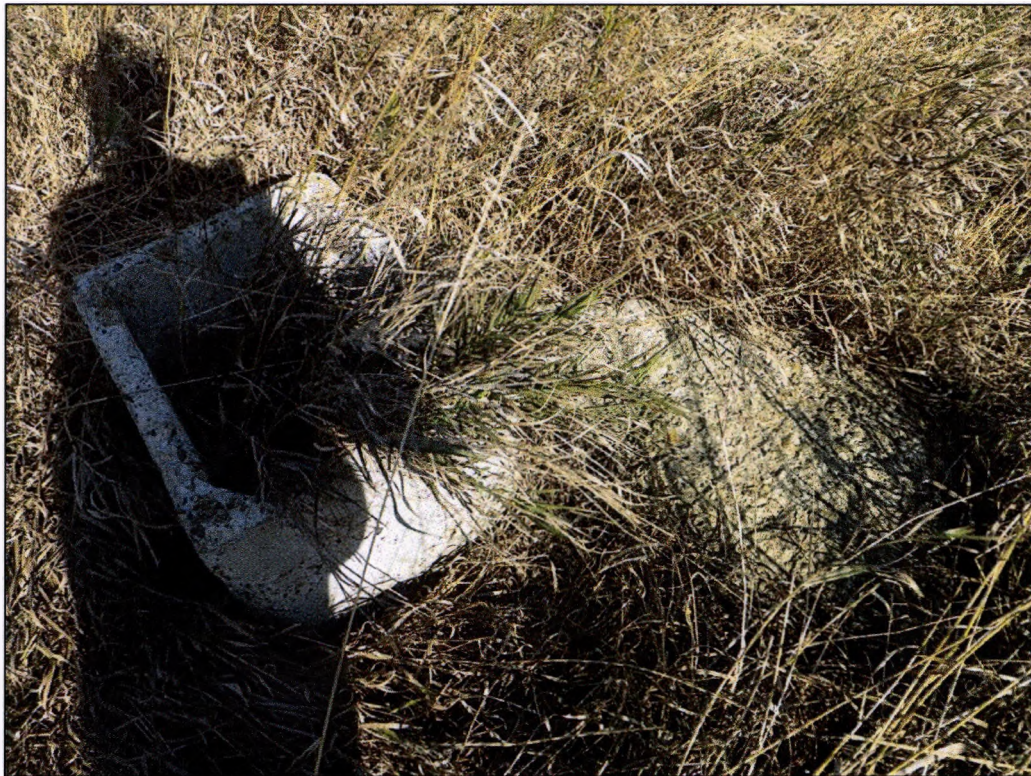
Feature 4 is 1 m west of Feature 3 and is a depression with a concrete cover and a piece of rectangular concrete cistern. It is approximately 2 m in diameter and is thought to be a second privy location.

Figure 12: Feature 4, view to the west.

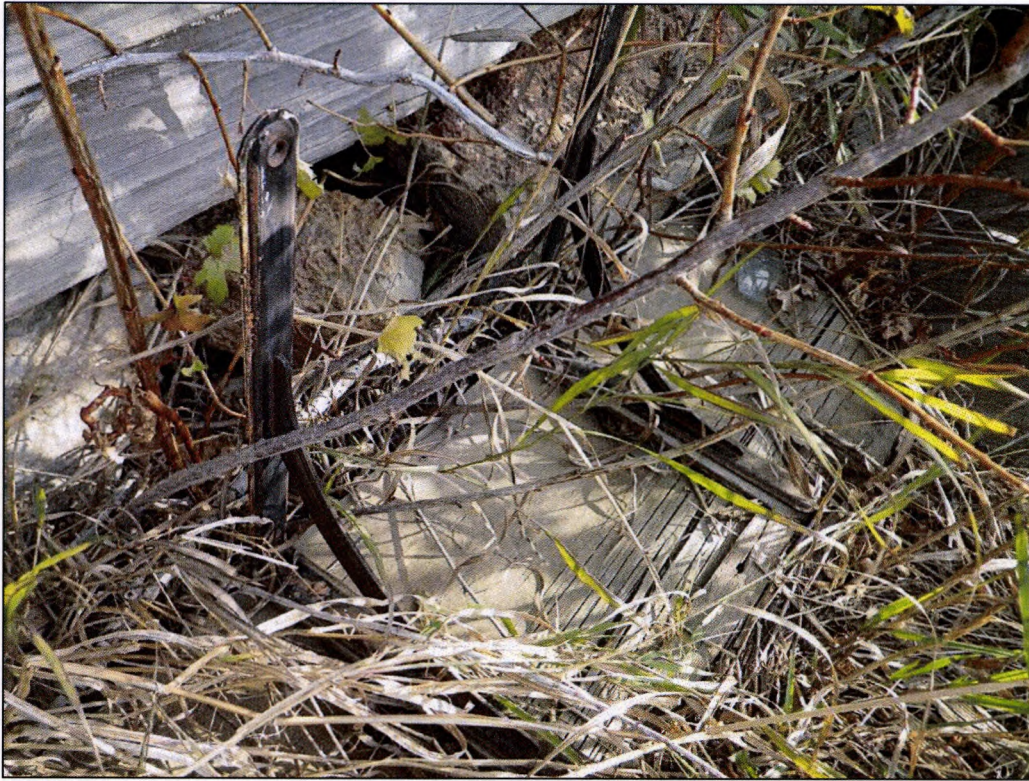
Figure 13: Shelf or desk part and glass on south side of Feature 1.

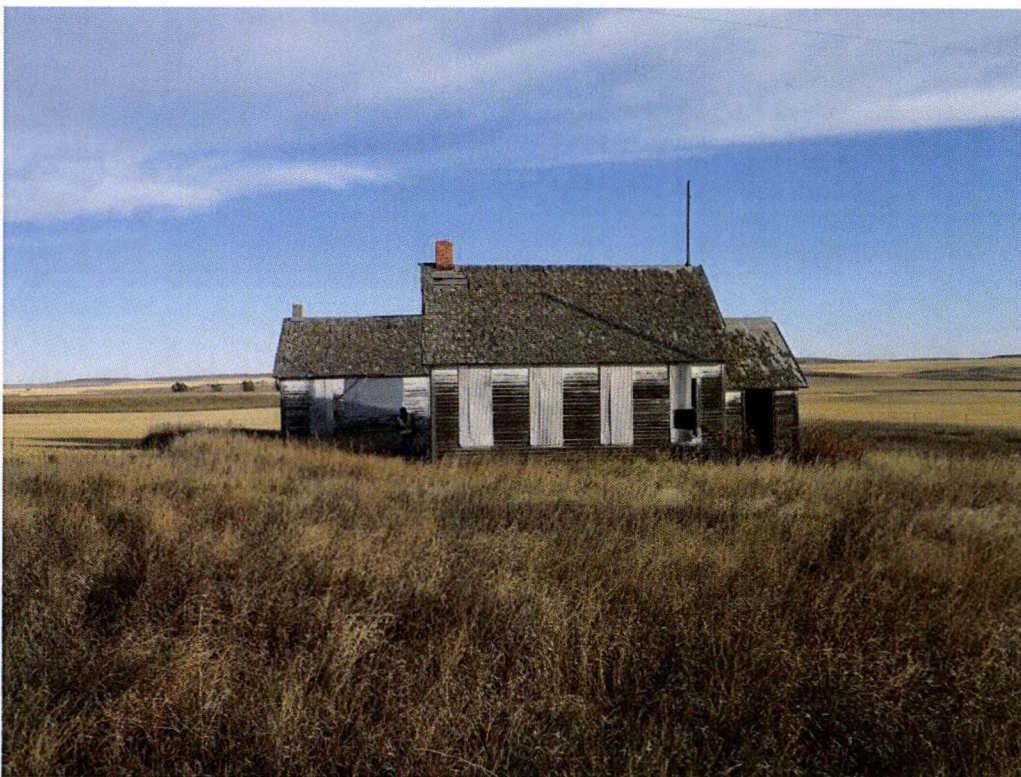
This site is comprised of two standing structures, a depression and a concrete plug in a depression that may be a well or a second privy location.

Figure 14: Site overview to the north.
