NDCRS ARCHITECTURAL SITE FORM

Field Code MAC-112

Project: Burke County Windfarm; PI: Ed Stine

Title: Architectural Survey for the Burke County Wind Energy Center, Burke County, North Dakota prepared for Burke Wind, LLC; Author: Emily Sakariassen

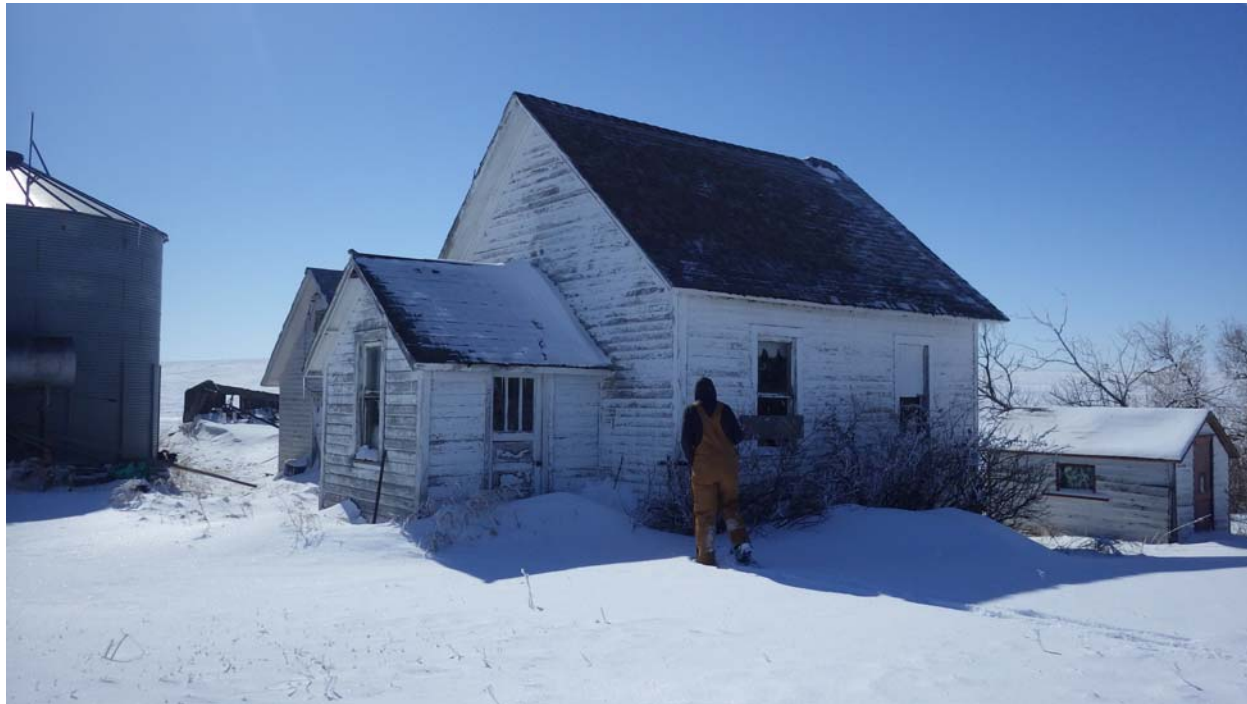
INTEGRITY: The feature is in fair condition. Some window glass is broken and the exterior materials show signs of prolonged exposure and deferred maintenance. Paint is failing and the shingles are worn affecting integrity of materials. Due to the building's relocation, integrity of location, association, setting, and feeling have been lost.

Figure 4: Site MAC-112, Feature 2, view southwest (Image 108-530).

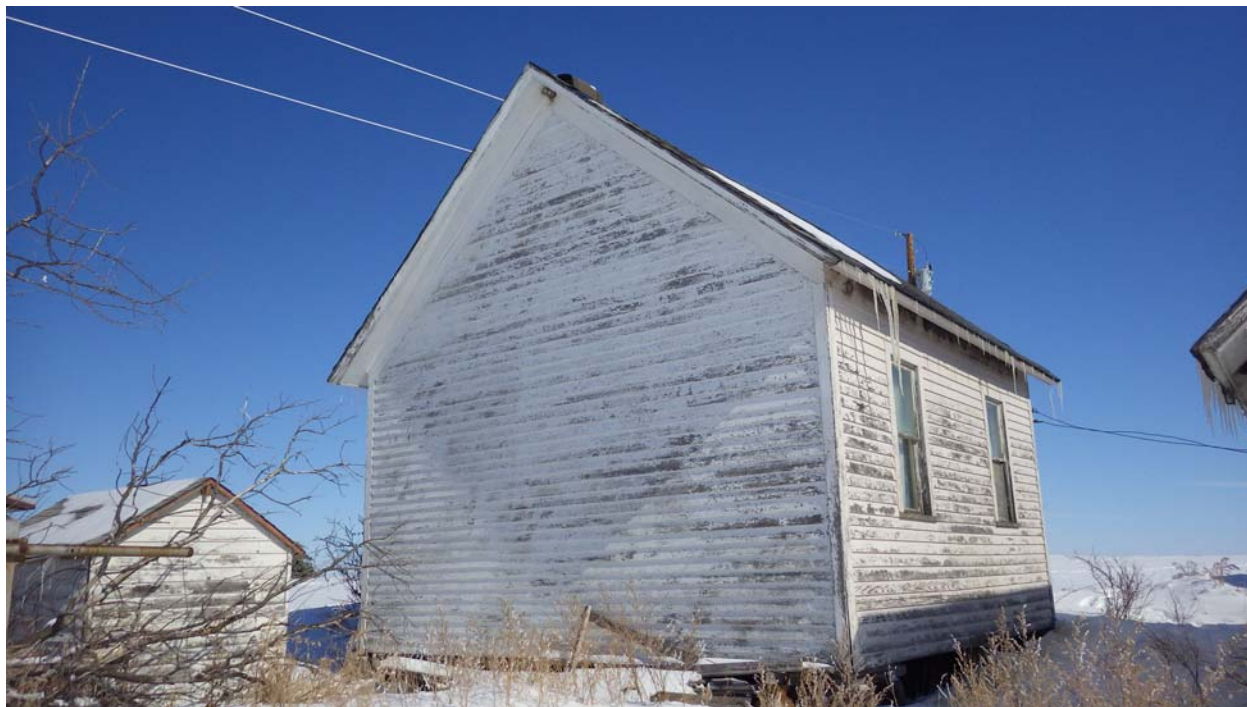
Figure 5: Site MAC-112, Feature 2, view northeast (Image 108-533).

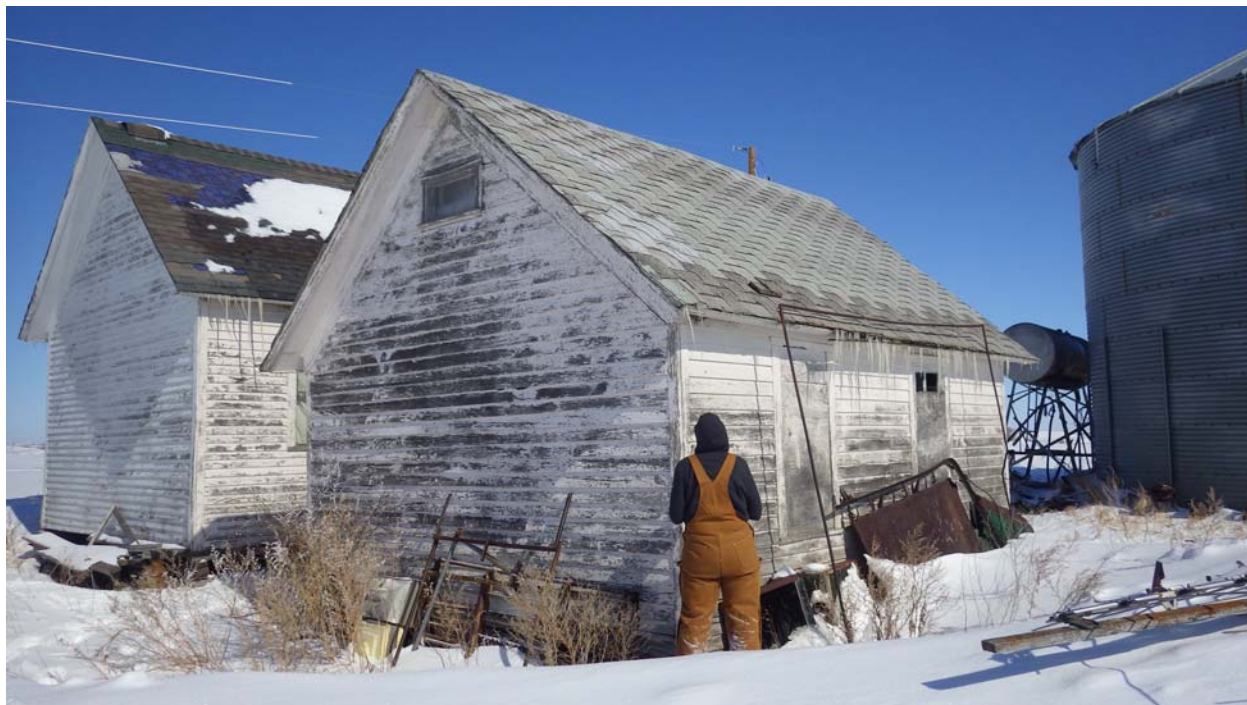
INTEGRITY: The feature is in fair condition. Exterior materials show signs of prolonged exposure and deferred maintenance. Paint is failing and windows have been damaged, affecting integrity of materials. Due to the building's relocation, integrity of location, association, setting, and feeling have been lost.

Figure 8: Site MAC-112, Feature 4 with Feature 2 in the background, view northeast (Image 108-537).

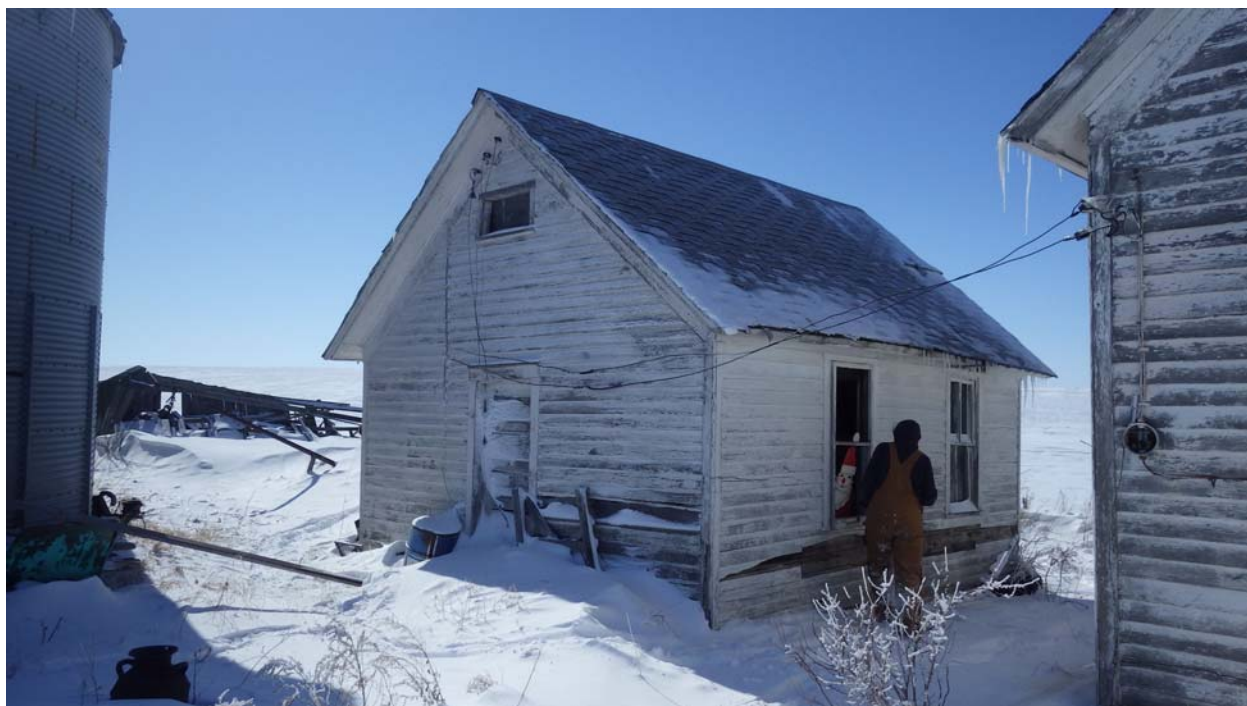
Figure 9: Site MAC-112, Feature 4, view southwest (Image 108-538).
