### NDCRS ARCHITECTURAL SITE FORM

Field Code MAC-115

Project: Burke County Windfarm; PI: Ed Stine

Report Title: Architectural Survey for the Burke County Wind Energy Center, Burke County, North Dakota prepared for Burke Wind, LLC; Author: Emily Sakariassen

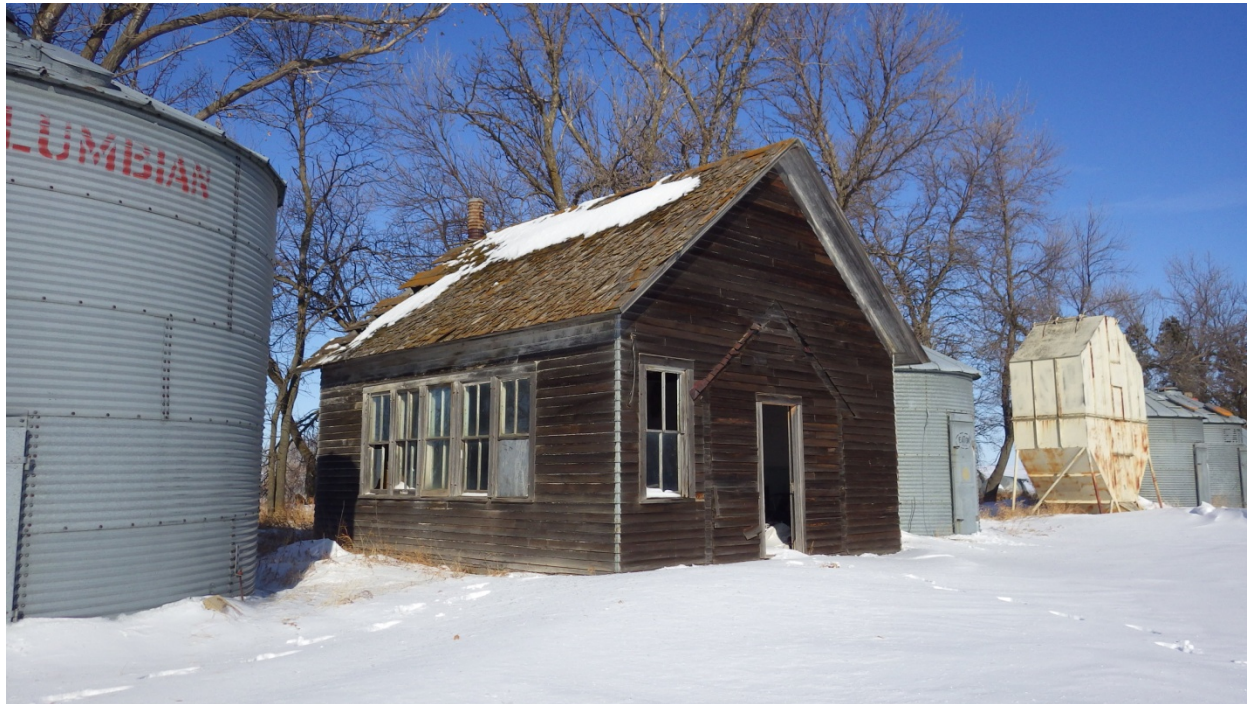
INTEGRITY: Feature 2 is in fair condition. Deterioration due to deferred maintenance and accumulated refuse has affected integrity of materials and workmanship. The loss of window glass, the doorway, and removal of the gable-roofed vestibule have affected integrity of design and feeling. Integrity of setting, location, and association have been compromised by the removal of the feature from its original site.

**Figure 4:** Site MAC-115, Feature 2, view northwest (Image 108-604).

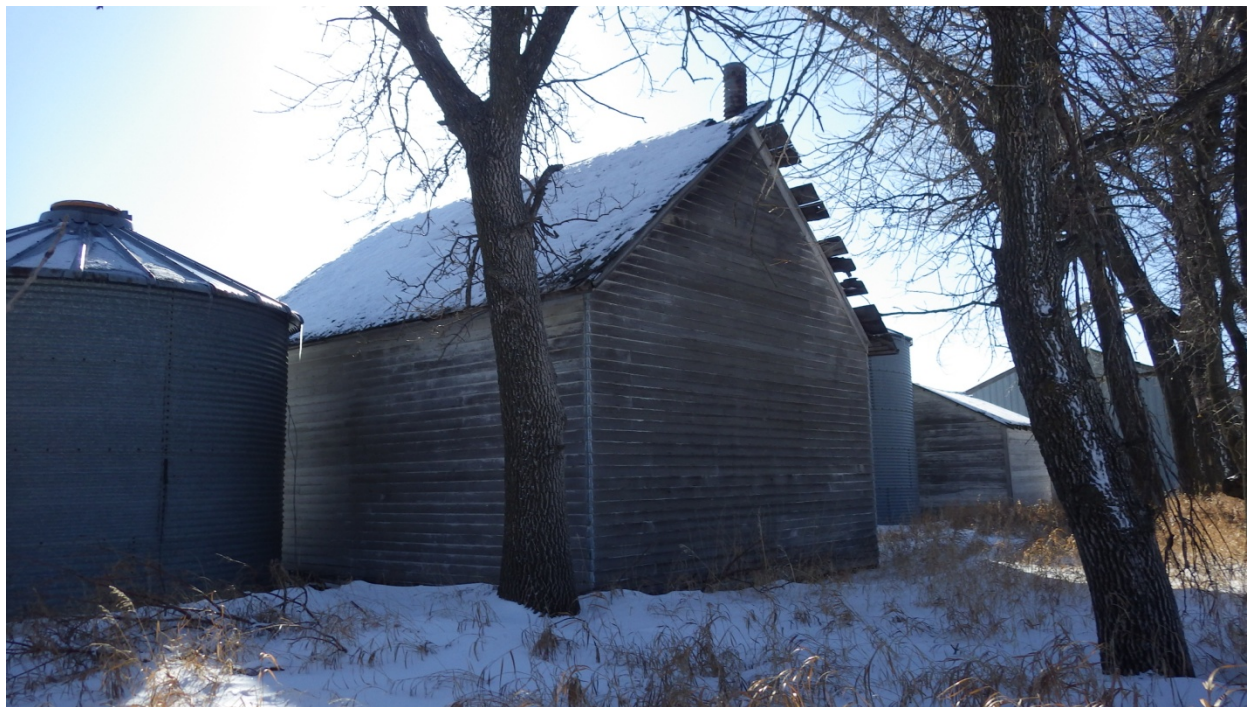
**Figure 5:** Site MAC-115, Feature 2, view southeast (Image 108-609).
