NDCRS ARCHITECTURAL FORM
PAGE 1

Field Code Brookside School

Project & Principal Investigator:

Country School House Project
Kathy Wilner
366 43rd Ave SE
Bowdon ND 58418

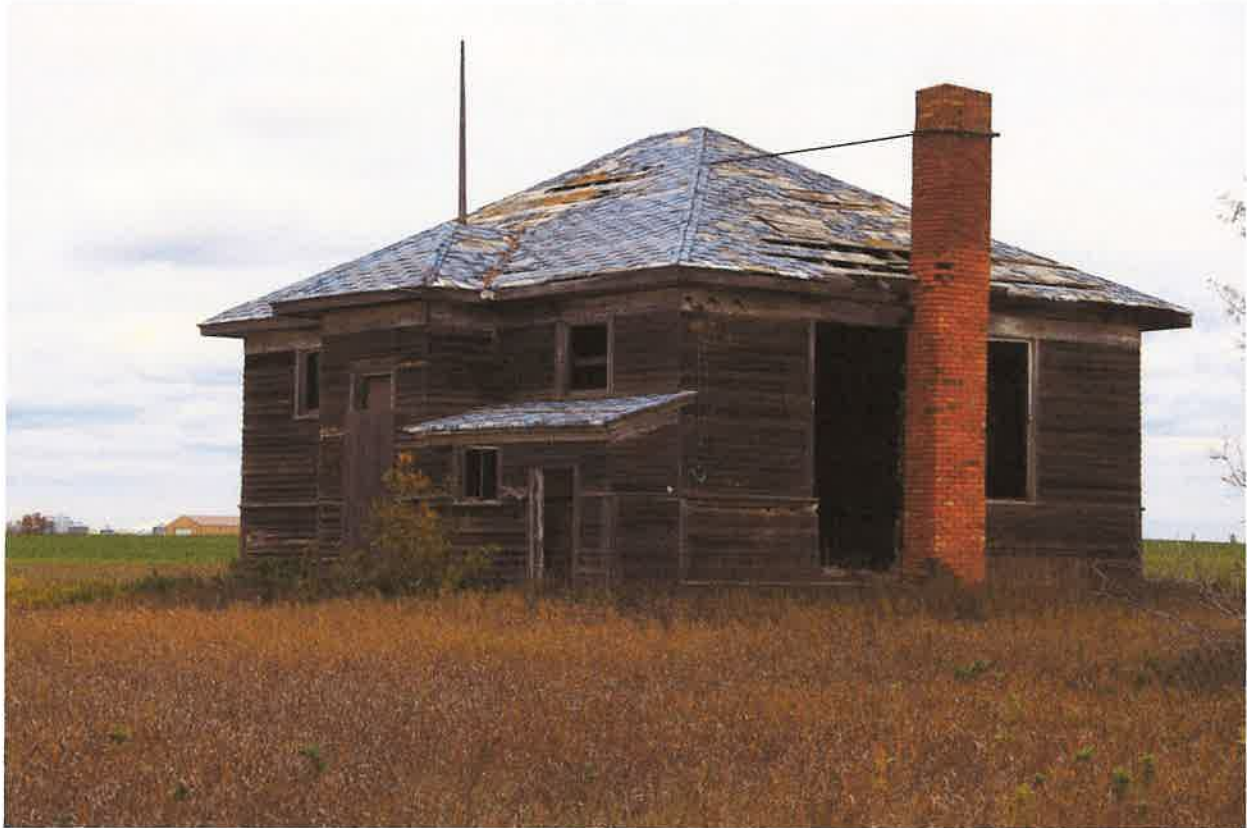
West and South Sides

The feature is a one room school sitting on the prairie. I have one picture to tell the story. The hip roof of the school and the entry roof are partially covered with failing blue asphalt shingles. There are several holes in the roof. There is a flag pole at the peak of the entry roof. A large, red brick chimney is located outside the south wall of the of the building. The chimney extends from the ground all the way up to the height of the roof peak. There are two long anchor wires connected to the south slope of the school roof to keep the chimney in place. The soffits are closed.

The siding begins with a rake board under the eaves on all sides of the school. The siding appears to be 6 inch wood lap with no corner trim. There is a waterboard at the bottom of the siding and another about 4 feet up. An entry faces west with a piece of plywood blocking the doorway. A small shed to the south of the entry has a door opening as well as a window opening, both facing west. Two small window openings are located to either side of the entry. On the south wall there is a large opening, floor to ceiling, to the west of the chimney. One window opening is east of the chimney. I have no information about the interior of this building. Wires on the outside of the building would indicate that electricity was present at some point in the history of the school.

The foundation is a combination of cement and partial basement. The front side addition, called a porch by the owner, leads up a few steps into the school on the right side and to the left the stairway goes to the partial basement. The furnace was never in the basement. He told me the furnace was located in the middle of the classroom. The furnace was stolen several years ago. Someone chainsawed under the window to the left of the chimney to get the furnace out of the school. He thinks the floor is wood. The walls and ceiling were plaster and it says much of that has fallen in. There was a fiberboard black or green board on the north wall and part of the west wall. The old entry has been boarded up because the steps inside the school have fallen in. He told me that those few steps went up to a hallway between two smaller rooms. He thought to the left was a small office for the teacher and to the right was a coat room. The office had a door near the north wall that led into the school and the coatroom had a door near the south wall that led into the school as well. He told me a few desks are still in the school. As you can see it is wide open to the weather.

The only picture available of this school.
