NDCRS SITE FORM  
ARCHITECTURAL SITES  
Page 1

Field Code SU 25 Site Name Grand River Farm and  
Field Code \_\_\_\_\_ Site Name Ranch

Manuscript/Report Title: Survey of Bowman County

Subject: Schoolhouse-garage

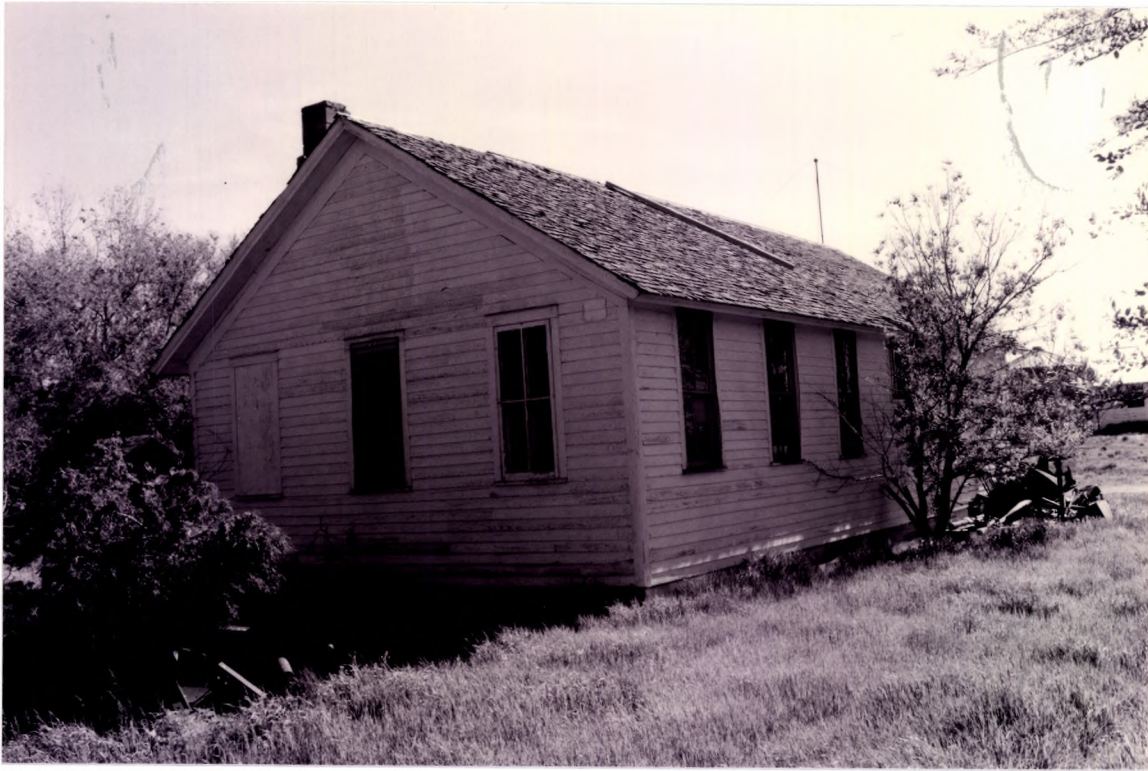
Roll I Frame 12 Site SU 25 Feature 30 Date 6/4 View from SW

This feature is a schoolhouse that has been moved to a location central to the farmstead and converted into a garage. It is a single-gabled building of one story. It is a wood frame building covered with horizontal siding and re-roofed with sheet metal. Its foundation is poured concrete. Both its single door and garage door open to the east. The double hung, tall school windows on the south and west are intact and in good condition except for one facing the west. It should be noted that it appears only about the western two-thirds of the building is the schoolhouse and the eastern one-third is an addition, including the garage door. The inside is in disrepair with the ceiling falling. Relocation and remodeling make this building ineligible for National Register consideration.

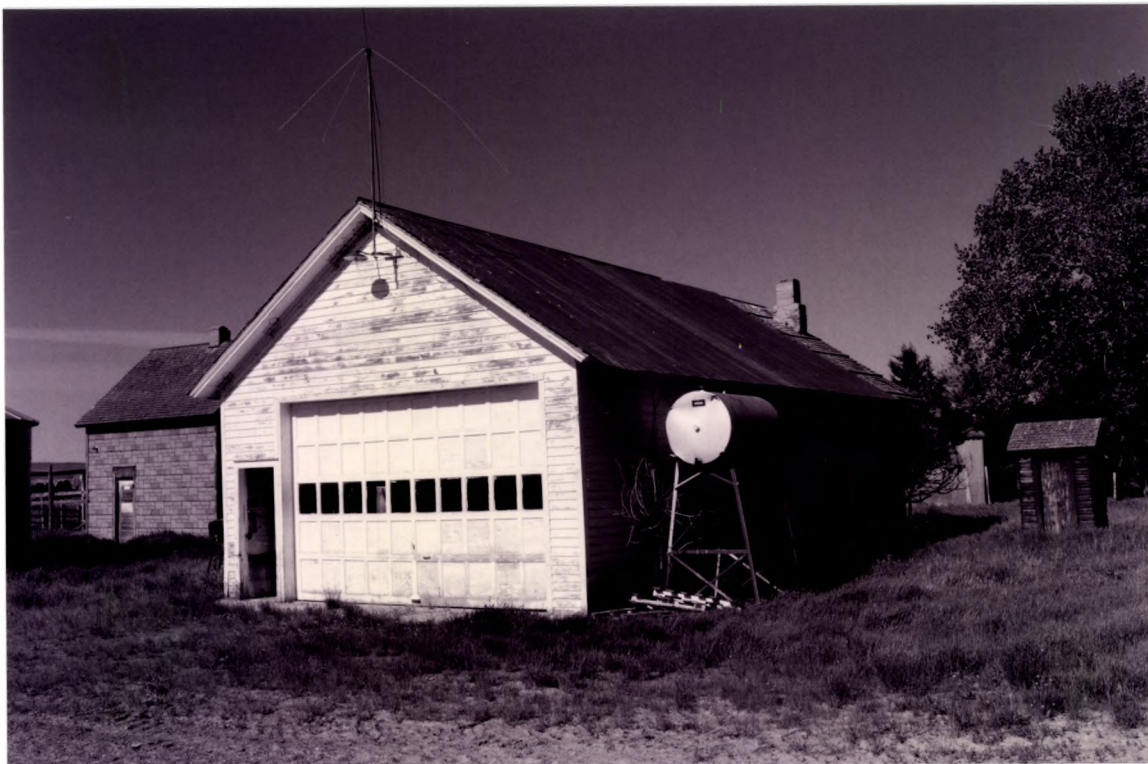
Roll I Frame 13 Site SU 25 Feature 30 Date 6/4 View from NE

Subject: Schoolhouse-garage
