NDCRS SITE FORM  
ARCHITECTURAL SITES

Field Code S14128 Site Name Grand River School  
Field Code \_\_\_\_\_ Site Name \_\_\_\_\_

Manuscript/Report Title: Survey of Bowman County

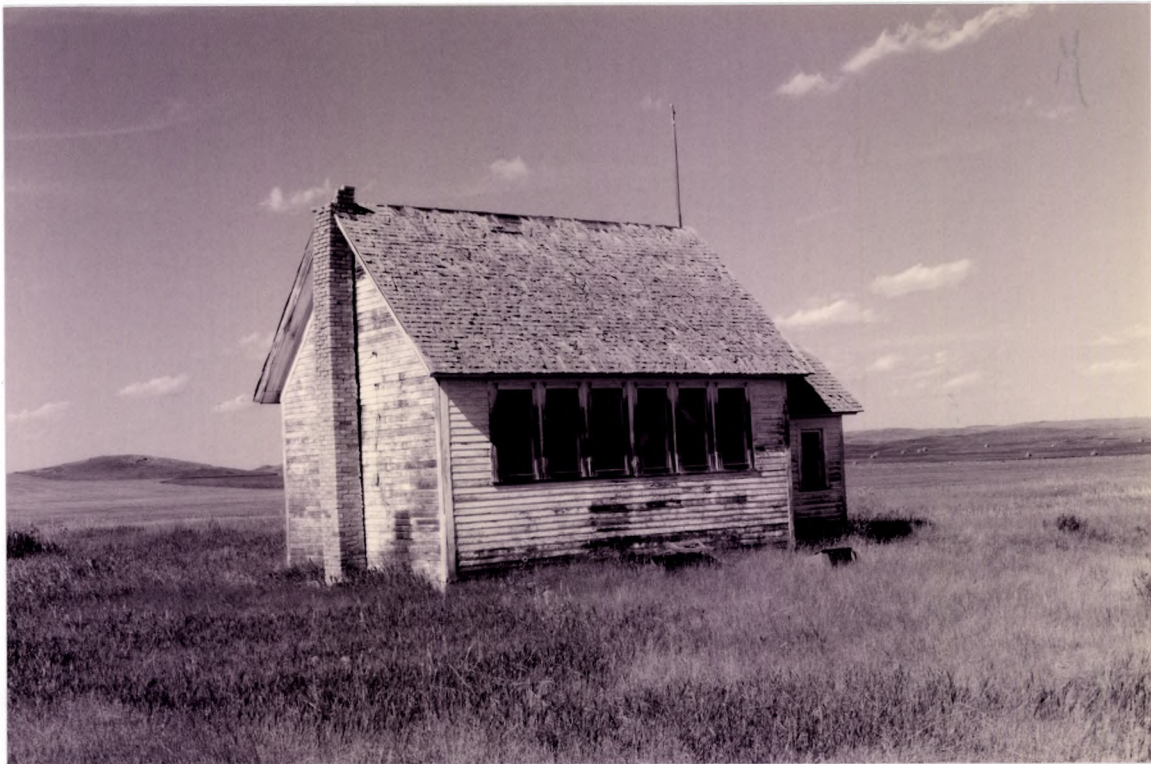
Roll FF Frame 9 Site SU 128 Feature 1 Date 8/4 View from SW

This schoolhouse is the Grand River School, constructed in about 1910. This is a wood frame building on a foundation of poured concrete. The exterior is horizontal wood siding, and the gable roof is covered with wood shingles. It has a brick chimney, the top of which has collapsed, centered on the west wall. A gable roof entryway has been built onto the east end of the building. Its door opens to the south. This entryway also has a broken roof addition on the north side of it, and thus on the northeast corner of the building. The building has a single double-hung window on the east and near the southeast corner and a row of six double-hung windows on the south wall, but no windows on the west or north walls of the original schoolhouse. These original windows are in remarkably good condition. Inside the schoolhouse, stacked on the classroom floor, are a set of church windows, origin unknown.

Subject: Schoolhouse

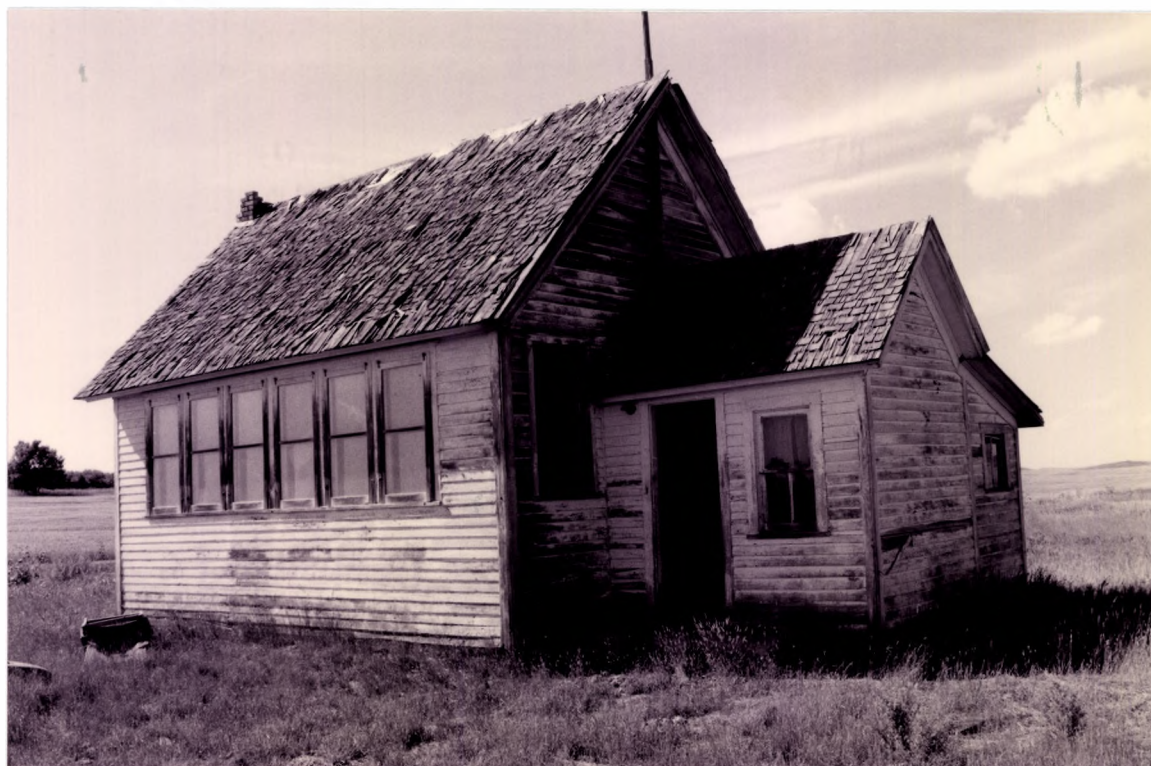
Roll FF Frame 10 Site SU 128 Feature 1 Date 8/4 View from SE

Subject: Schoolhouse

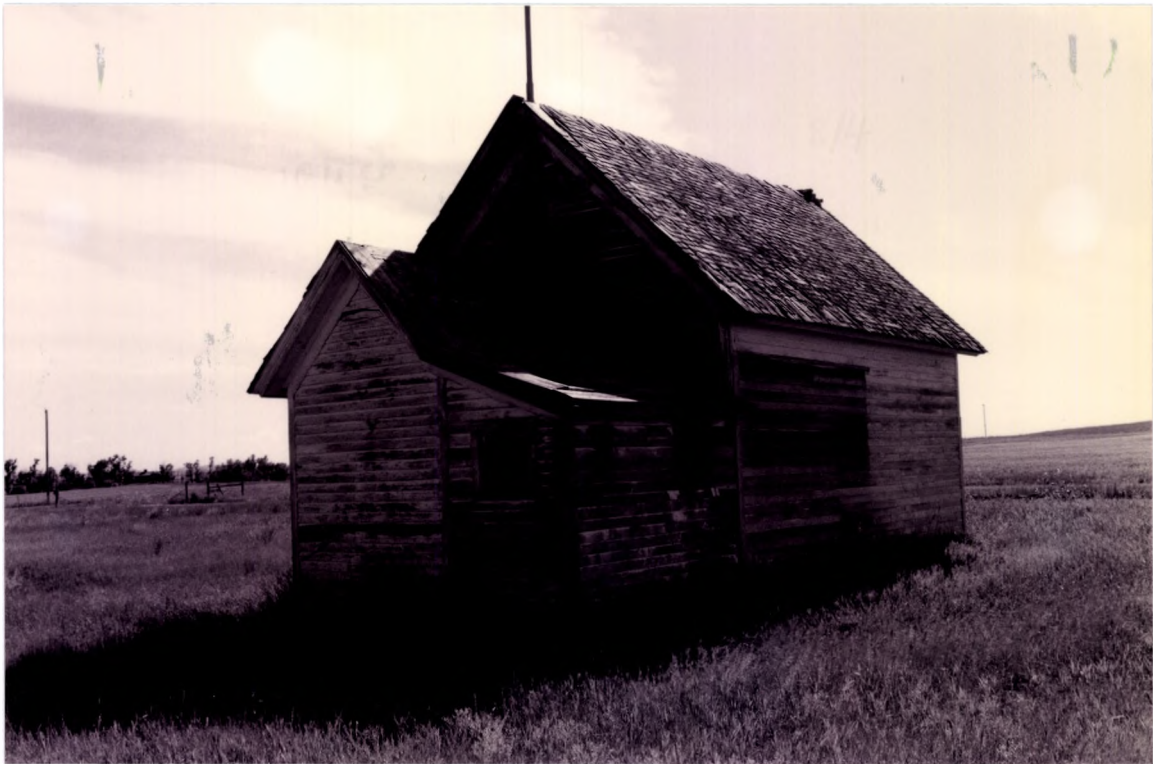
Roll FF Frame 11 Site SU 128 Feature 1 Date 8/4 View from NE

Subject: Schoolhouse

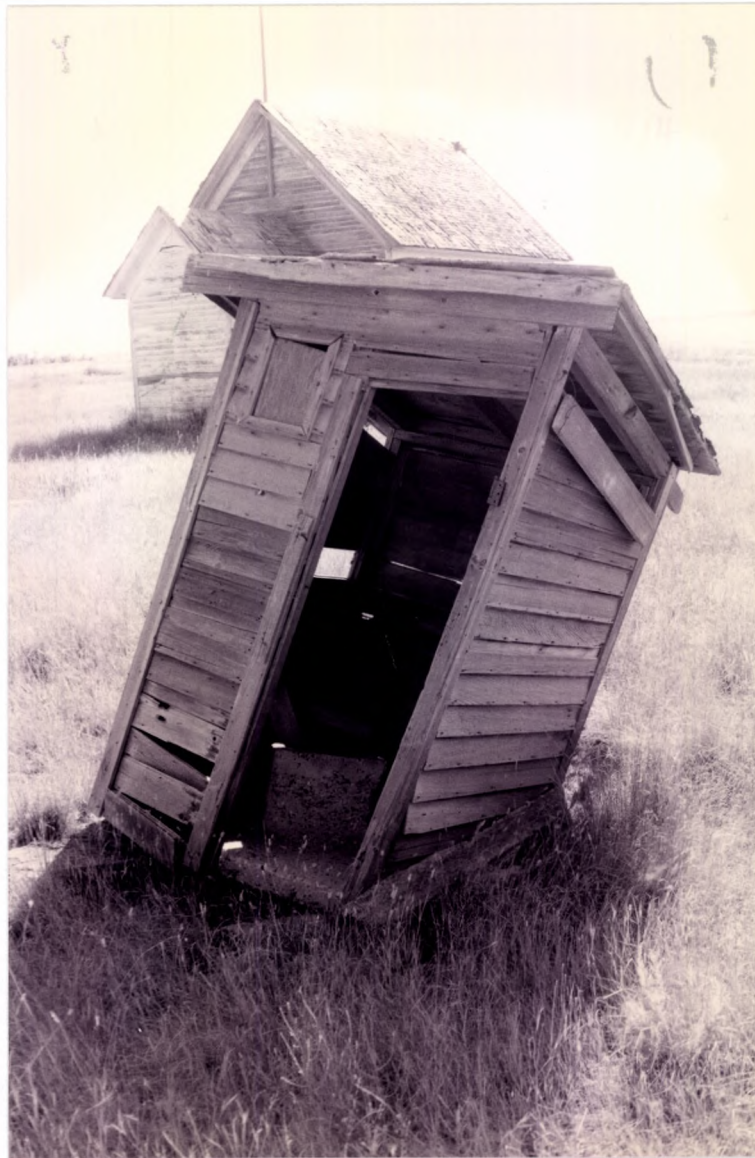
Roll FF Frame 12 Site SU128 Feature 2 Date 2/4 View from NE

This privy stands northeast of the schoolhouse. This is a wood frame building on a foundation of wood timbers. The exterior is horizontal wood siding. The shed roof is covered with asphalt shingles. The door opens to the east. This privy has a poured concrete combination floor and toilet pedestal that is similar to ones found in other privies in the area, especially schoolhouse privies, and so must have been produced by a local provider and sold in the area. The privy likely dates from the 1910s.

Subject: Privy

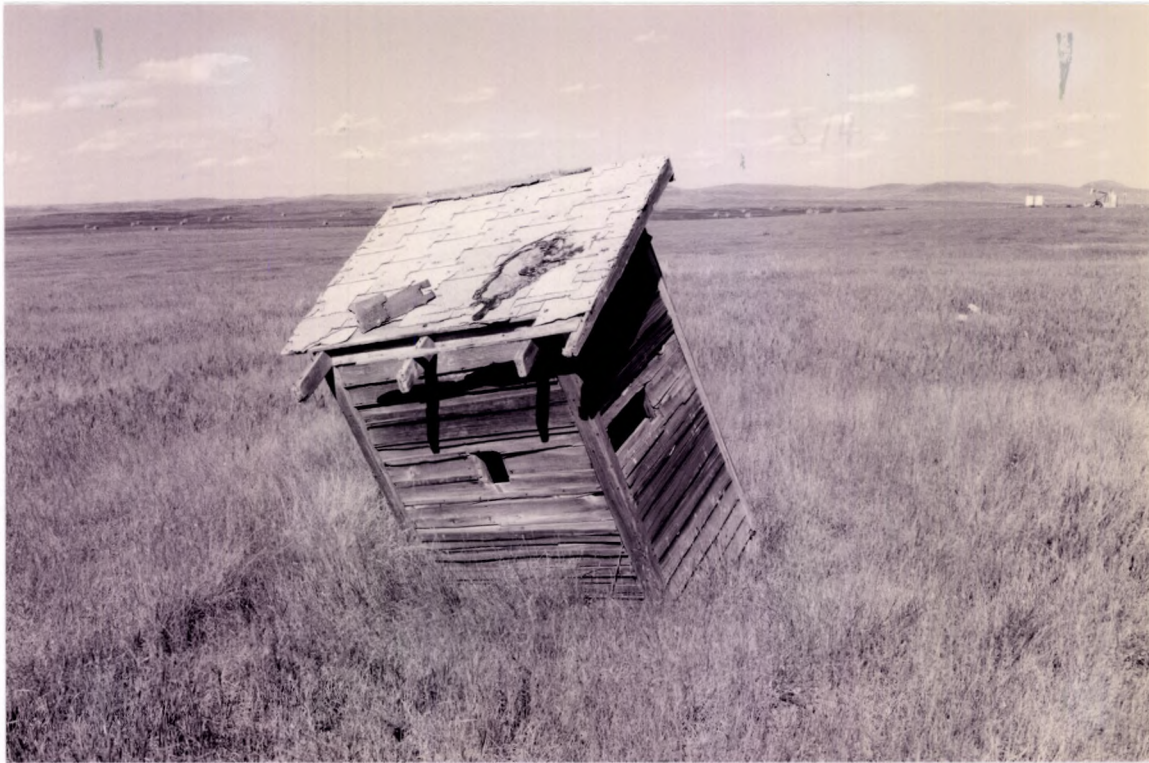
Roll FF Frame 13 Site SU128 Feature 2 Date 8/4 View from SW

Subject: Privy
