NDCRS SITE FORM  
ARCHITECTURAL SITES

Field Code SU 137 Site Name Schoolhouse  
Field Code \_\_\_\_\_ Site Name \_\_\_\_\_

Manuscript/Report Title: Survey of Bowman County

Photographic Coverage, Historic Architectural Survey of Bowman County, 1997

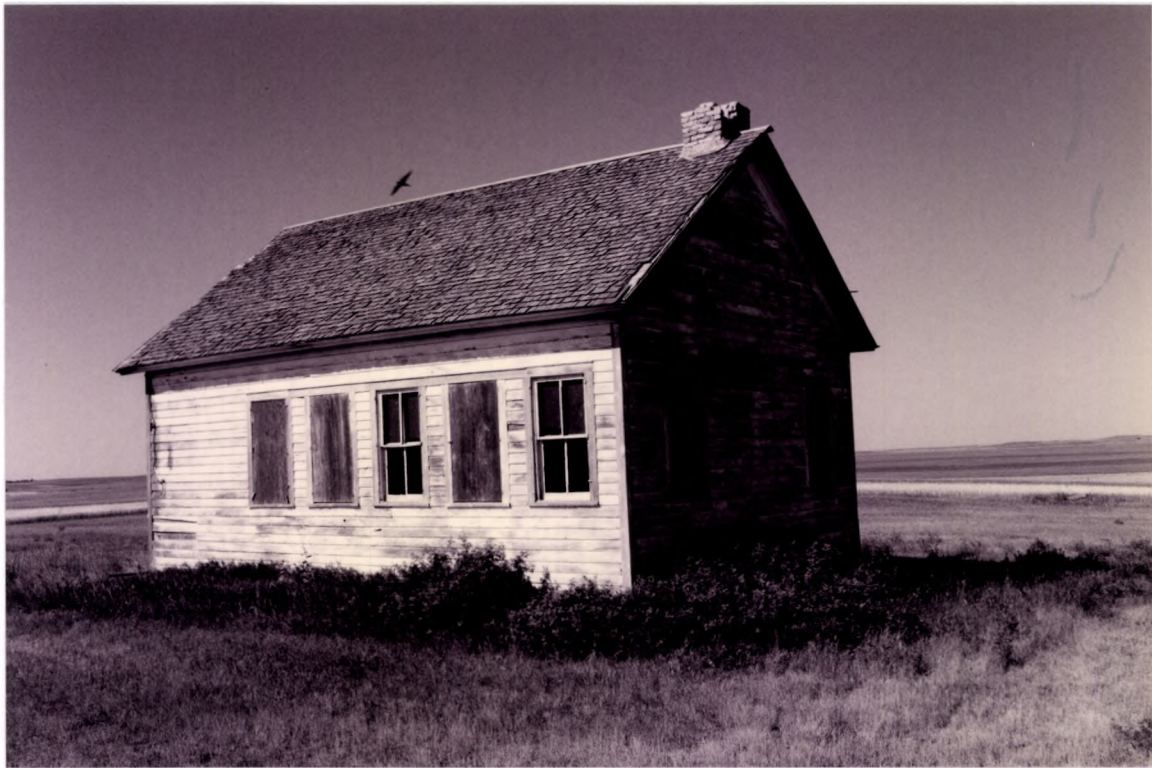
Roll JJ Frame 21 Site SU 137 Feature Date 8/6 View from NE

Subject: Schoolhouse

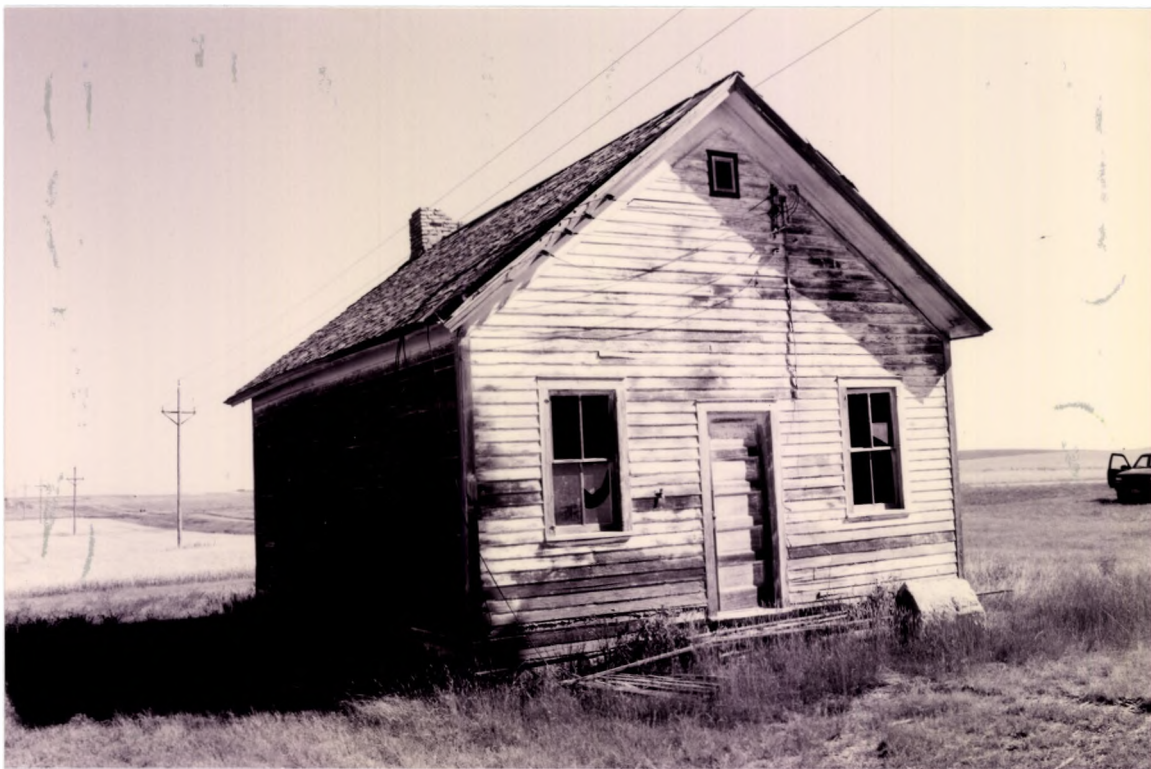
Roll JJ Frame 22 Site SU 137 Feature Date 8/6 View from SW

Subject: Schoolhouse
