NDCRS ARCHITECTURAL SITE FORM PAGE 3—Feature Data

Field Code QCRS-MC2A

SITS# 32 BO 945

1. Feature Description, Integrity, Eligibility:

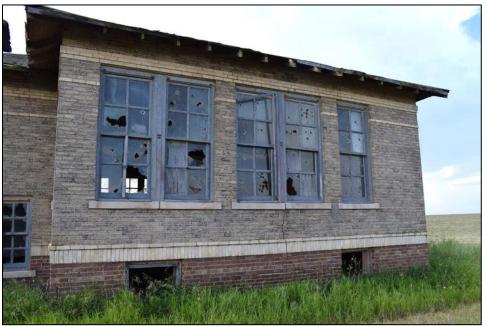
Exterior window frames are largely in tact on the main floor and still contain some of the original hardware, however most glass panes are broken or have sustained bullet holes.

Figure 9. Detail of windows on north side of QCRS-MC2A facing south.

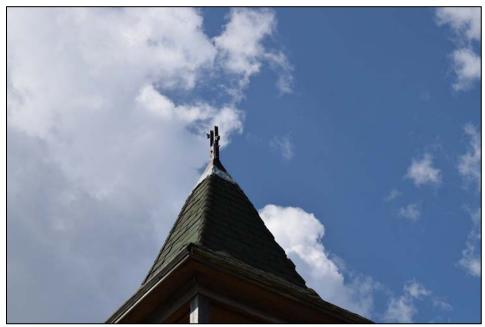
[2023] When the site form was originally completed in 2020 the school building was recorded as having only one story. During the 2023 visit the interior was documented and shows a complete basement level. Additionally, in 2020 a weather vane base on the top of the steeple was noted and that the weather vane was missing. Interviews with Braatan and Hedrickson tell us that it was the base of the flag pole and that the flag pole is missing, not a weather vane.

Figure 16. Detail of flagpole attachment on bell tower of QCRS-MC2A facing southeast.

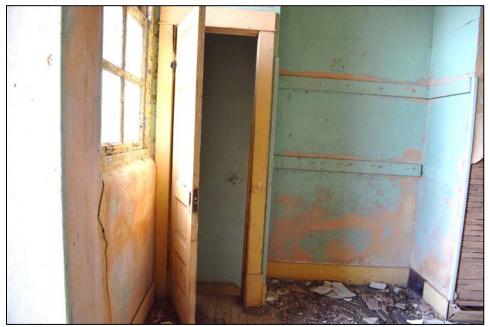
Extensive damage has been done to the main floor of the Adelaide Schoolhouse. The ceiling has holes that proceed through the roof and sunlight can be seen. This has allowed rain and snow to penetrate the roof and caused the plaster to rumble. Laths behind the plaster are visible and in some places missing. Other portions of the walls are exposed brick where the plaster has crumbled. Interior door frames and interior transom window frames are largely intact. The hardware for opening and closing the interior transoms are still attached to the door frames, however only one is still attached to the transom as well. One remaining interior door is still attached to the hinges and opens to the stairwell that leads to the girls' toilet.

Figure 20. Inside QCRS-MC2A front door showing doorway to girls' toilet stairway, facing south.

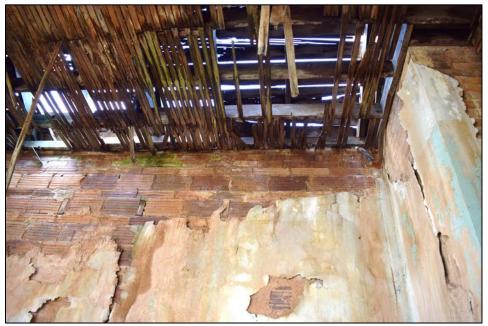
Figure 31. Ceiling details slightly south of center of rear wall in QCRS-MC2A.

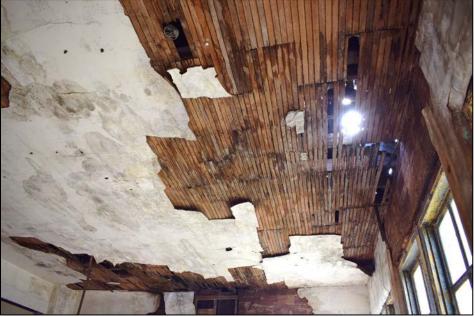
Figure 32. Ceiling details in northwest corner of interior QCRS-MC2A.

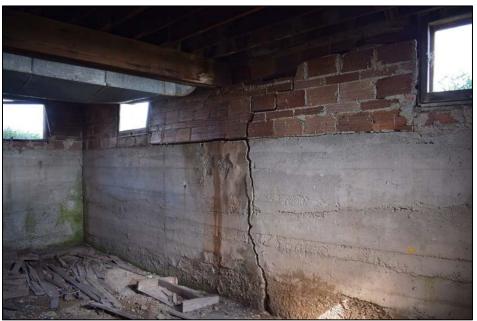
The basement level of the school and is accessed by a stairwell in the northeast corner. Floors and walls in the basement are poured concrete with brick completing the basement walls from about ground level to the base of the main floor walls. Windows in the basement are all missing and the frames are bent or missing, likely due to the bowing foundation.

Figure 47. North basement wall showing bowed foundation.

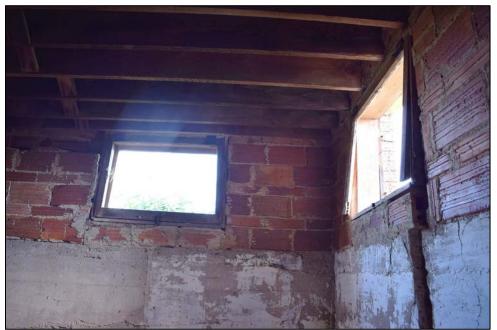
Figure 48. Northeast basement windows facing north.
