NDCRS SITE FORM
ARCHITECTURAL SITES

Field Code SU 187 Site Name Schoolhouse
Field Code _____ Site Name _____

Reconnaissance Survey Historic Architectural Intensive Survey _____
Survey of Bowman County

Author(s): Isern & Velure

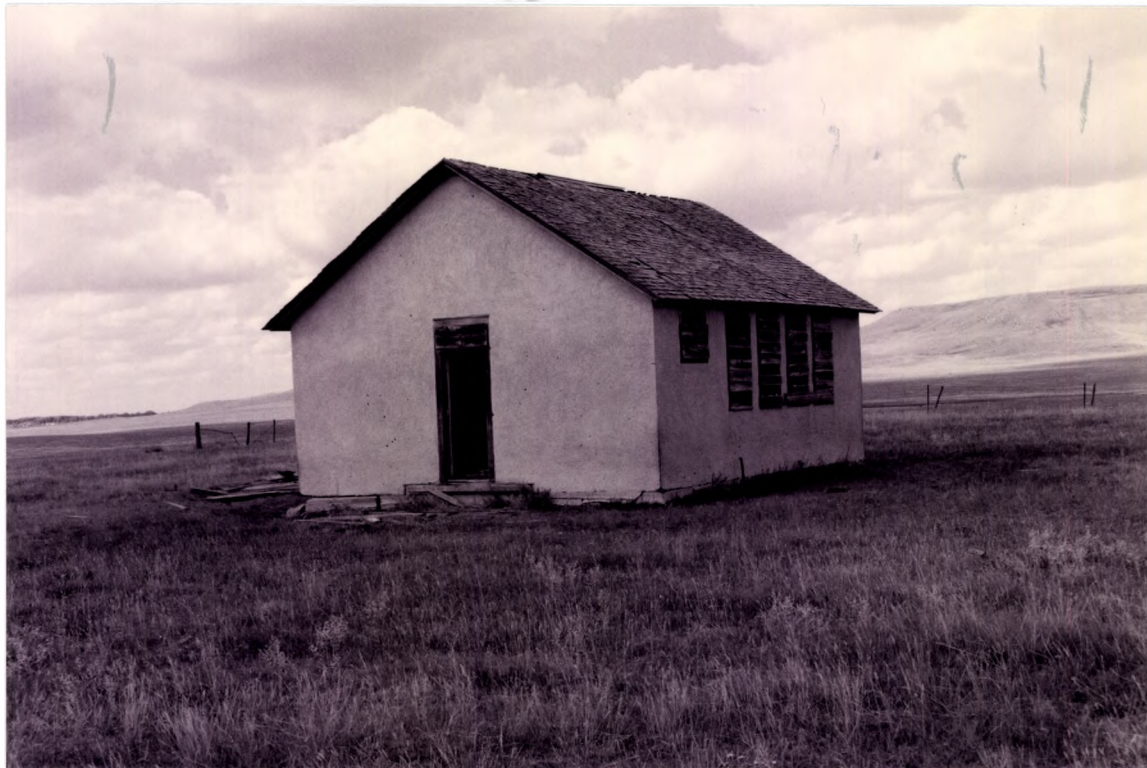
Roll KKK Frame 7 Site SU 187 Feature Date 8/12 View from SF

Subject: Stucco schoolhouse

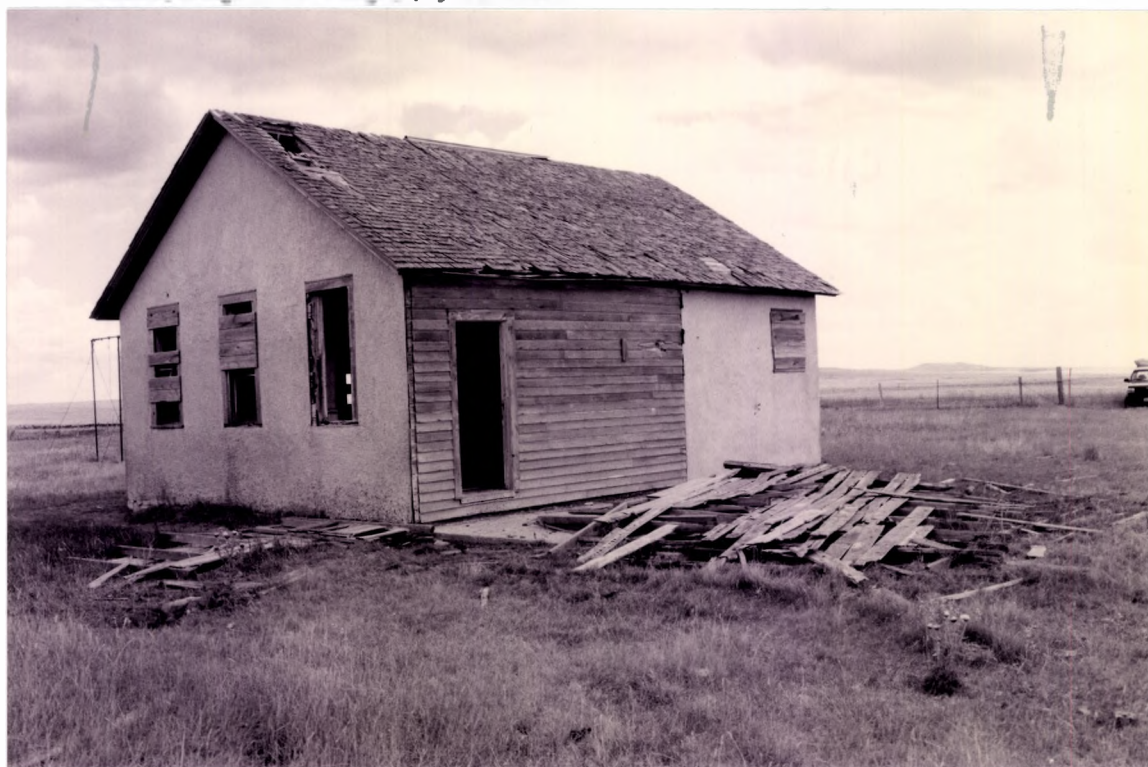
Roll KKK Frame 8 Site SU 187 Feature Date 8/12 View from NW

Subject: Stucco schoolhouse
