### NDCRS ARCHITECTURAL SITE FORM PAGE 1

·/(OL ·	SIT	<b>IS# 32</b> BU	760
SITE IDENTIFICATION					
Field Code Scandia #1		Site Name So			
Map Quad Roth		Site Name			
Map Quad					
LTL TWP 163 R	78 SEC	5 qqq[	a QQ	8	Q 8
	SEC _	. <u>.</u> QQQ.			<u> </u>
LTL TWP R	R SEC _ R SEC _	QQQ _ QQQ _			=
UTM 542688	3 IN	70NF		ſ	
UTM 367048	114	ZONE NAD 1	13N 927 NA	D 1983	Subsection: 1 = N½
City:					2 = E½ 3 = S½
Street Number:					4 = W½
[ door o. th			=		5 = NE1/4 6 = SE1/4
Street Name: 108th St N	70				7 = SW1/4
Urban Legal Description:			_	l	8 = NW1/4
SITE DATA					
Total # <b>Architectural</b> Fea	itures: 1				
Fieldwork Date: 3/	18/2020				
Reconnaissance Survey	Intens	ive Survey			
Project Title & Supervisor:	:				
Country Schoolhouse Pro	oject				
Report Title & Author(s):					
Additional Information:					
SHSND USE Area of Significance Area of Significance	Ecozone	Verified Site Non-Site _		CR Type .	2
Recorded By	Kathy Wilne	er	Date Reco	orded 5/23	/2020

FAGE 3—Feature Date	V-2
Field Code Scandia #1		SITS# 32 BU

The feature is a one room prairie school on a concrete foundation. The roof is covered with pieces of asphalt shingles over wood shakes. The roof on the west side is fall

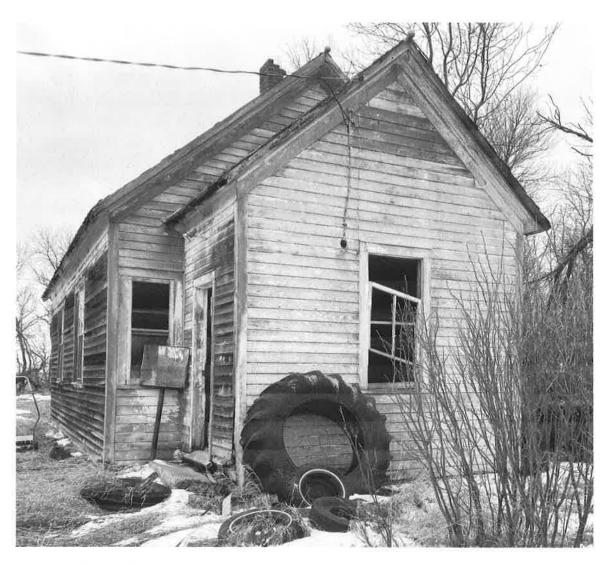
North Side

A rake board runs under the peaks of the roof followed by 6 inch wood lap siding with 6 inch corner trim. There is an entry at the north end of the building with a 5 panel wood door. There is one broken, double hung window on the north wall of the entry, no glass left. There are two pairs of two over two double hung windows on the east wall of the school with some glass. Four more two over two, double hung windows are on the south wall, again some glass. There is one narrow window on the north side of the school room and I believe the coatroom is between the entry and the school room. A 4 panel wood door leads into the school room from that coatroom. Two half moon windows are located above the blackboards on the west wall. The interior walls are wallboard and beadboard with much of it fallen off. The ceiling is wall board over lathe and much of the wallboard has fallen. The floor is tongue and groove hard wood. There is a lot of junk laying around in the school. A picture rail can be seen on some of the walls and there is an oil burning stove on the north wall of the school. Light fixtures and outside electrical lines indicate electricity.
