## NDCRS SITE FORM ARCHITECTURAL SITES

Field Code US.W.R.O.6 Site Name PUBLIC SCHOOL #69  
Field Code \_\_\_\_\_ Site Name \_\_\_\_\_

# NORTH DAKOTA CULTURAL RESOURCES SURVEY

#### Feature 1: Historic Schoolhouse

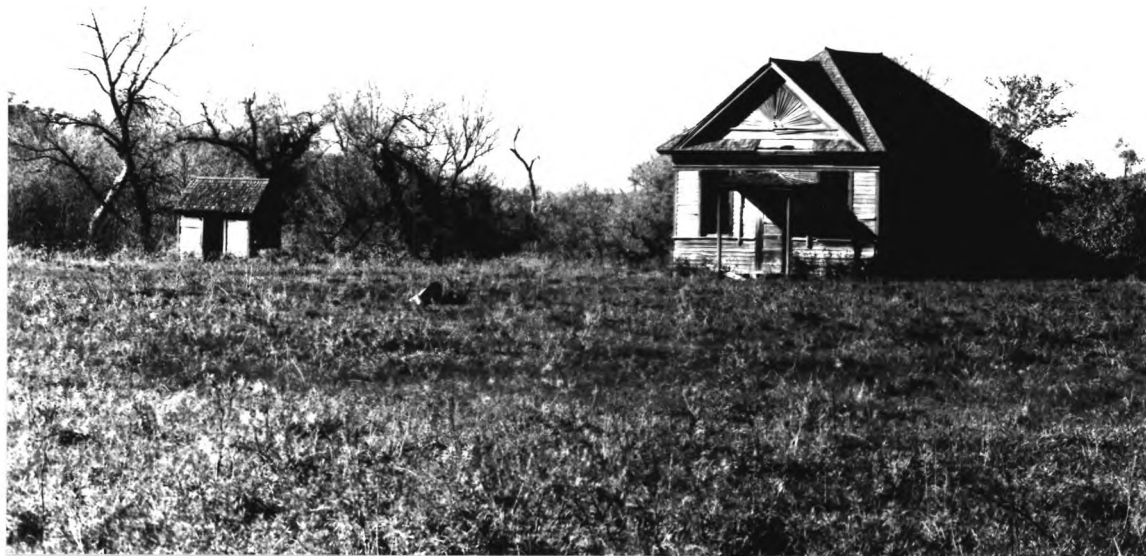
Photograph #1: Schoolhouse/Privy Looking West (Roll 1, Neg. 19)

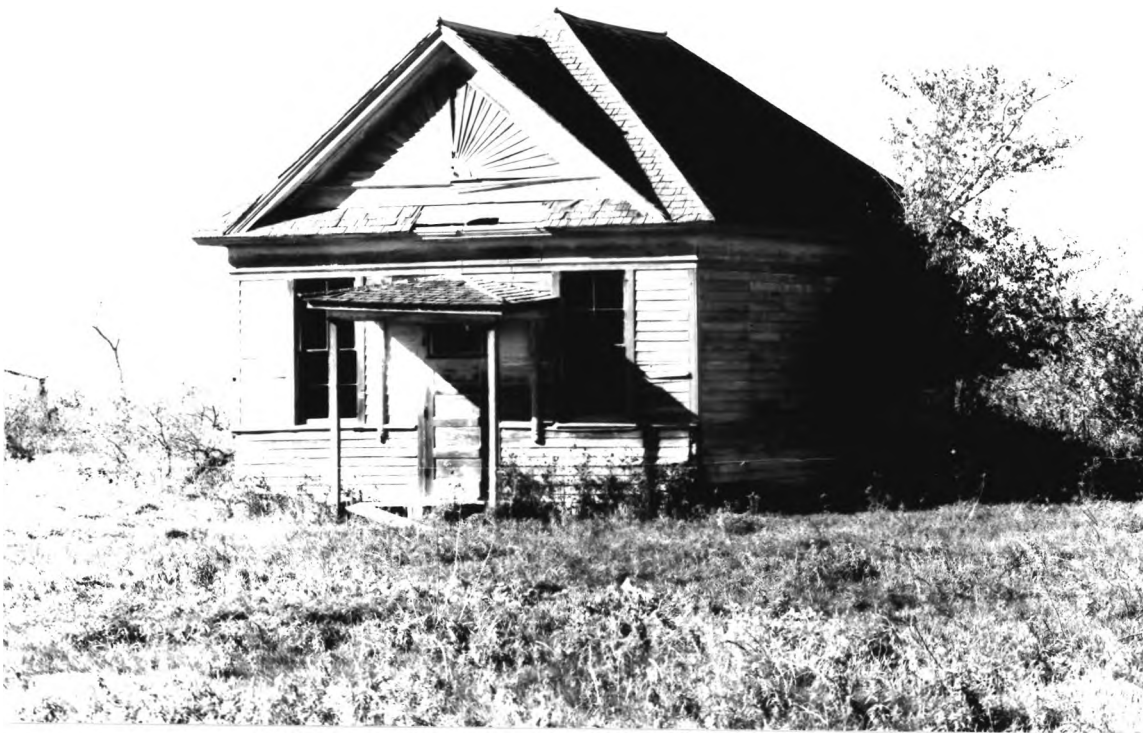
In October, 1999, Dr. Godfrey visited Site 32CS24, which had deteriorated considerably since it was first evaluated in 1985. The schoolhouse on Site 32CS24 is a 20 x 32 foot woodframe constructed, wood shingled hip roofed schoolhouse with a fronted/centered fan-shaped sunrise or sunburst motif gable end with a pent roof and no returns. The west facade of the building has a rectangular hipped porch supported over the main entrance by two square posts [not original] and two half-turned clapboard piers. The porch is missing 90% of the original gingerbread decoration that once adorned the entrance. The building is banded by a 12 inch frieze board.

Photograph #2: Schoolhouse Looking West (Roll 1, Neg. 20)

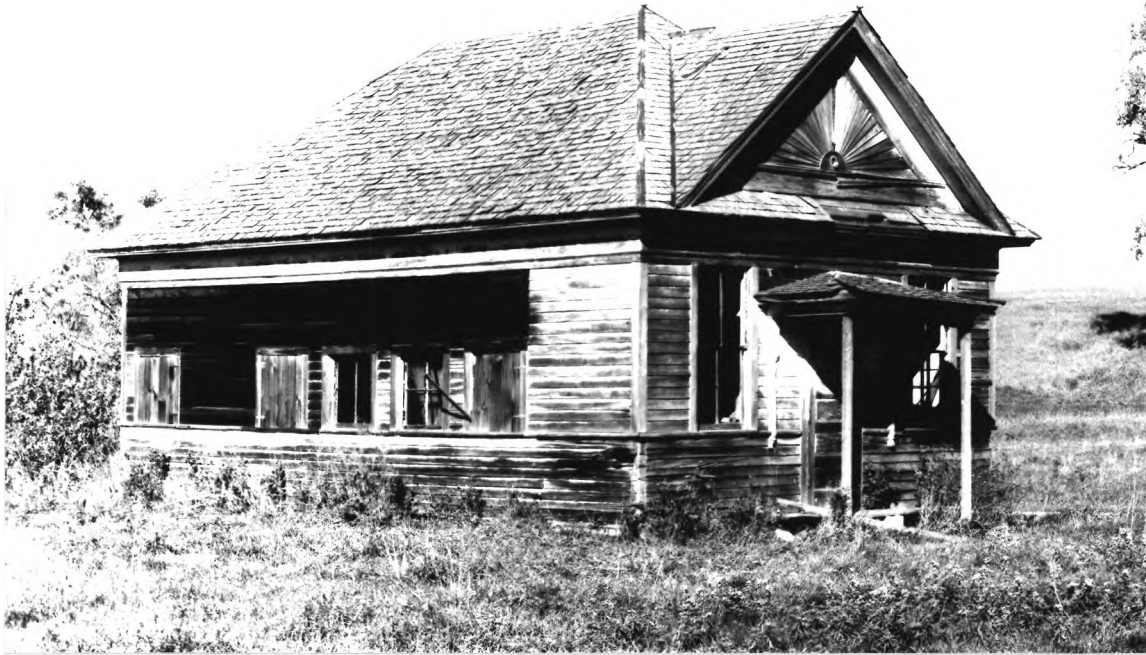
Photograph #3: Schoolhouse Looking Northwest (Roll 1, Neg. 21)

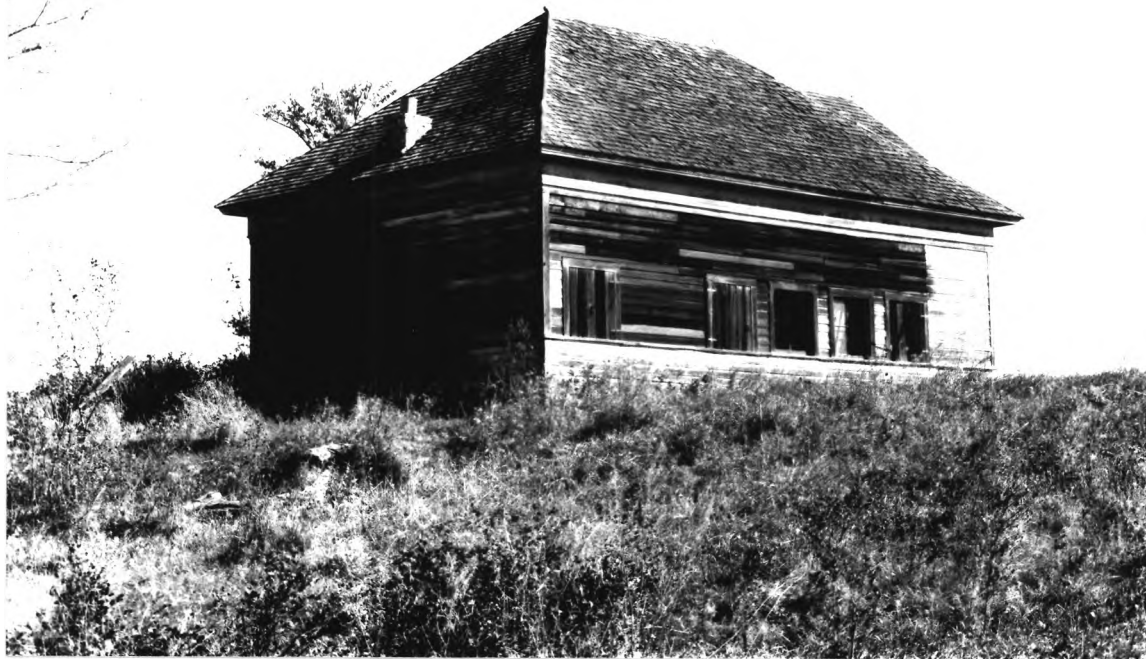
Photograph #4: Schoolhouse Looking Northeast (Roll 1, Neg. 22)

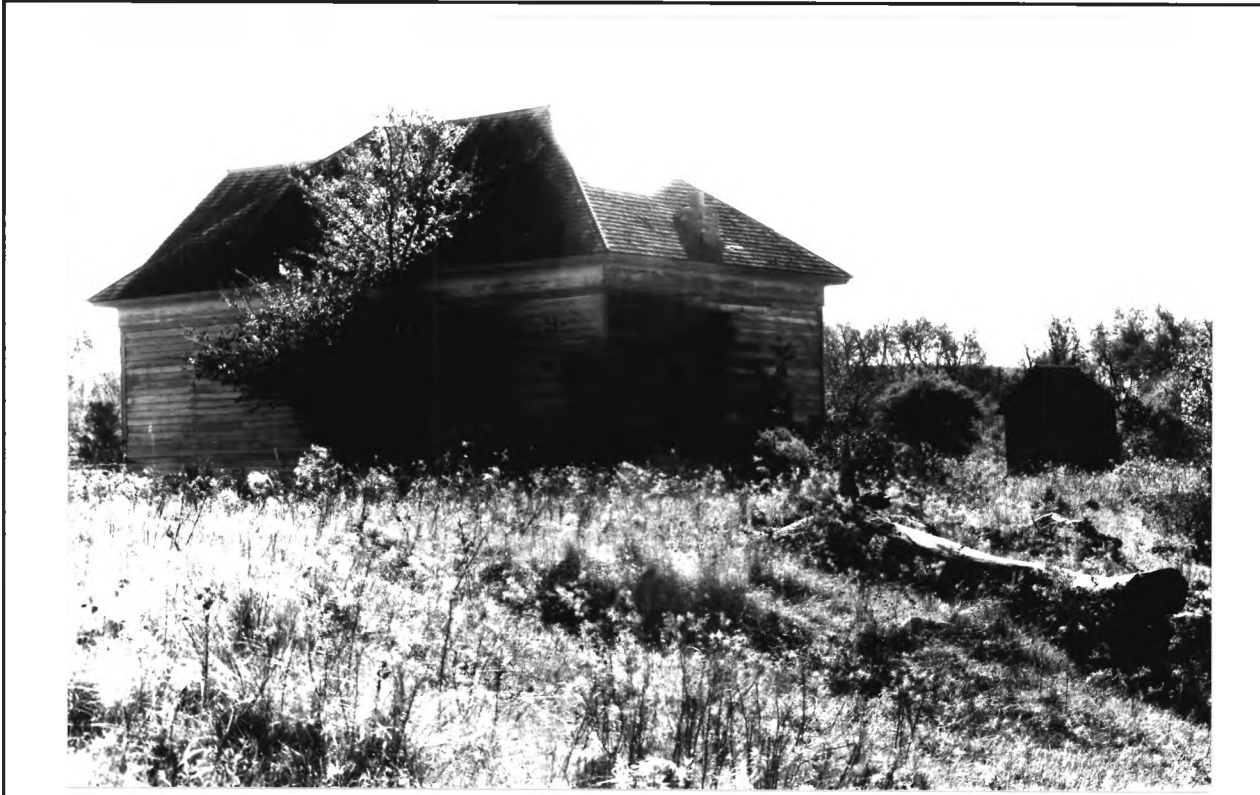
Photograph #5: Schoolhouse Looking Southeast (Roll 1, Neg. 23)

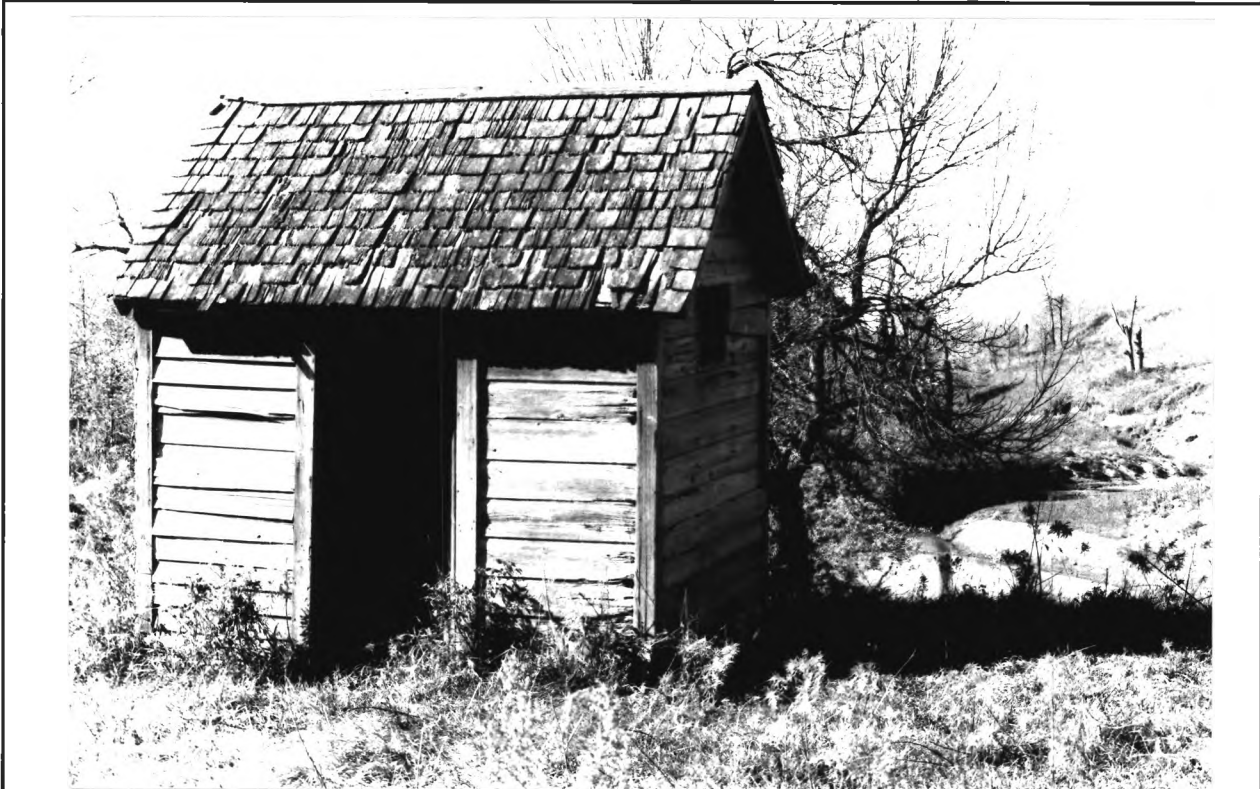
In October, 1999, Dr. Godfrey visited the privy located on Site 32CS24, which had deteriorated considerably since it was first evaluated in 1985. The privy is 55 feet due south of the schoolhouse located on Site 32CS24 and is 6 x 8 feet in dimension with a doorway on the east

Since its recording in 1985, the outhouse has deteriorated considerably. Upon analysis, USWR has determined that the privy or outhouse located on Site 32CS24 is ineligible for nomination to the NRHP, mainly because it no longer holds its integrity of building materials, as well as its original setting and location.

Photograph #6: Privy Looking West (Roll 1, Neg. 24)
