NDCRS ARCHITECTURAL SITE FORM

Map Quad Hickson (1980) Site Name Ramstad Farm Complex

Fargo-Moorhead Metro Flood Risk Management Project
Gordon C. Tucker, Jr.

Architectural Feature # 2

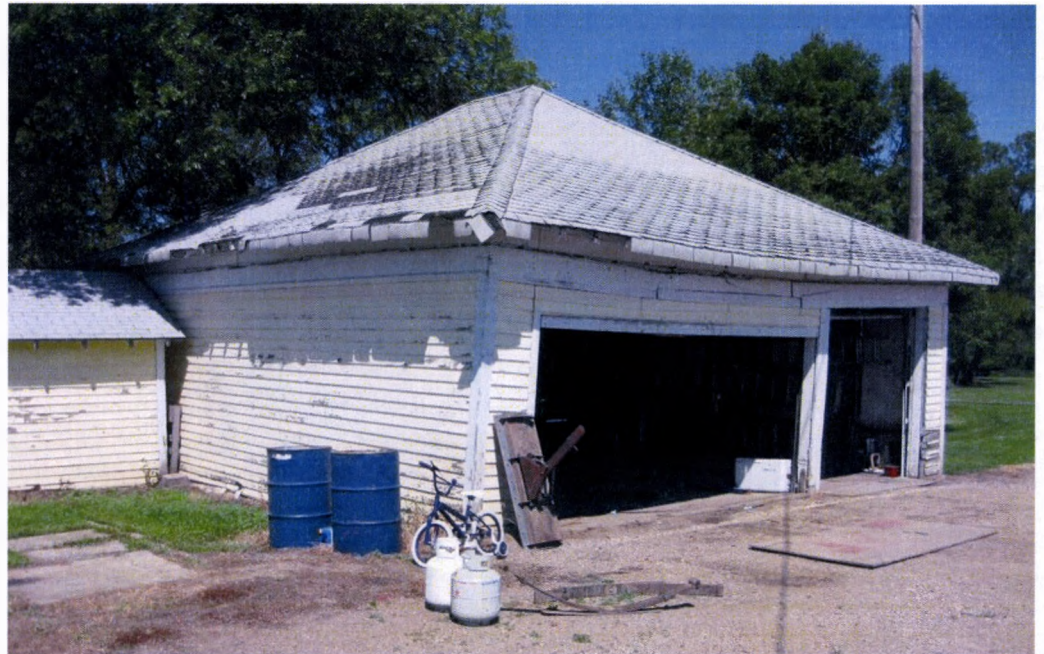
Photo No.:
ND_14-10

Description:
Feature 2: eastern and southern elevations of former school used as garage. Note opening for roll-up door, along with pedestrian opening, barge board below eave line, and wood siding.

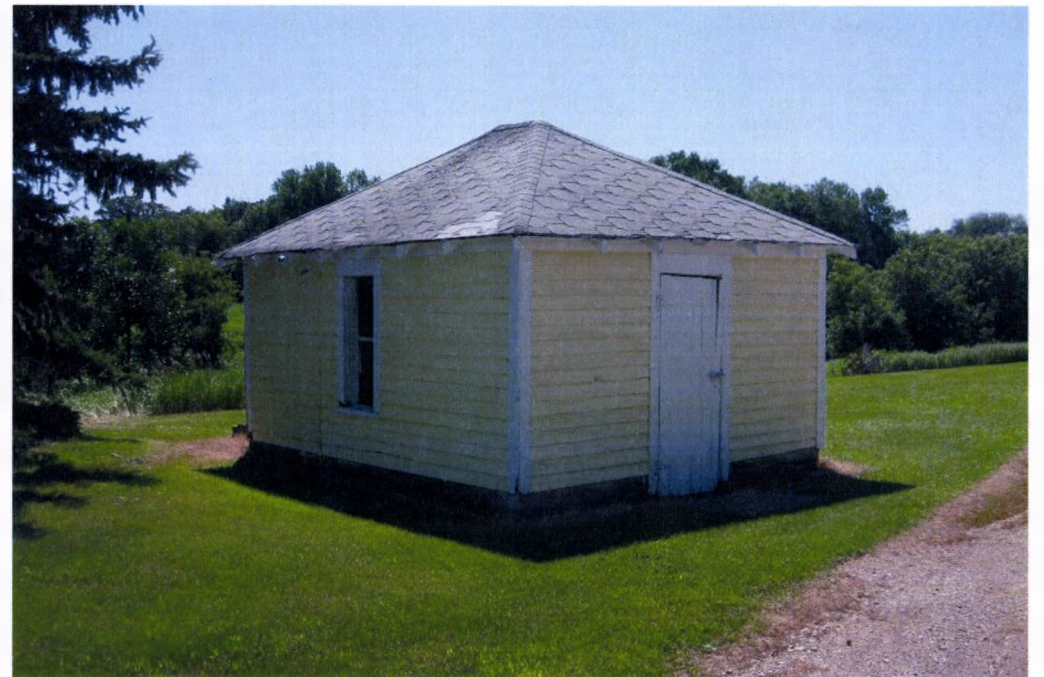
Photo No.:
ND_14-4

Description:
Feature 3: northwest corner of pump house. Note original windows and door, and wood siding.
