### NDCRS ARCHITECTURAL SITE FORM

Field Code JUP-17090-303

NEWUD Expansion Project, John G. Morrison

Northeast Water Users District Expansion Project: Class II and III Inventory, Benson, Cavalier, Pembina, Ramsey, Towner, and Walsh Counties, North Dakota.  
John G. Morrison

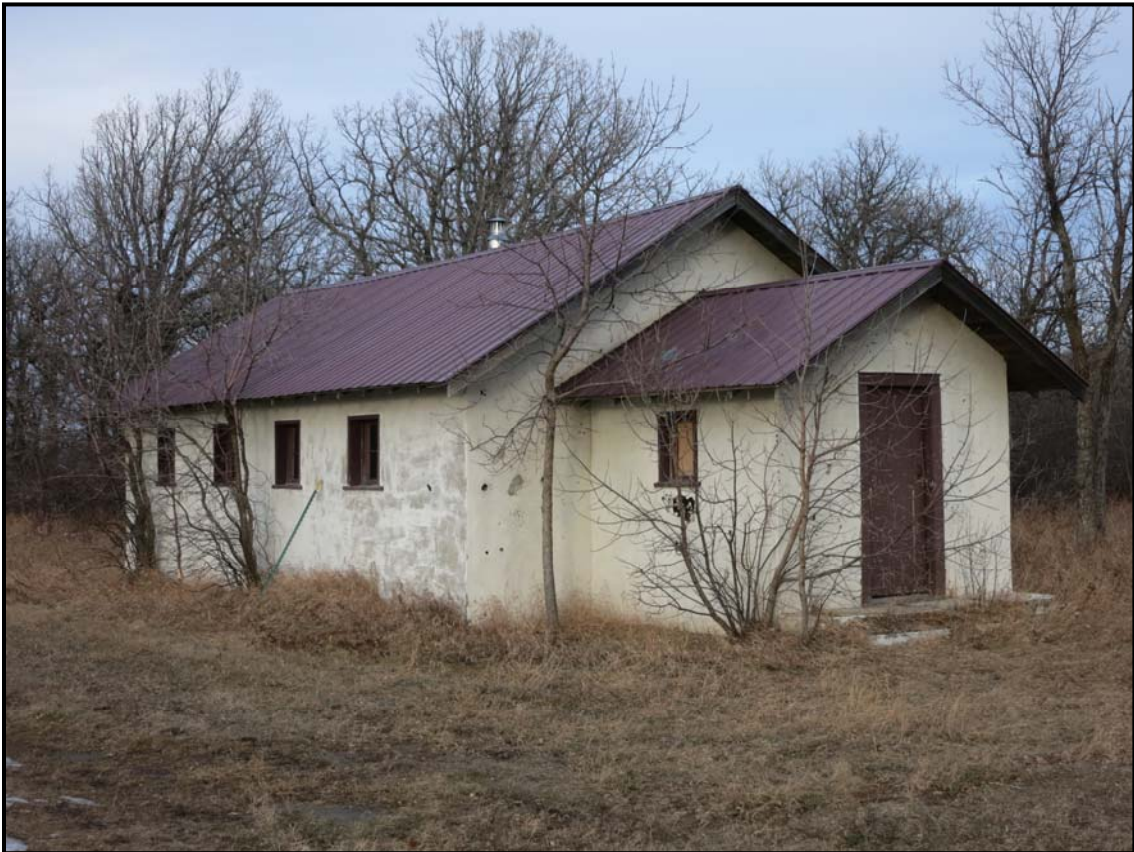
Feature 1 is in good condition. Feature 1 retains aspects of spatial integrity, but lacks some aspects of structural integrity due to modern repairs and some damage.

**Figure 4:** Overview of the southwestern corner of Feature 1, view to the northeast.

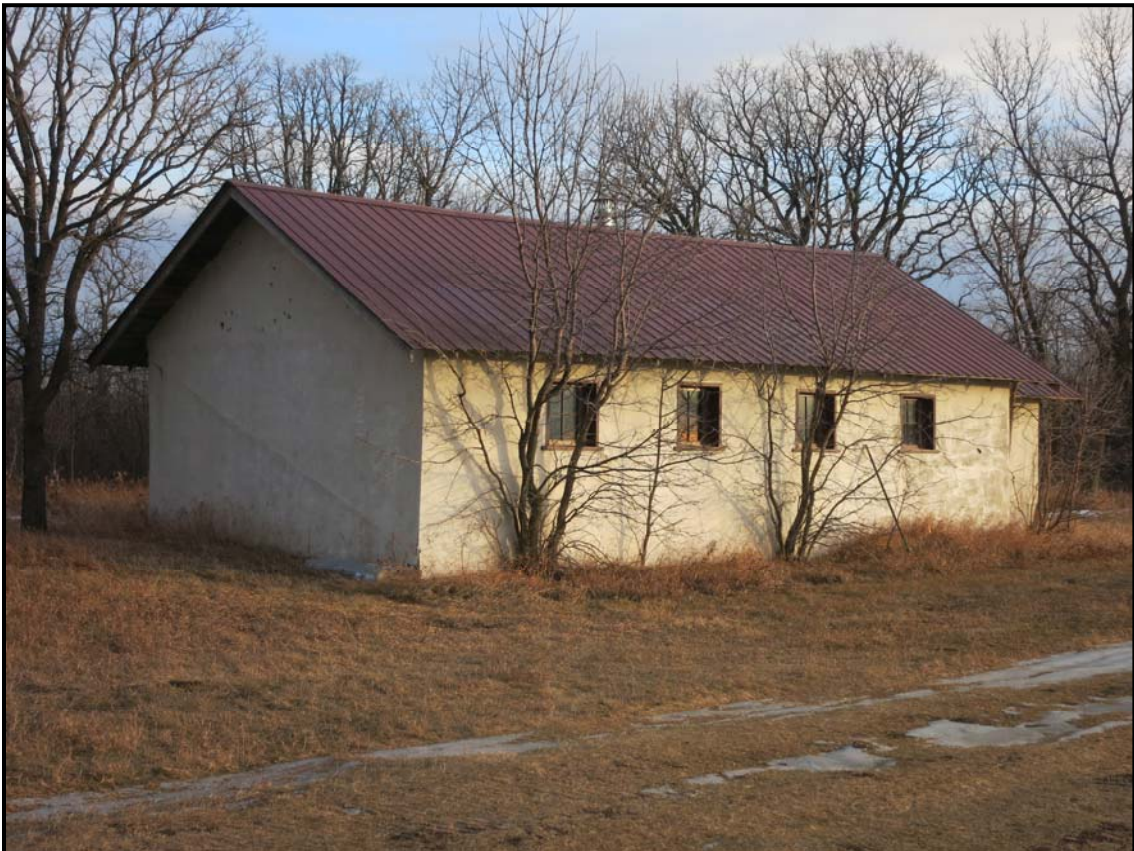
**Figure 5:** Overview of the northwestern corner of Feature 1, view to the southeast.

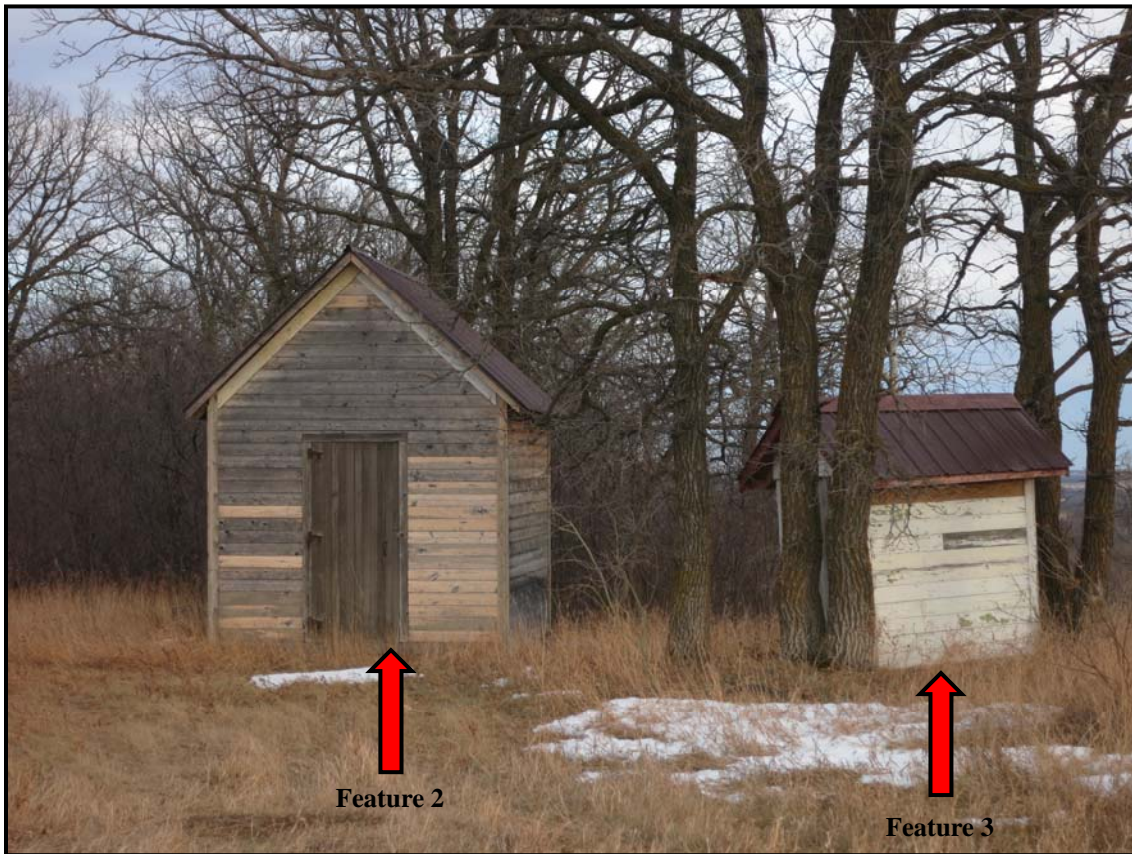
Feature 2 is in good condition. All modern materials appear original to the structure. Feature 2 retains significant aspects of spatial and structural integrity. Feature 2 does not meet the 50 year guideline for consideration for the NRHP.

Figure 6: Overview of Feature 2 and Feature 3 at Site JUP-17090-303, view to the east.

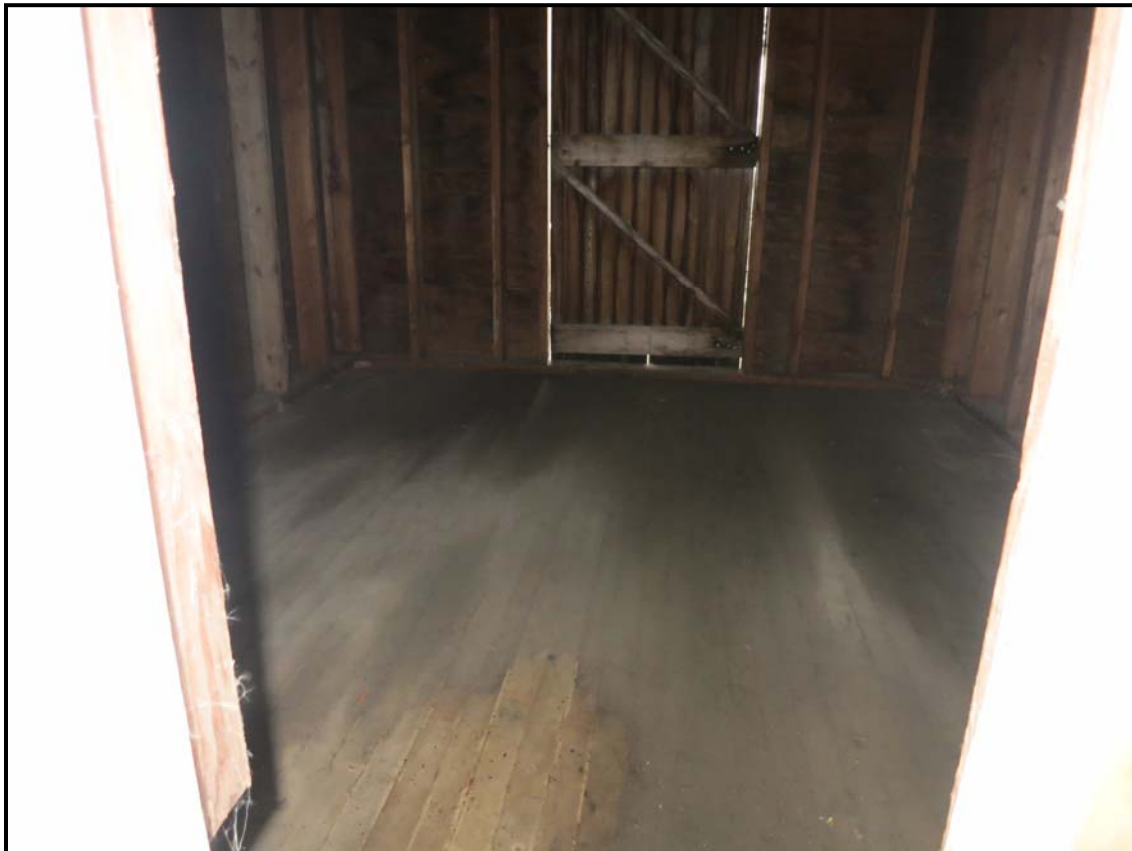
Figure 7: Overview of the interior of Feature 2, facing west.

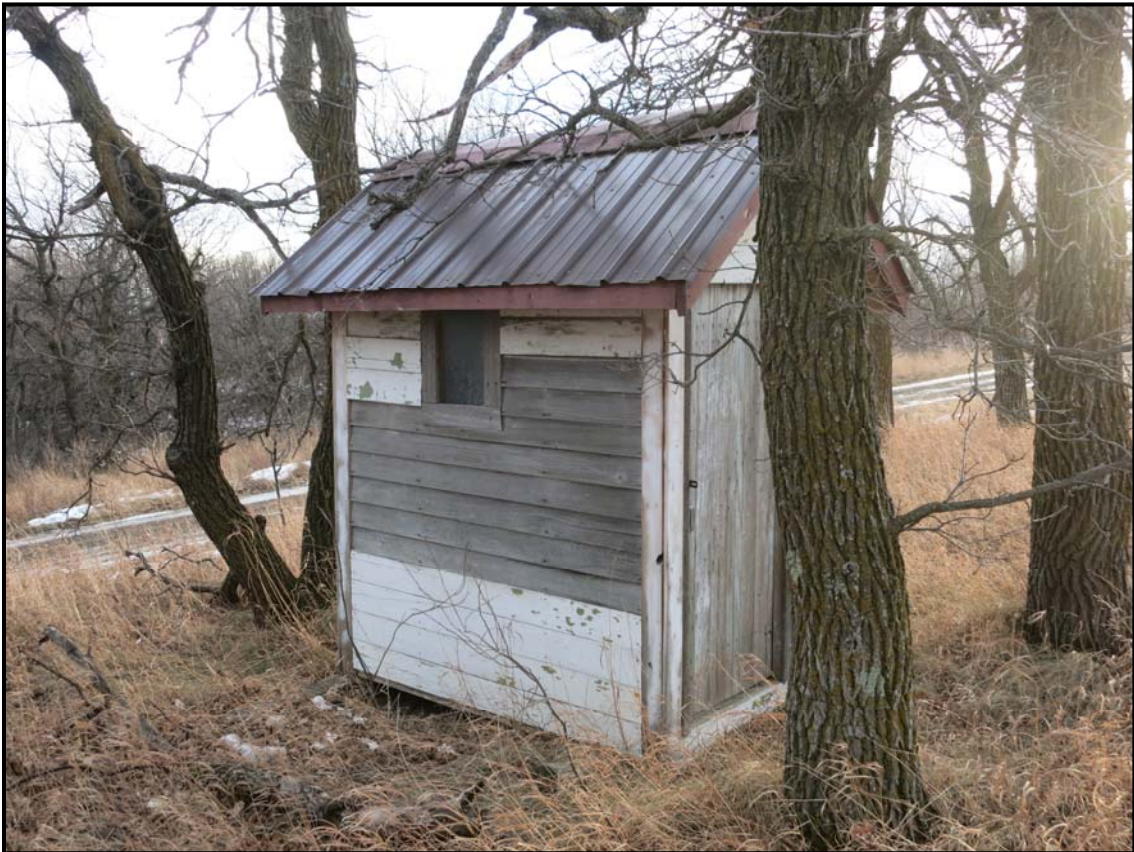
Feature 3 is in good condition. Feature 3 retains aspects of spatial integrity, but aspects of structural integrity have been compromised by modern repairs.

**Figure 8:** Overview of Feature 3 at Site JUP-17090-303, view to the southwest.

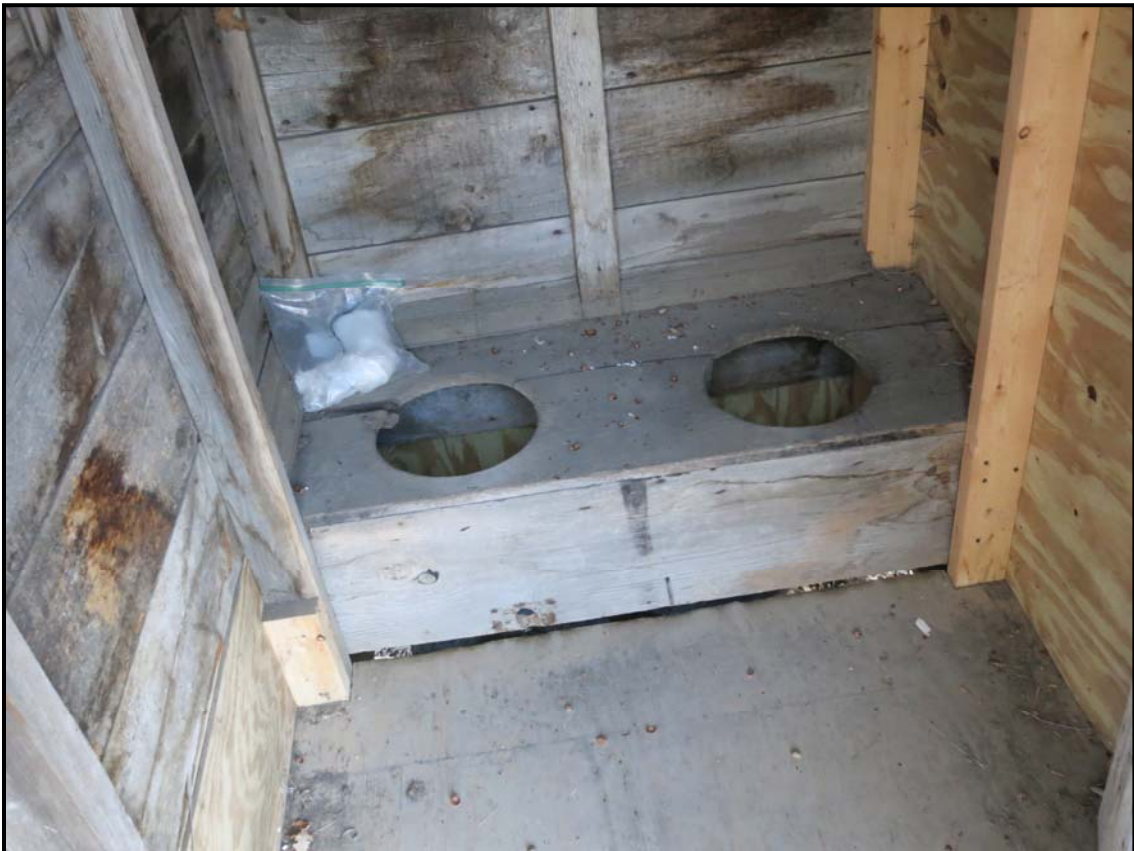
Feature 3 is an historic double - seater privy with modern repairs. Feature 3 measures approximately 7' on each side. Feature 3 has a wooden frame foundation, and a wooden frame supporting horizontal wooden siding. The degree of wear on parts of the frame and on the siding, as well as the style, indicate that Feature 3 may be about as old as Feature 1. The siding on Feature 1 has been repaired with modern boards, and part of the interior have been repaired with plywood. There is a modern door on the northern wall of Feature 3. There is a vent on the eastern wall. Feature 3 has a gable roof covered with the same sheet metal as Feature 1.

**Figure 9:** Overview of the interior of Feature 3. Note the modern repairs to the structure.
