NDCRS ARCHITECTURAL FORM

Field Code Semerada School

SITS# 32DU 1657

Project Title & Supervisor: Dunn County Roads Survey No. 1, 2011. Michael A. Jackson, UND Anthropology Research.

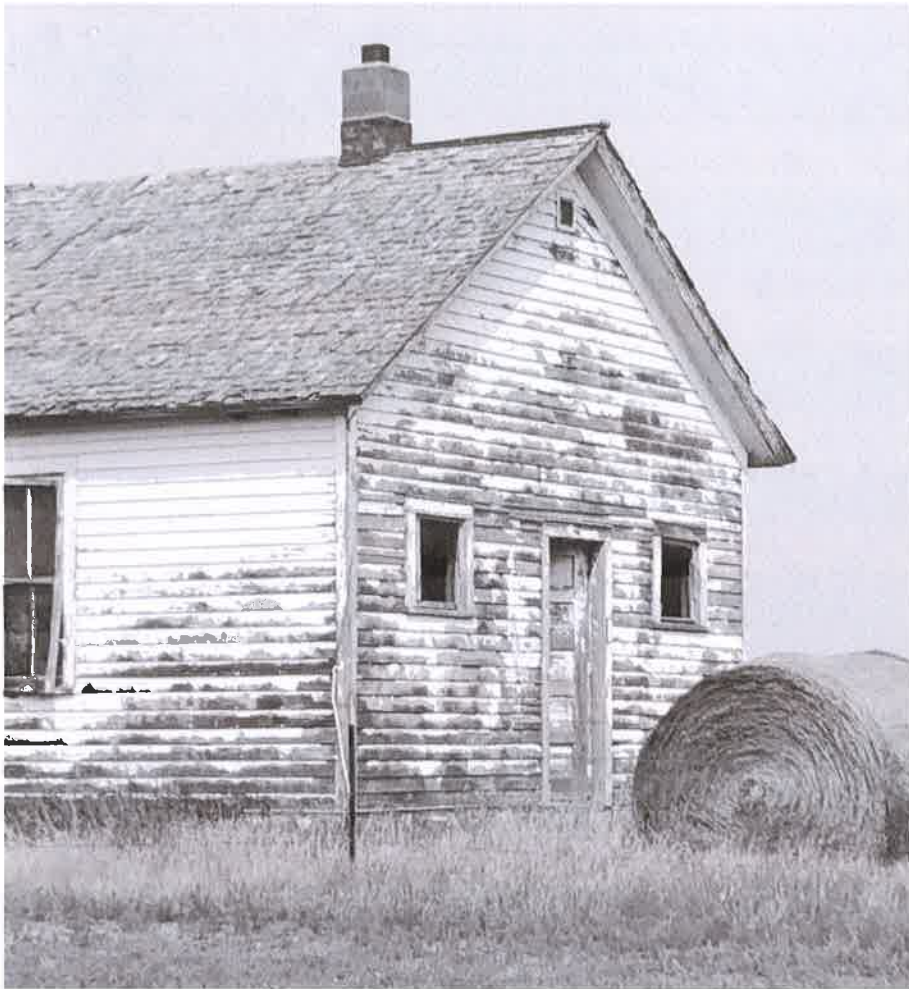
East Side

East exposure: This is the building front. The east face of the building has a central panel construction wooden door with five recessed panels. The door measures 34-in wide by 80-in high and has the original knob and hardware. The door and door frame are intact and in fair condition. Two identical windows flank this central door. The windows measure 2-ft 4-in wide by 2-ft high. The glass in these windows has been removed and window screen has been installed. The window frames are slightly deteriorated along the bottom sill.

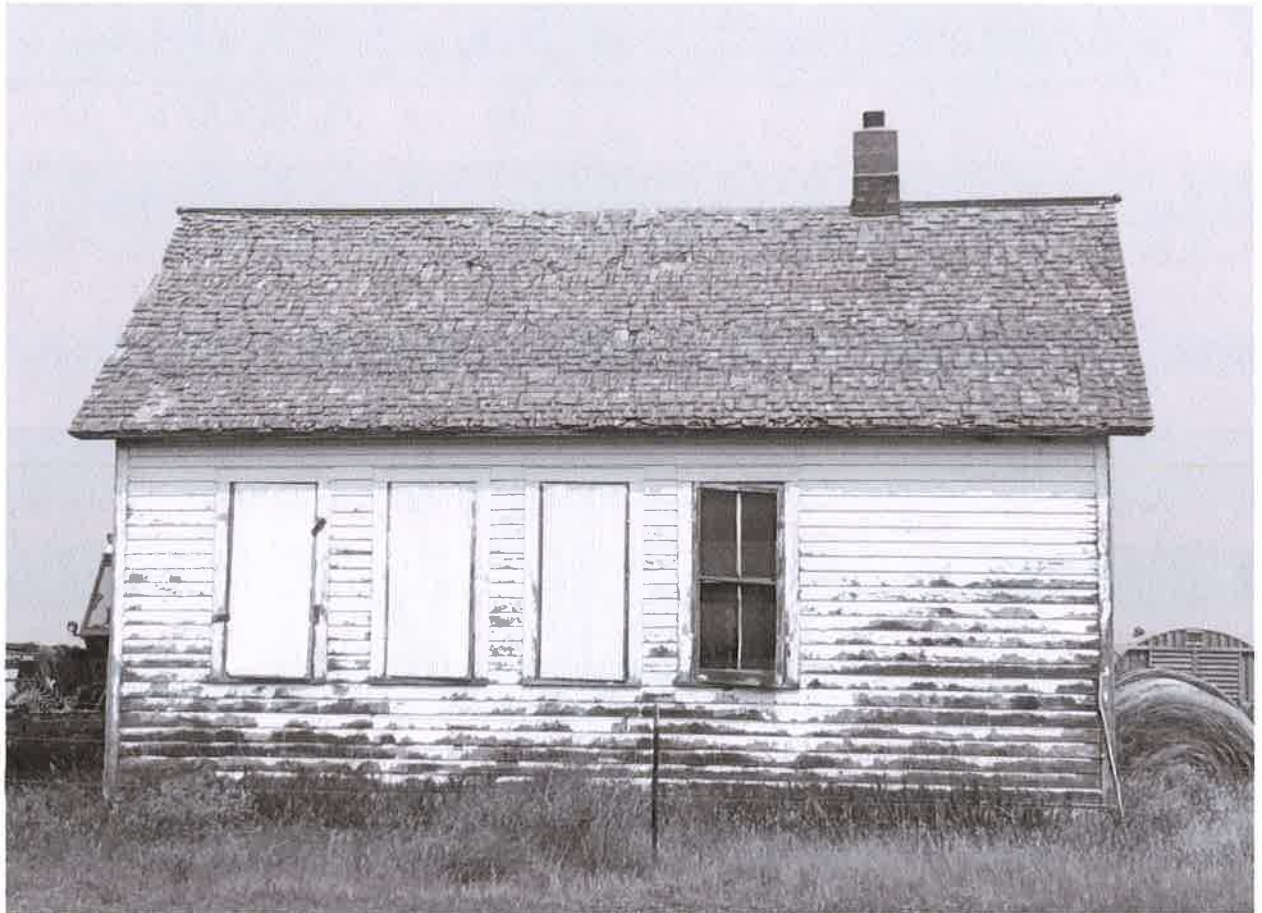
South
Side

South exposure: The south face of the building has four larger windows with separate frames. These windows measure 5-ft 4-in high by 2-ft 6-in wide and are of undetermined type. Three of the windows have been covered with corrugated metal panels. Some glass panes are missing and the bottom sills of the windows are completely without paint. The frames are in fair condition overall.

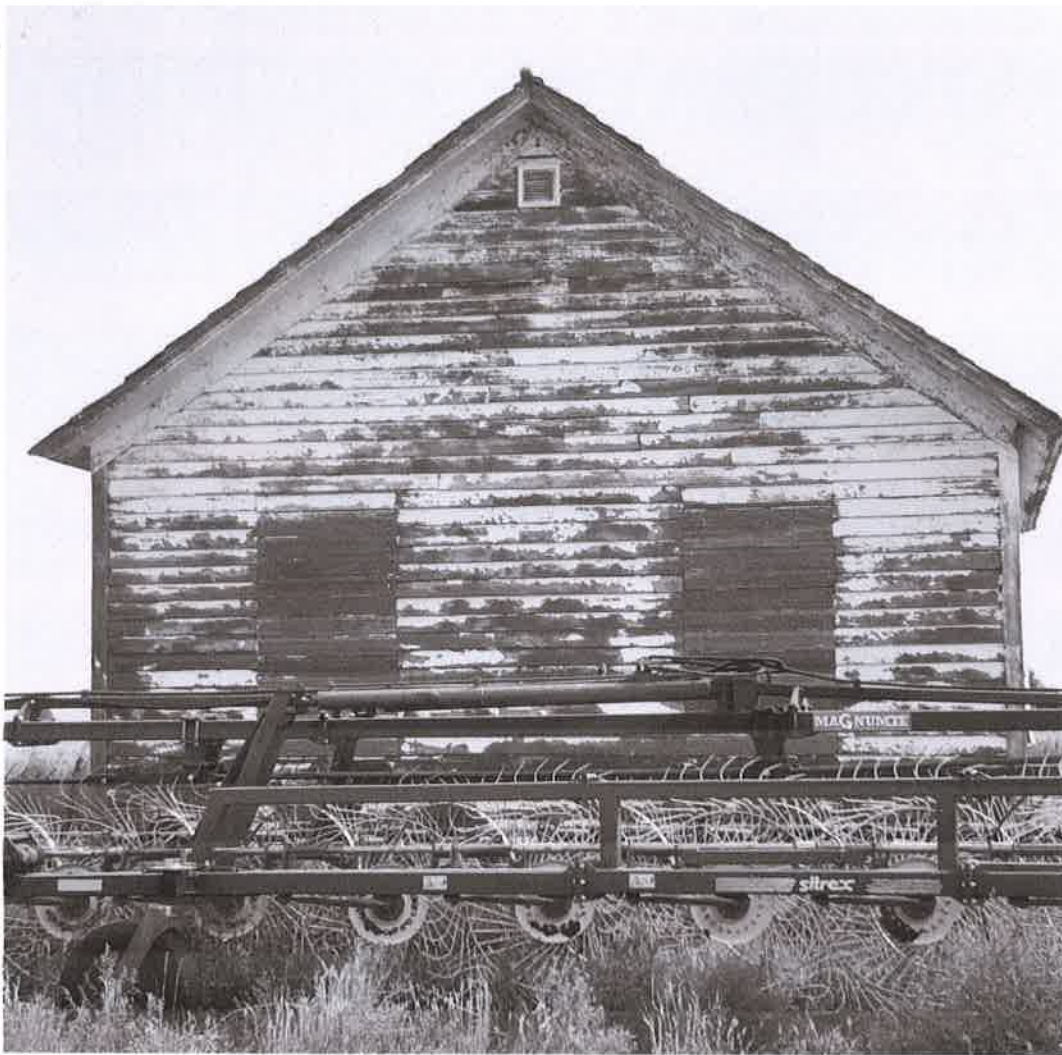
West Side

West exposure: There are two window openings on the west facing wall. These windows have been boarded over and are of undetermined type. The condition of the windows or frames is unknown.

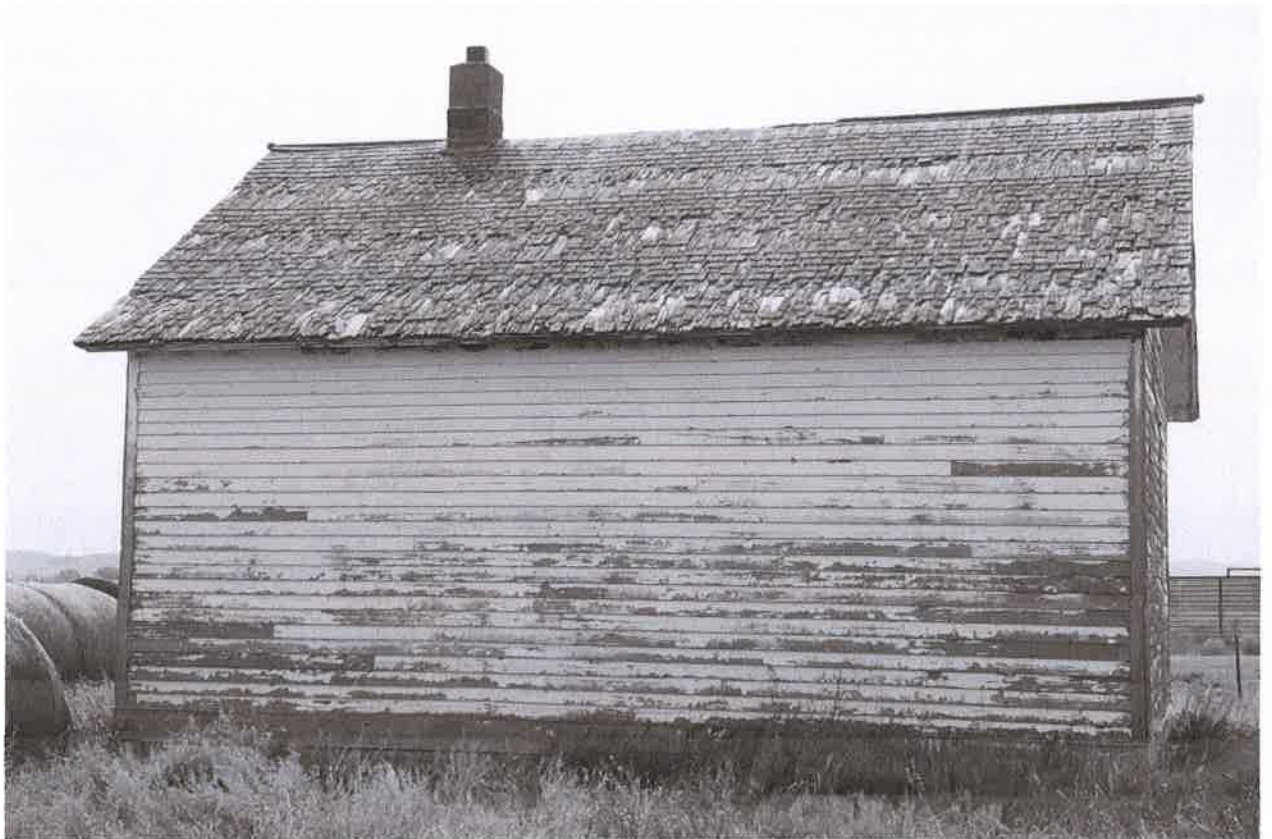
North
Side

North exposure: There are no doors or windows in the north face of the building.

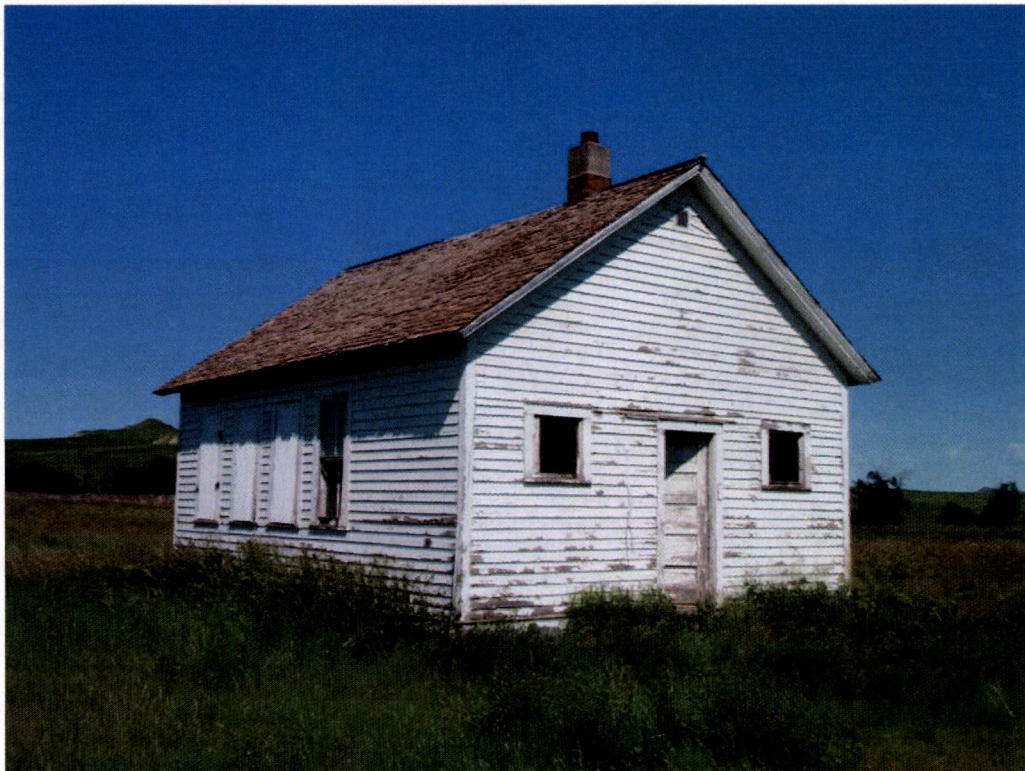
Feature 1 schoolhouse, front-side oblique view (View NW; UW2582-099).

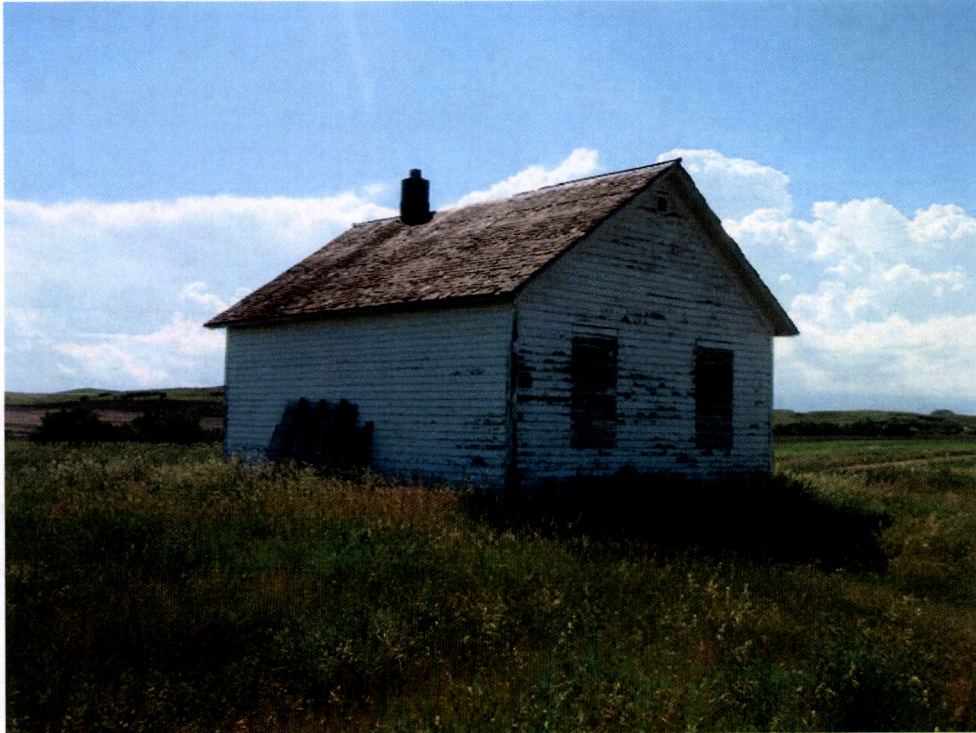
Feature 1 schoolhouse, rear-side oblique view (View SE; UW2582-104).

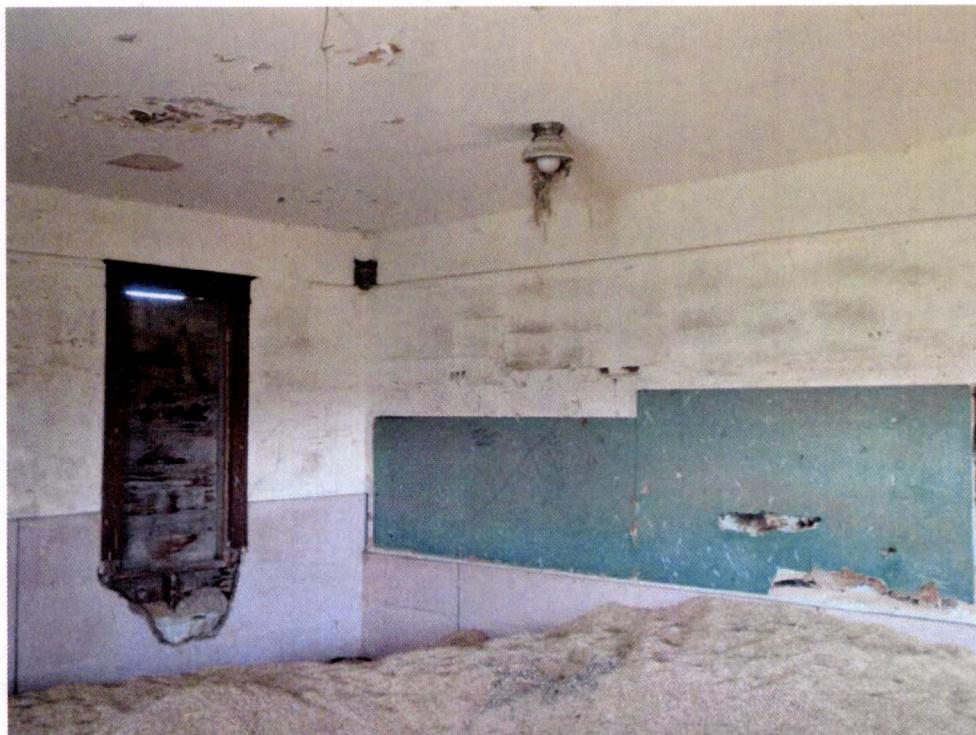
Interior: The school is divided into three rooms. A small entryway, in the southeast corner of the building, opens into the main classroom area. A small office or coat room is located in the northeast corner of the building. The chalkboard and several school desks remain inside the building. Sheets of 4-ft by 8-ft laminate bathroom wallboard have been attached to the base of the walls. One-to-two feet of wheat seed covers the floor of the main room and the office/coat room. It appears the wallboard has been used to reinforce the base of the walls, so that the abandoned school could be made useful as a granary. The original light fixtures are present.

Interior of Feature 1 schoolhouse. West and north walls with chalkboard and boarded-up window. (View NW; UW2582-088).
