NDCRS ARCHITECTURAL FORM PAGE 1

Field Code			SITS# 32 DV	198
			Long Creek Twp Sch	
Map Quad Paulson Map Quad		Site Name	Bounty School	
LTL T. <u>163</u> N., R LTL T N., R LTL T N., R LTL T N., R	W., Sec W., Sec	_ QQQ of the Q _ QQQ of the Q	Q of the Q Q of the Q	1 = N½ 2 = E½ 3 = S½
NAD 1983 UTM	634213 St NE :			4 = W½ 5 = NE¼ 6 = SE¼ 7 = SW¼ 8 = NW¾
Fieldwork Date: 05 Reconnaissance Survey		Intensive Survey _	<u>~</u>	
Project & Principal Inves WAWSA 29 Mile Waterlin		/ Abbott		
Contracting Firm or Agel Beaver Creek Archaeolog		Form:		
Additional Information: Structure has been demo	olished.			
SHSND USE Component Component	_	Verified Site	CR Type	
Recorded By:	Melody Abl	oott Da	ate Recorded:	05/15/2023

32DV198 Update

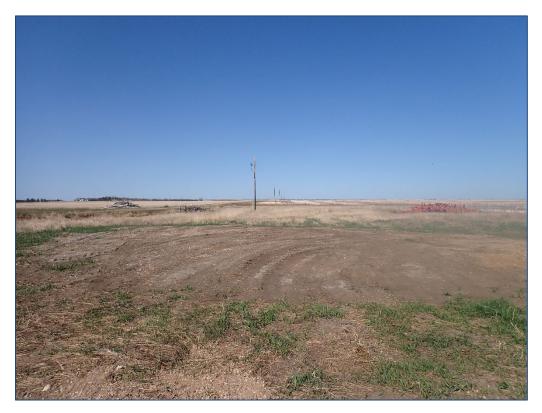
Figure 1. Overview of site area, view west.

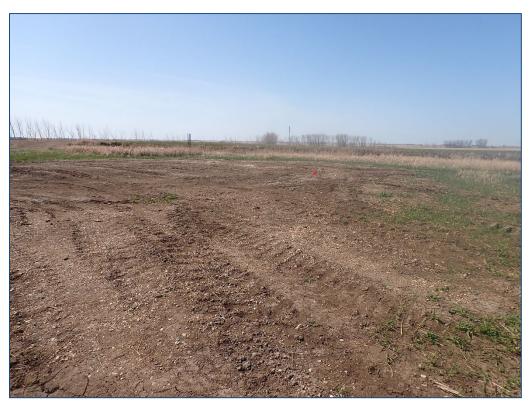
Figure 2. Overview of site area, view south.
