NDCRS ARCHITECTURAL FORM

Field Code Wilson Township School

SITS# 32EM 998

A Class II Architecture Survey - Emmons-Logan Wind Energy Center in Emmons and Logan Counties, North Dakota; Melinda McCarthy, Thomas Eiceman, & Marcia Bender

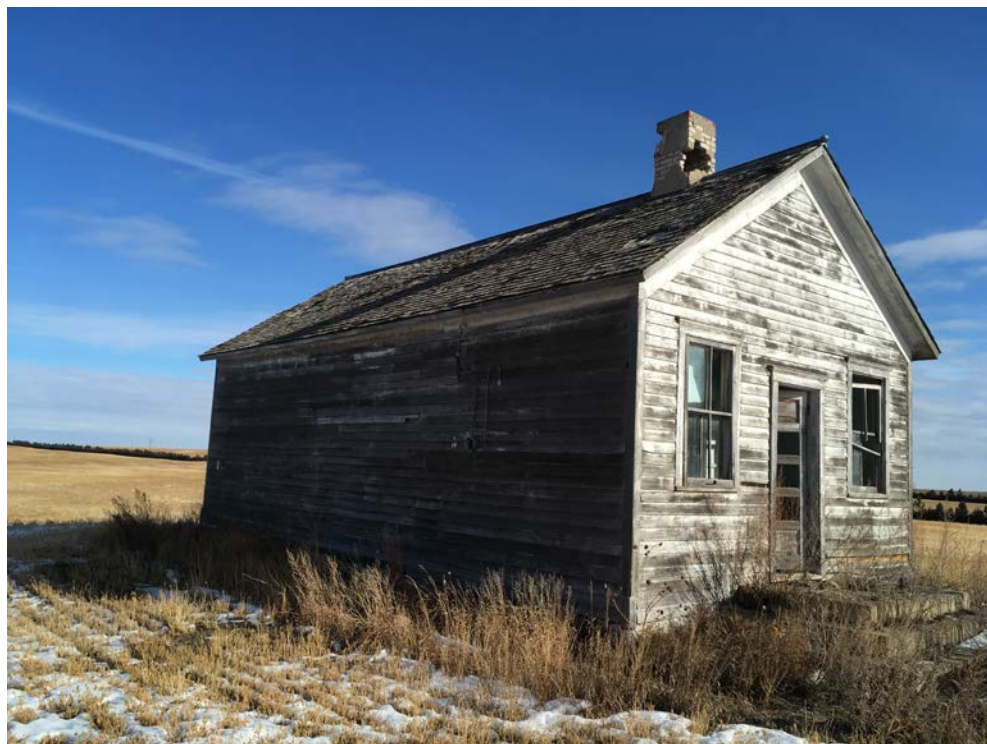
Photo No.:
IMG_9976

Description:
The front (southern) façade and western elevation of Feature (F.)1, a historic school house. View to the northeast.

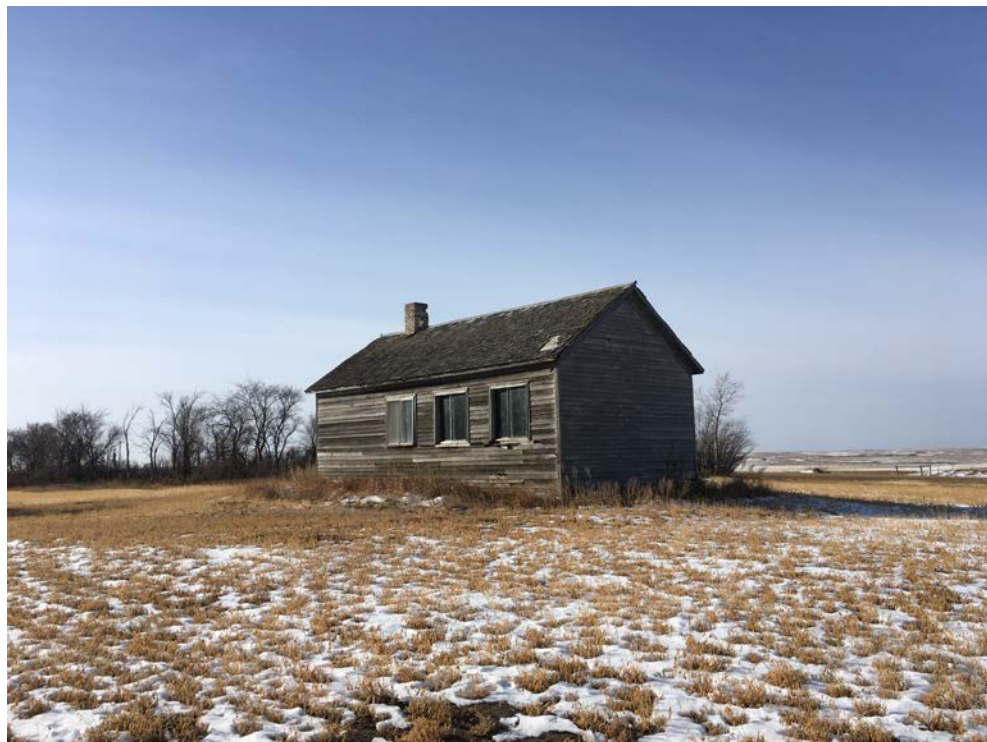
Photo No.:
IMG_9943

Description:
The eastern and northern elevation of F.1, looking southwest. Note the replacement windows on the eastern elevation.

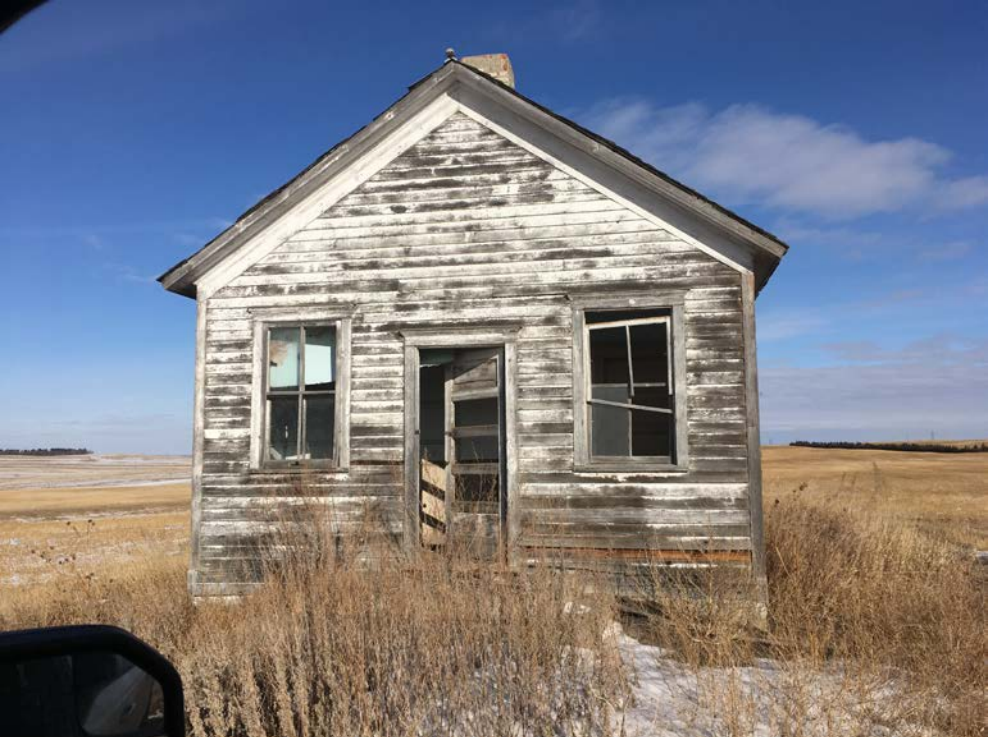
| Photo No.: IMG_9956 | Date: Feb. 2, 2018 | | |

On the front (southern) façade, the centrally-placed wood-framed entrance is flanked by two, 2:2 sash windows. The front door appears to be original and is accessed by a set of tiered concrete steps; both are in poor condition. The door is missing several panels, and the steps have collapsed in the center. The western and northern elevations contain no fenestration, while the eastern elevation contains three sets of horizontal sliding windows. These windows are asymmetrically placed in a group on the northern end of the wall. These windows appear to be replacement windows in altered window openings. The interior of the building retains its lath and plaster walls and wooden flooring. Both are largely intact but in poor condition due to water seepage from the roof. A drop ceiling and chalkboard remain from the building's last period of use.

| Description: The front façade of the school house, looking north. Note the poor condition of the building's window and doors. | | | |

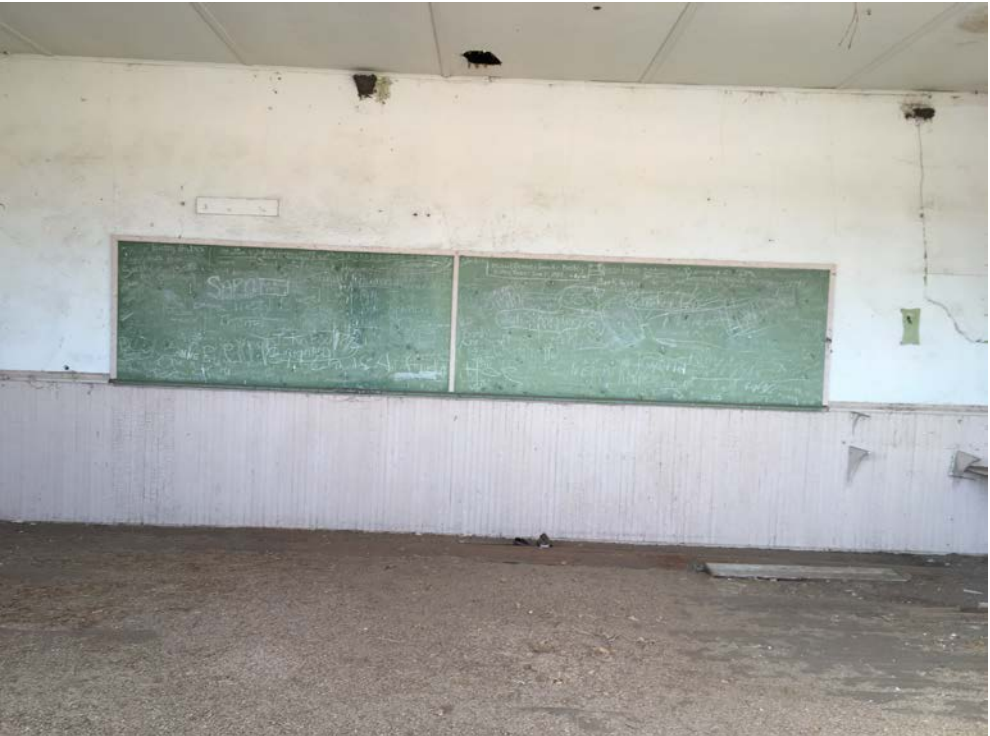
| Photo No.: IMG_9969 | Date: Feb. 2, 2018 | | |

| Description: Overview of the school room, which has been partially updated with modern features. View to the west, looking through the eastern elevation's windows. | | | |

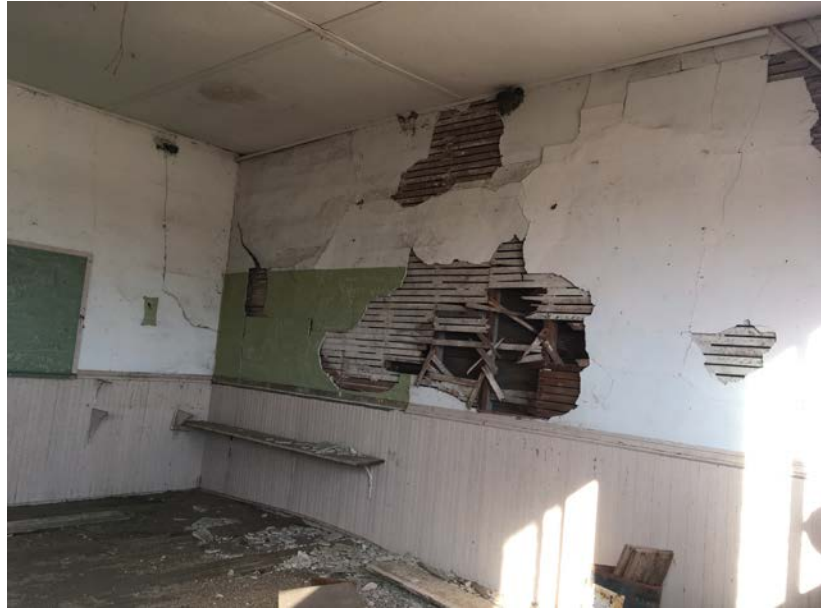
Photo No.:
IMG_9970

The building is falling into disrepair; its integrity is diminished due to rot, water damage, and the alteration of over half the building's original window openings. The school's diminished integrity and its condition have affected its connection to its historical significance. Further, more intact examples of early school houses can be found within Emmons County. The building is recommended not eligible for the National Register of Historic Places (NRHP). See the Feature Summary for more a more detailed discussion of the school's property ownership and historical significance.

Description:
The interior of the northern wall of the building, which showcases both the original lath and plaster and the extensive water damage present inside the structure. View to the northwest.

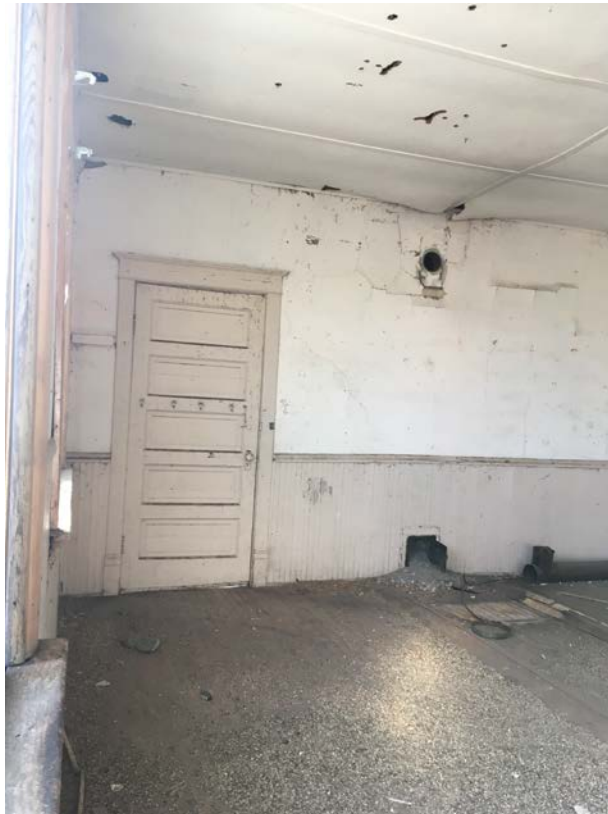
Photo No.:
IMG_9971

Description:
Overview of the southern wall of the classroom portion of the school house. View to the south.

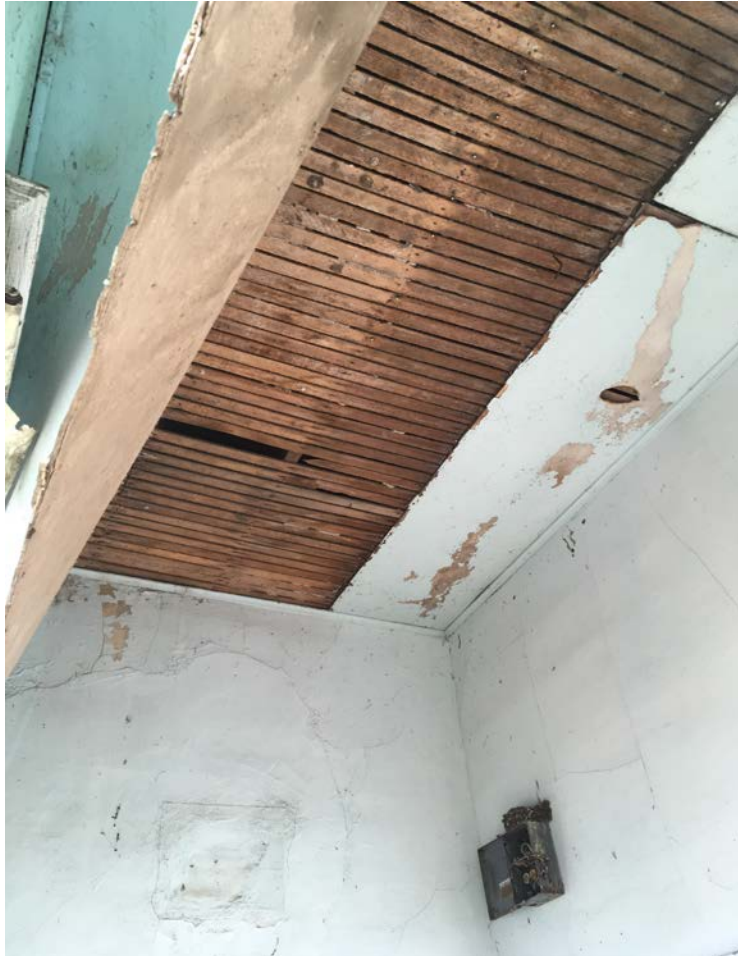
Photo No.:
IMG_9961

Description:
Overview of the interior ceiling in the front entranceway from the doorway. View to the northwest.
