NDCRS ARCHITECTURAL SITE FORM

Field Code: UND-CNTR11-SK03

SITS#: 32 ME 2419

Report Title & Author(s): Center Service Area Rural Distribution Lines 2011 Class II-III Cultural Resources Inventories, Southwest Water Pipeline Project, Mercer, Oliver, and Morton Counties, North Dakota.
by Michael A. Jackson, Nathan J. Rokke, and Dennis L. Toom.

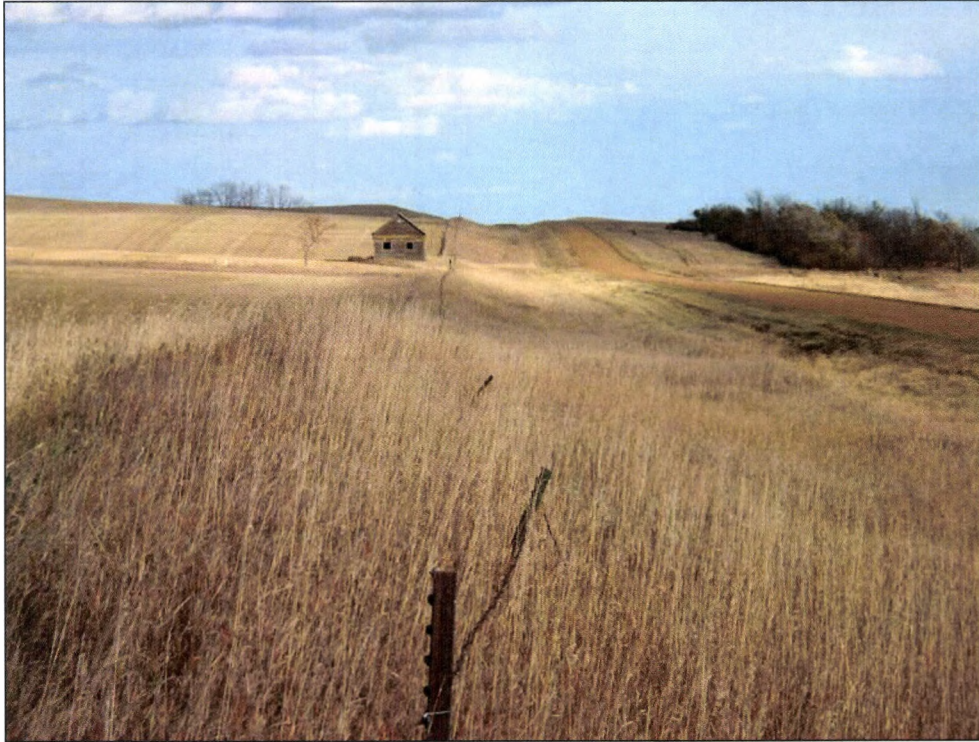
Site overview, view east (CNTR11 280)

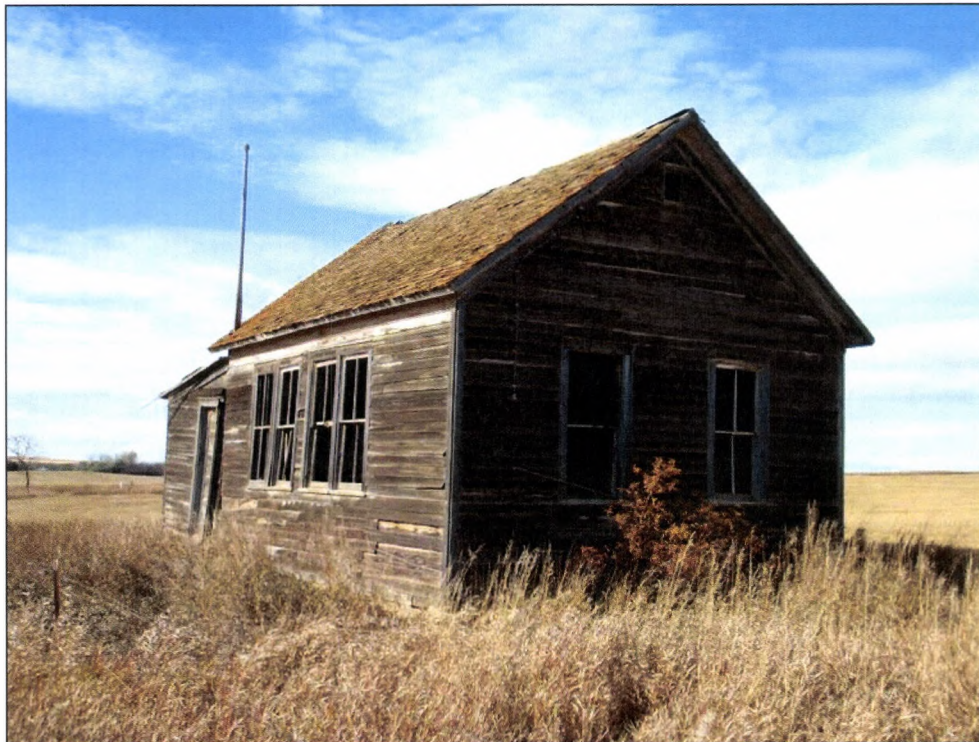
1. Feature Description, Integrity, Eligibility: The feature is a standing rural schoolhouse, located in the extreme southwestern corner of the section. It is on the edge of a plowed field, and plowing has expanded into the former schoolyard, and right up to the edge of the building. The wood frame building is clad in horizontal wood siding. It was originally painted white, but most of the paint has weathered away. There are two, tall windows on the east wall, there is a bank of four windows on the south wall, the north wall has a single window opening, and the west wall has two window openings. The main structure of the building is rectangular shaped with a gabled roof, however there is a smaller room attached on the western side of the building. This room has a shed-style roof. The entire roof is clad in wood shingles. The size of the entire building is 32.5ft E-W by 18ft N-S. The building rests on a mortared, sandstone block foundation. The main entrance door is located on the west end of the south wall, and it opens into the western room with the shed-style roof.

The interior of the building is in poor condition. The interior walls are lath and plaster, painted a two-toned yellow. Most of the plaster has fallen down on the north wall. The floor has been removed completely, including the subfloor, and joists. All that remains is the dirt ground surface. The wall footer sills, constructed of 8-x-8-in beams, are visible and they rest atop the sandstone block foundation. There are metal pieces of desks and furnace legs visible on the dirt floor. There is also a large amount of broken window glass which is scattered throughout the main room. The ceiling plaster has mostly fallen down as well. The western part of the school, with the main entrance, is divided into two rooms. The southern of these was used to store garments, boots, and the like, for the school-going children. The northern room was a small coal/furnace room and it was full of coal dust.

The condition of the building is poor. It does not appear to have been remodeled or updated in any way since it was built. Its potential eligibility for listing in the National Register of Historic Places is currently unknown, but given its condition, a formal determination of NRHP-eligibility would be unlikely.

F1 schoolhouse, view northwest (CNTR11 198)

7. References/Comments: The site is located in an area of potential effect from a proposed SWPP rural distribution water pipeline. It is recommended that the site be avoided by rerouting the proposed pipeline to the north, and around the building.

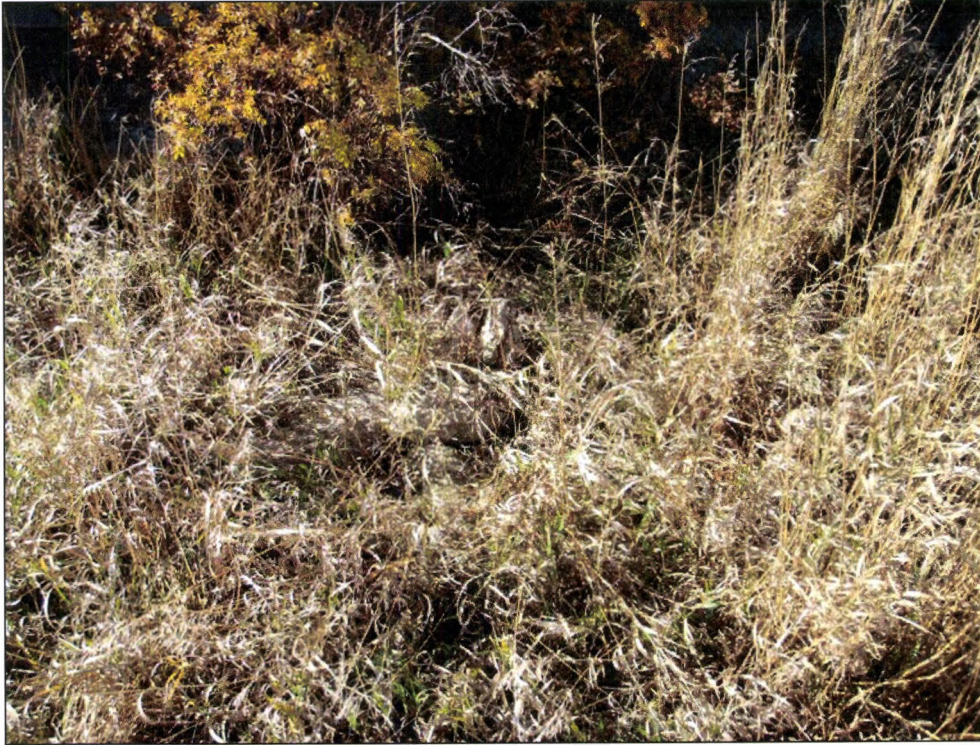
2. Site Description (include features): The site is a rural schoolhouse that has been long-abandoned. It is located in rolling/sloping uplands below a ridge, far off to the north, and an intermittent drainage, to the south. The site is perched on a small promontory above the nearby creek drainage. The former schoolhouse is located next to a plowed field, and the farmer has plowed almost right up against the standing structure. Various artifacts are scatter about, with most being located inside the building. The site contains two features, including the F1 schoolhouse, and an F2 foundation. The latter is a small, poured concrete slab. It was more likely than not, a base for a water pump.

F2 foundation, view west (CNTR11 213)
