NDCRS ARCHITECTURAL SITE FORM

Report Title: SRT Communications' Upham FTTP Exchange: A Class II and Class III Cultural Resource Inventory in Bottineau and McHenry Counties, North Dakota Author: Amie Meade

Additional Information: Site lead: Windmill, three sheds, and a garage

Field Code MAC-UP-43x

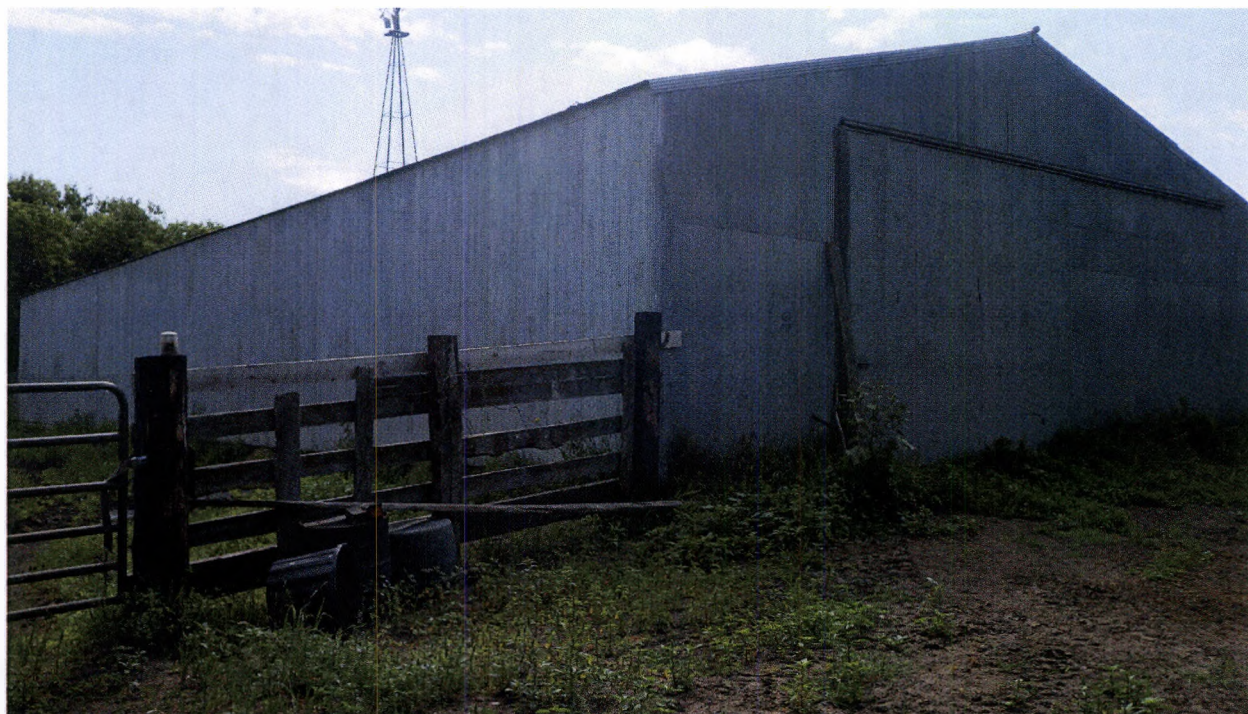
Figure 6: View of MAC-UP-43x, to the southeast, Feature 2 (Image 0892).

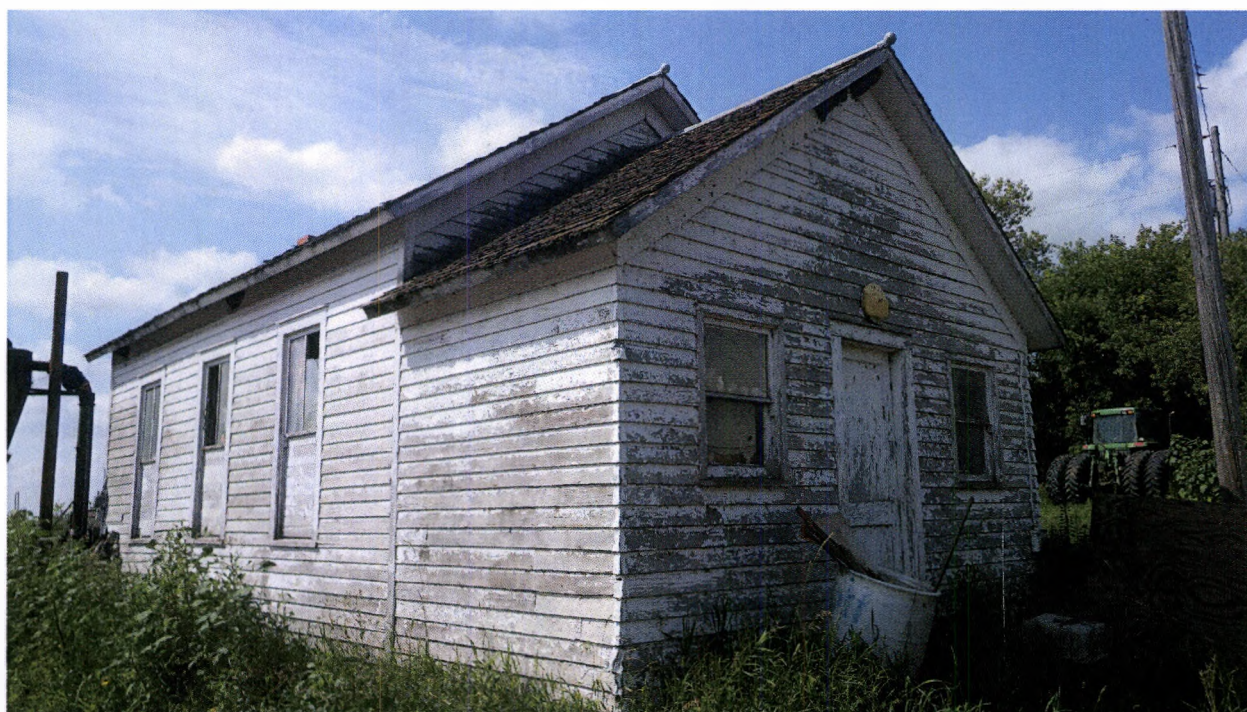
DESCRIPTION: Feature 3 is a one-room schoolhouse that was moved from its original location and converted into a shed. The shed is sitting atop pieces of lumber, and has no actual foundation. The structure is front-gabled, and has a front-gabled entryway/mudroom attached to the north facade. Both the entryway and the main structure are sided in horizontal wood clapboards. The roof is clad in wood shingles. A small shed-roofed addition was placed on the west side, most likely after the structure was moved to its current location. This addition has corrugated steel roofing material, and a large wooden sliding door. The shed has horizontal wood clapboard siding, painted white. The primary entrance to this feature is a standard wood door located on the north facade. There are two double-hung windows, with original wood frames (painted white) and glass intact, on either side of this door. There are three two-over-two-light windows on the east facade, though the bottom two lights of each are boarded up. The remnants of a brick chimney are located on the south end of the roof.

INTEGRITY: Feature 3 is in fair condition. Integrity of location and setting are lost, due to the fact that the structure has been moved, and then converted into a shed. Integrity of materials has been impacted by the loss of glass in several windows, as well as the destruction of most of the chimney. Integrity of design has been reduced by the addition on the west side. Integrity of feeling is profoundly impacted by not only the conversion and relocation of the structure, but by its current general state of deterioration. Only integrity of workmanship is retained.

Figure 7: View of MAC-UP-43x, to the southwest, Feature 3 (Image 0909).

ELIGIBILITY: Feature 3 has not been evaluated for eligibility to the NRHP. Current survey data are not sufficient to determine significance. Until a deed search can be performed, avoidance is recommended.

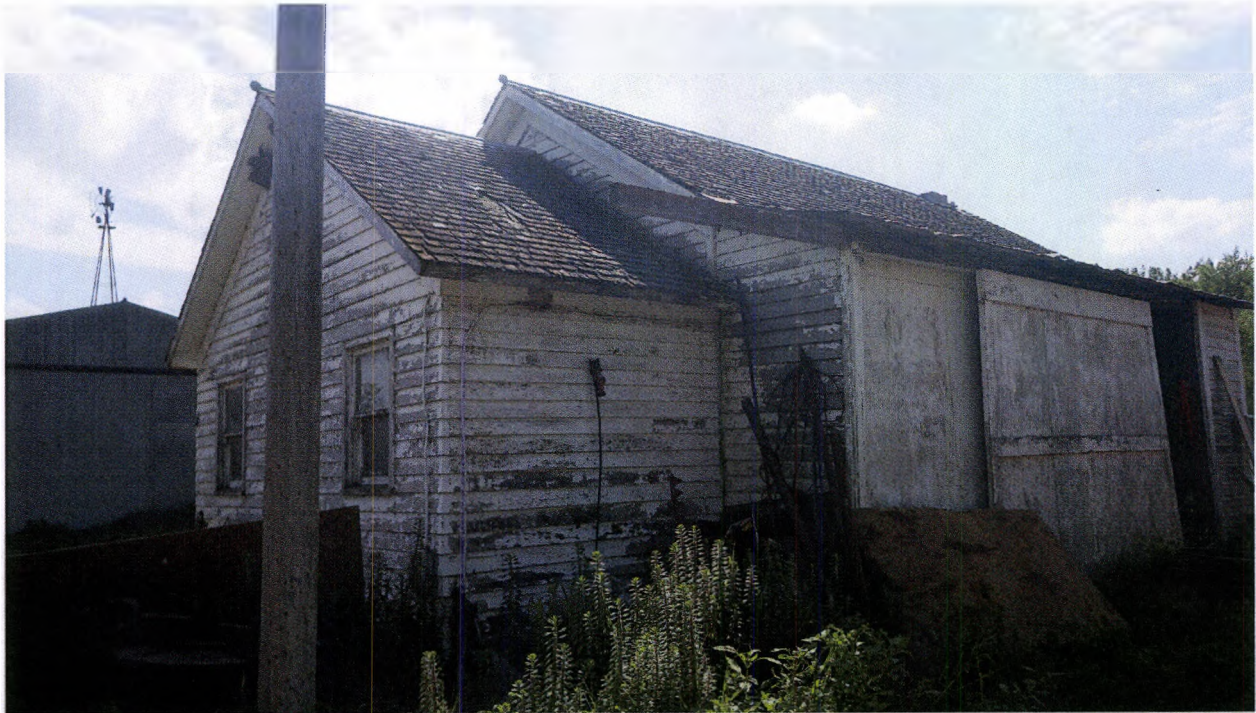
Figure 8: View of MAC-UP-43x, to the northeast, Feature 3 (Image 0915).

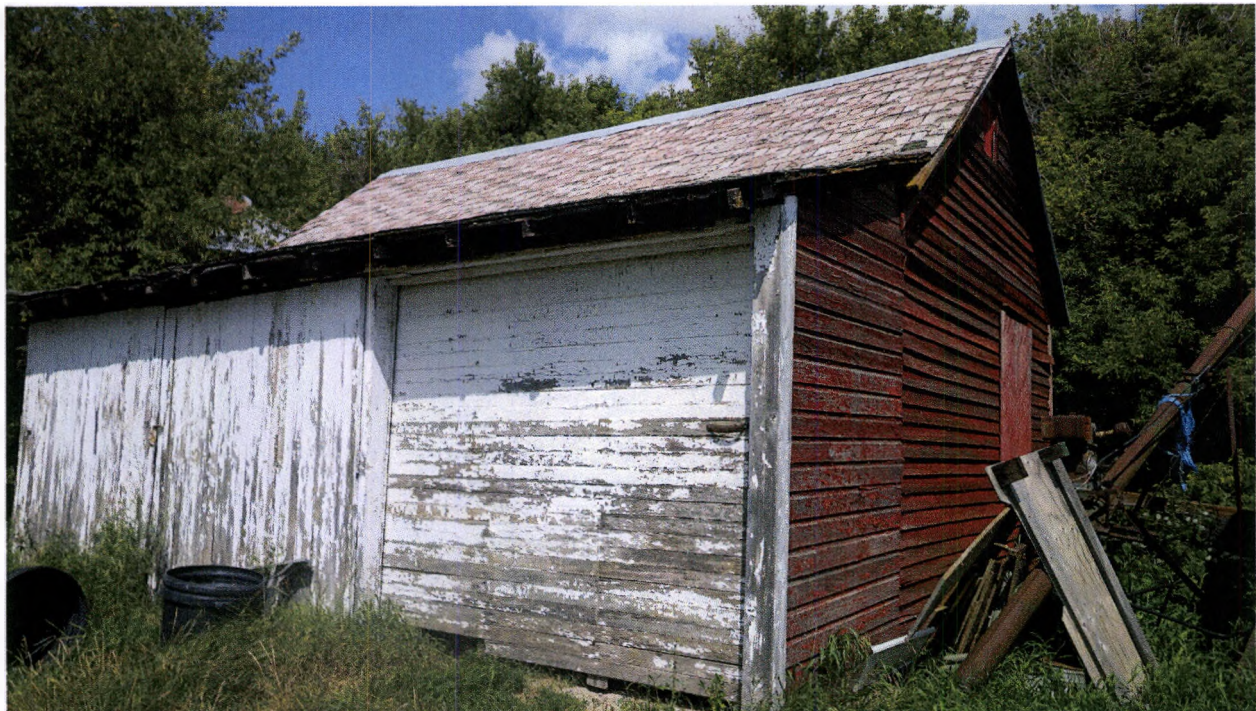
Figure 9: View of MAC-UP-43x, to the northwest, Feature 4 (Image 0930).
