NDCRS SITE FORM
 ARCHITECTURAL SITES
 page 1

Field Code B.R.W.U.S.2.S.O.2.4 Site Name F.L.I.C.K.E.R.T.A.I.L.V.I.L.L.A.G.E.
 Field Code _____ Site Name _____

Manuscript/Report Title: US Hwy 2 Cultural Resource Inventory in Ward, Mountrail, & Williams Counties

PROJECT TITLE US Hwy 2 Cultural Resources Inventory for FHWA and North Dakota Dept. of Transportation
(subcontracted through Houston Engineering); B. E. Perkl and B. A. Mitchell, Co-Principal Investigators

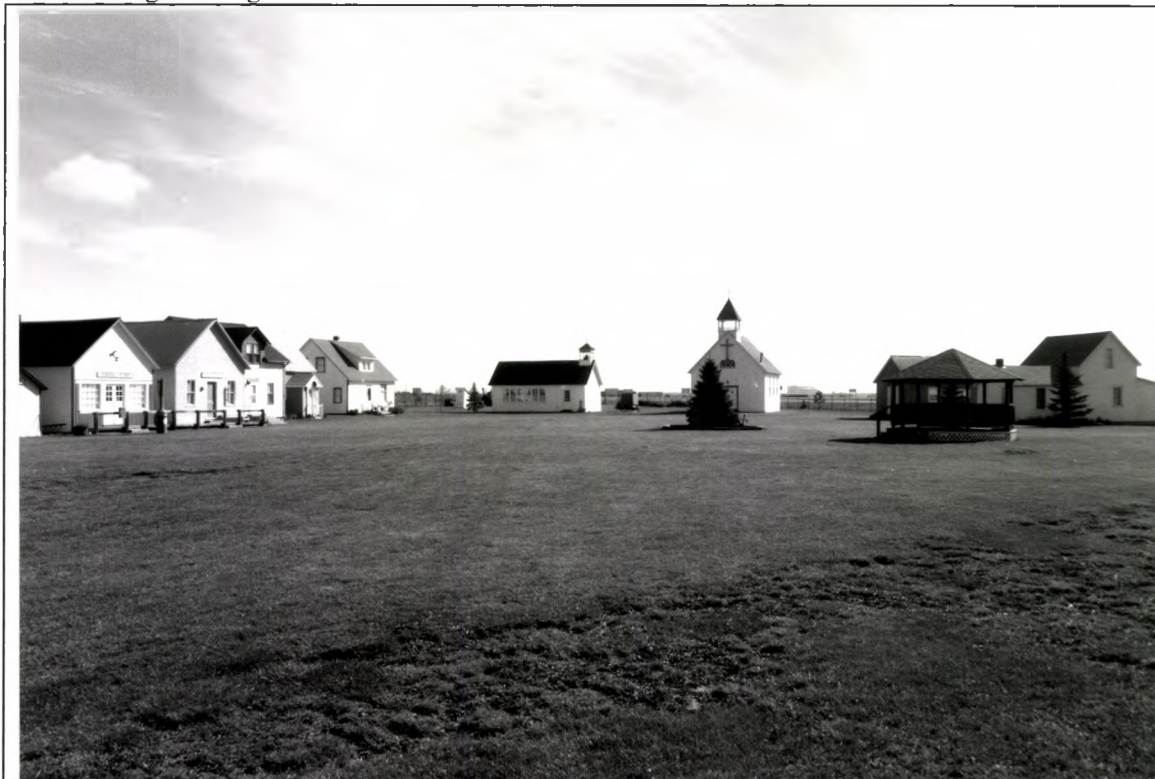
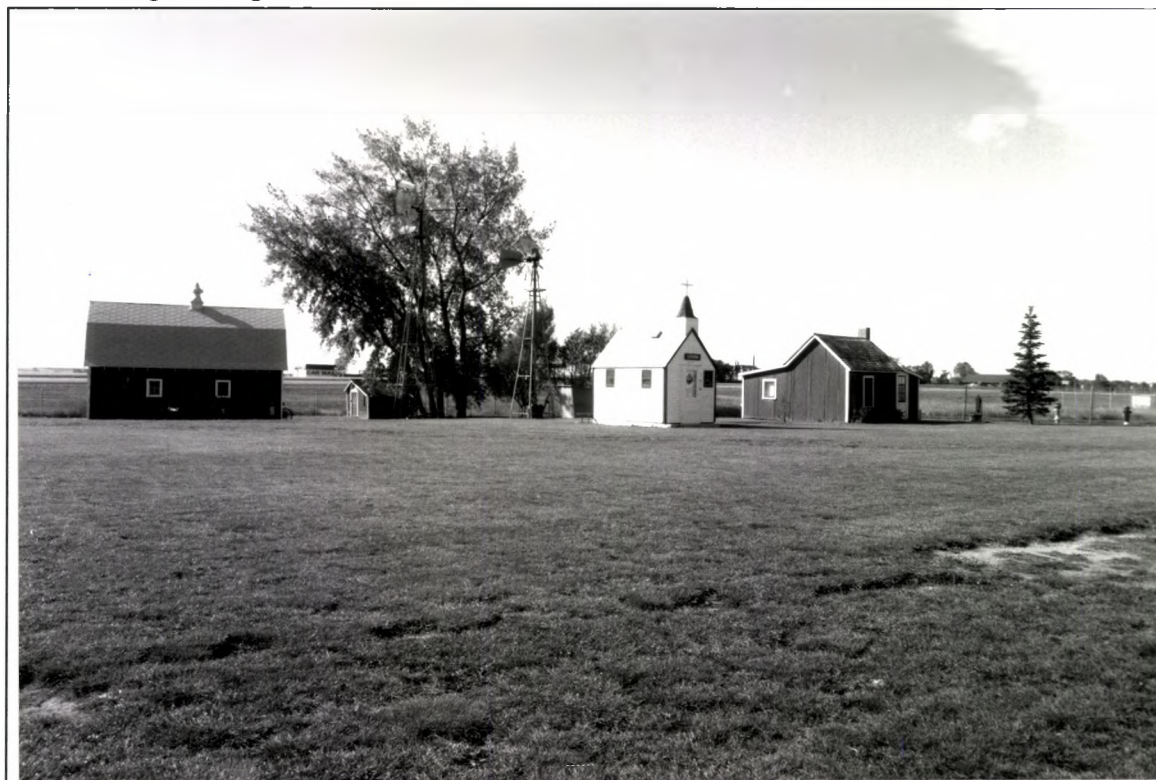
Per Criteria Consideration B, the Village as a whole cannot be considered eligible for listing on the National Register of Historic Places because it has not achieved significance since the time of its assemblage. None of the individual buildings on the property meets any of the considerations under Criteria Consideration B. Although the Depot (Feature #1) retains some material integrity, modifications during the early 1980s may preclude its nomination under Criterion C.

Flickertail Village, facing East

Flickertail Village, facing SW

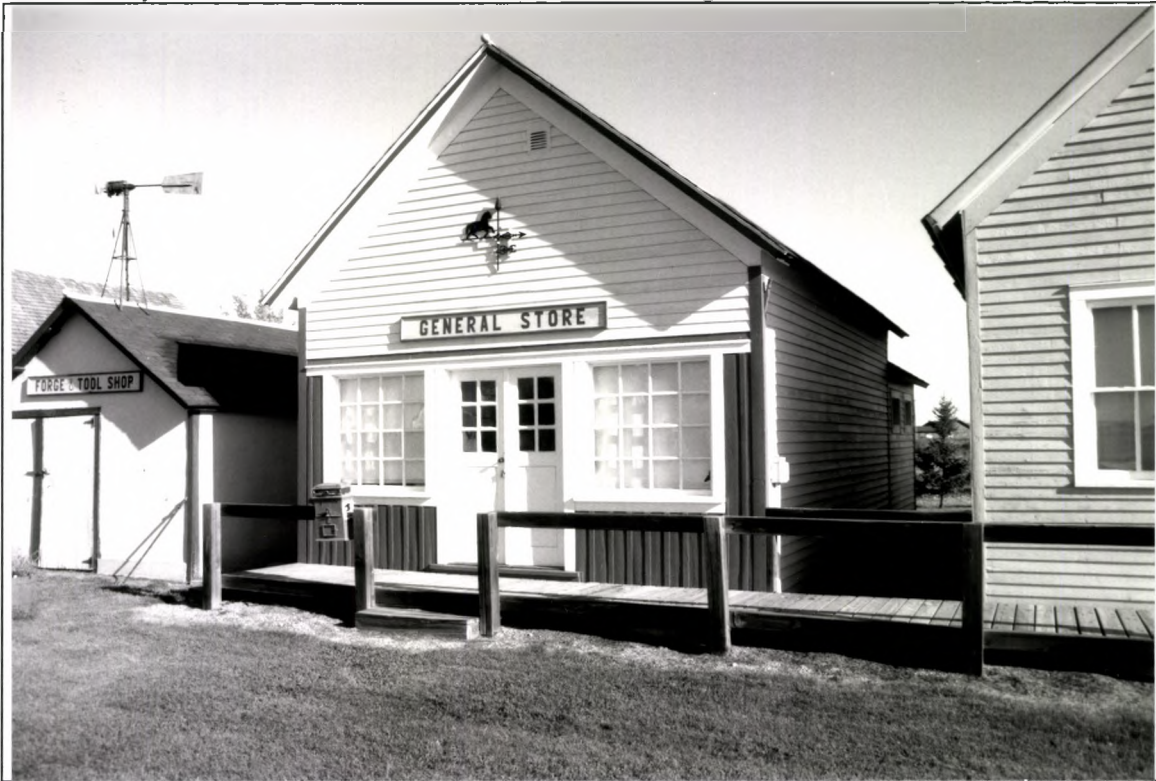
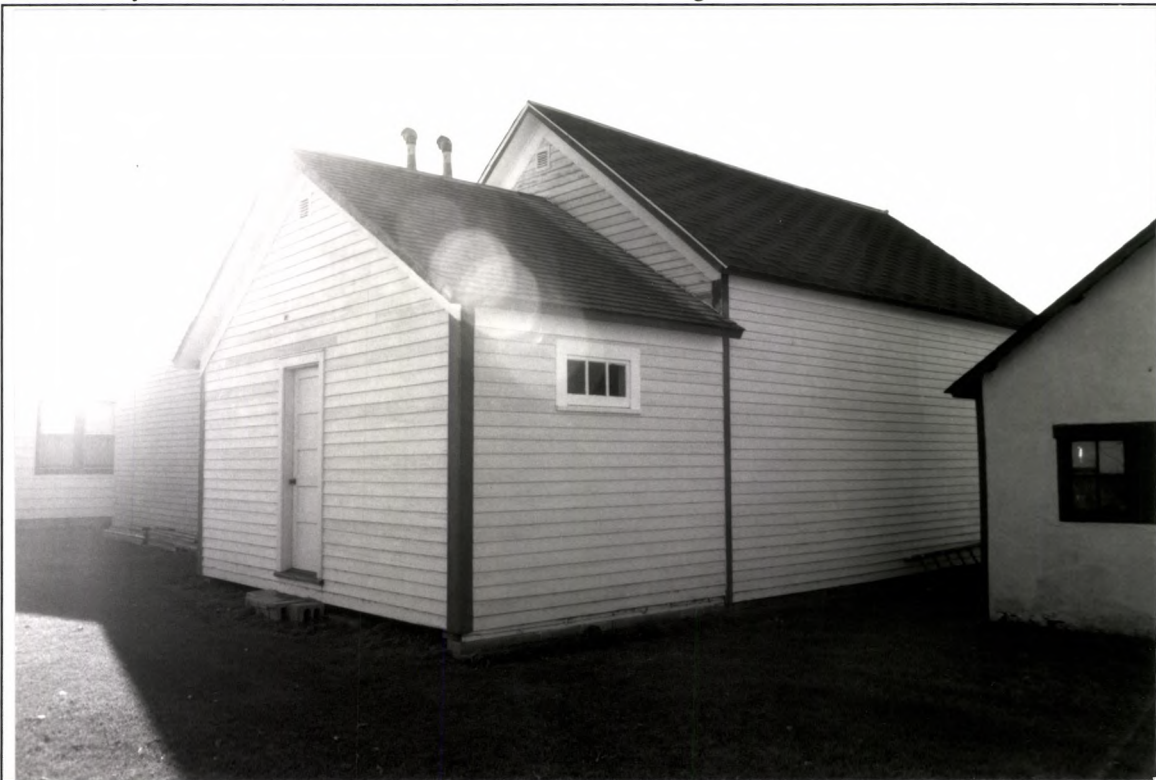
DESCRIPTION/INTEGRITY/ELIGIBILITY Feature #6 is a rural schoolhouse that has been moved into Flickertail Village and currently serves as the "general store." The one-story building is rectangular in plan and is located along the "Main Street" of Flickertail Village. The wood-frame structure has a concrete block foundation and is primarily clad with horizontal wood siding with corner boards. The cladding is not original. A portion of what now serves as a "storefront" has vertical board-and-batten cladding. The front-gable roof is clad with composition shingles. There are two large, divided-light windows on the "storefront." The rest of the windows have been filled in. There is a wood platform on the front of the building that connects it to Feature #7. On the rear of the building there is a slightly shorter gable-roofed addition. The building has been severely altered to be interpreted as a general store, including the in-filling of windows, the introduction of a "storefront," the replacement of the wall cladding, and the addition to the rear.

The building retains little integrity. Furthermore, its removal from its original location has damaged its eligibility. The building does not meet any of the considerations under Criteria Consideration B.

Front of Country School #1 (*General Store*) (Feature #6), facing NW

Rear of Country School #1 (*General Store*) (Feature #6), facing SE

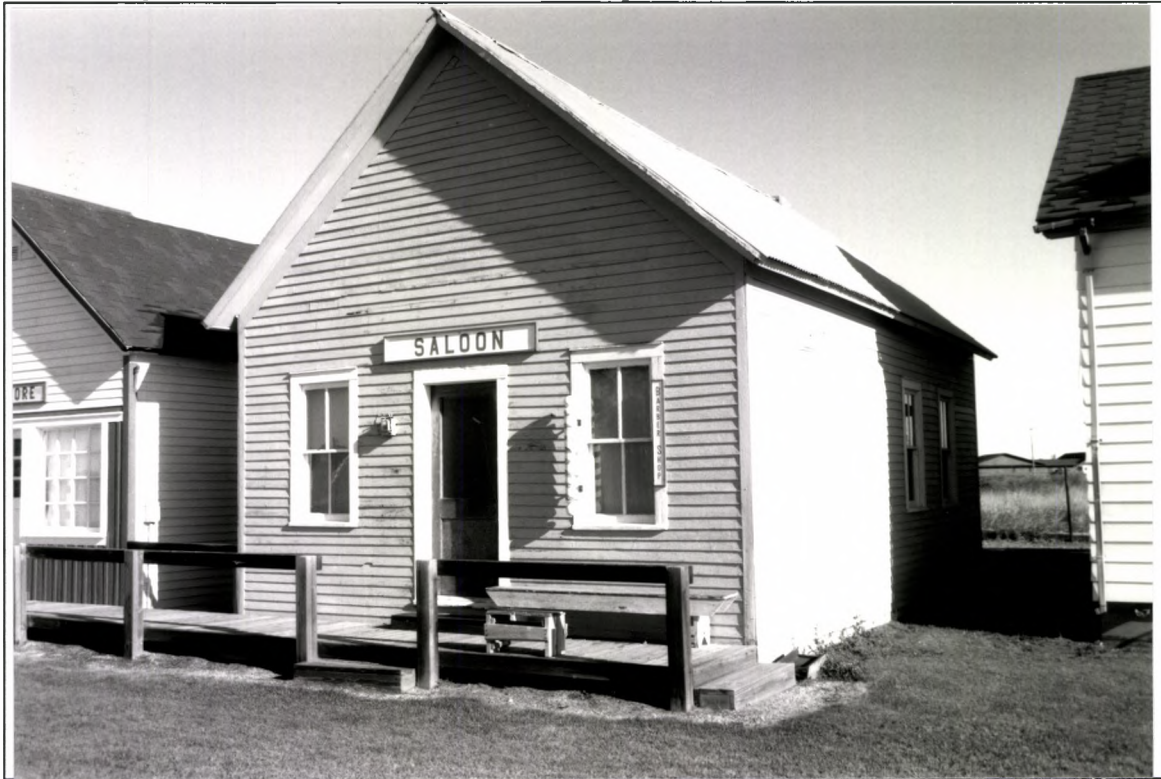
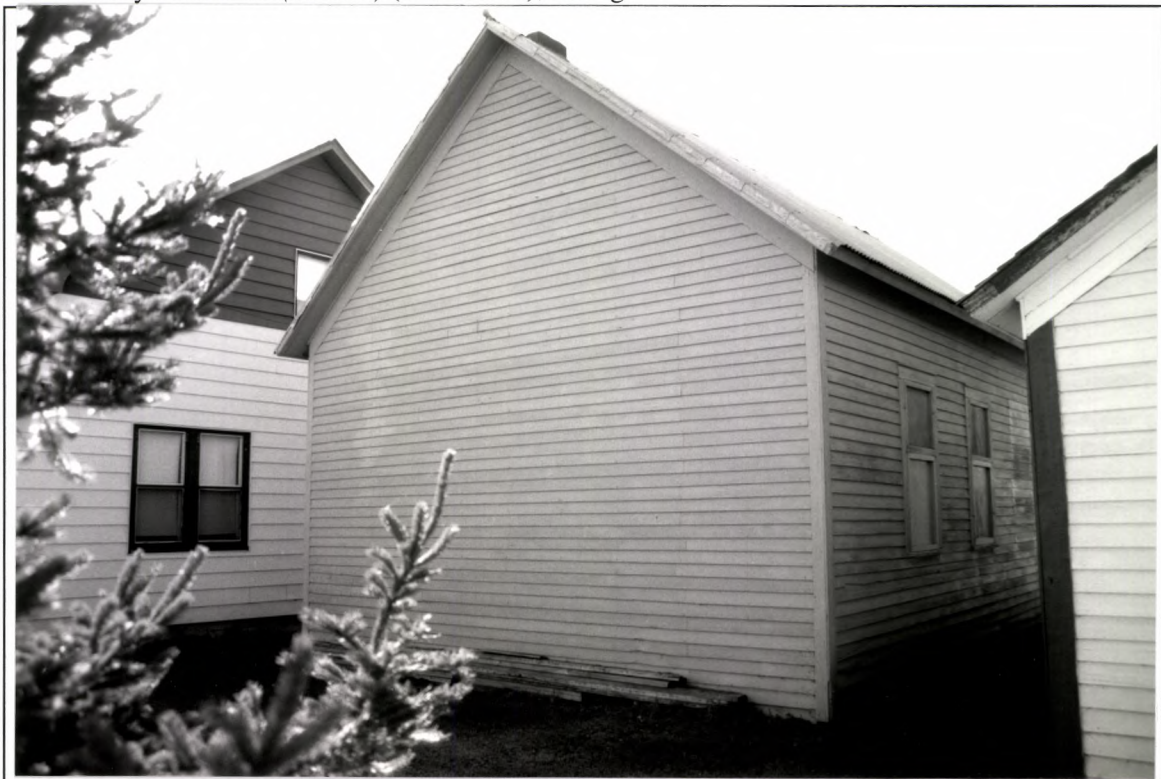
DESCRIPTION/INTEGRITY/ELIGIBILITY Feature #7 is a rural schoolhouse that has been moved into Flickertail Village and currently serves as the "saloon." The one-story building is rectangular in plan and is located along the "Main Street" of Flickertail Village. The wood-frame structure has a concrete block foundation and is clad with horizontal wood siding with corner boards. The cladding is not original. The front-gable roof is clad with corrugated metal. The windows are primarily wood-framed two-over-two-vertical double-hung. Several of the windows have been filled in. There is a wood platform on the front of the building that connects it to Feature #6. The building has been severely altered to be interpreted as a saloon, including the in-filling of windows and the replacement of the wall cladding.

The building retains little integrity. Furthermore, its removal from its original location has damaged its eligibility. The building does not meet any of the considerations under Criteria Consideration B.

Front of Country School #2 (*Saloon*) (Feature #7), facing NW

Rear of Country School #2 (*Saloon*) (Feature #7), facing SE

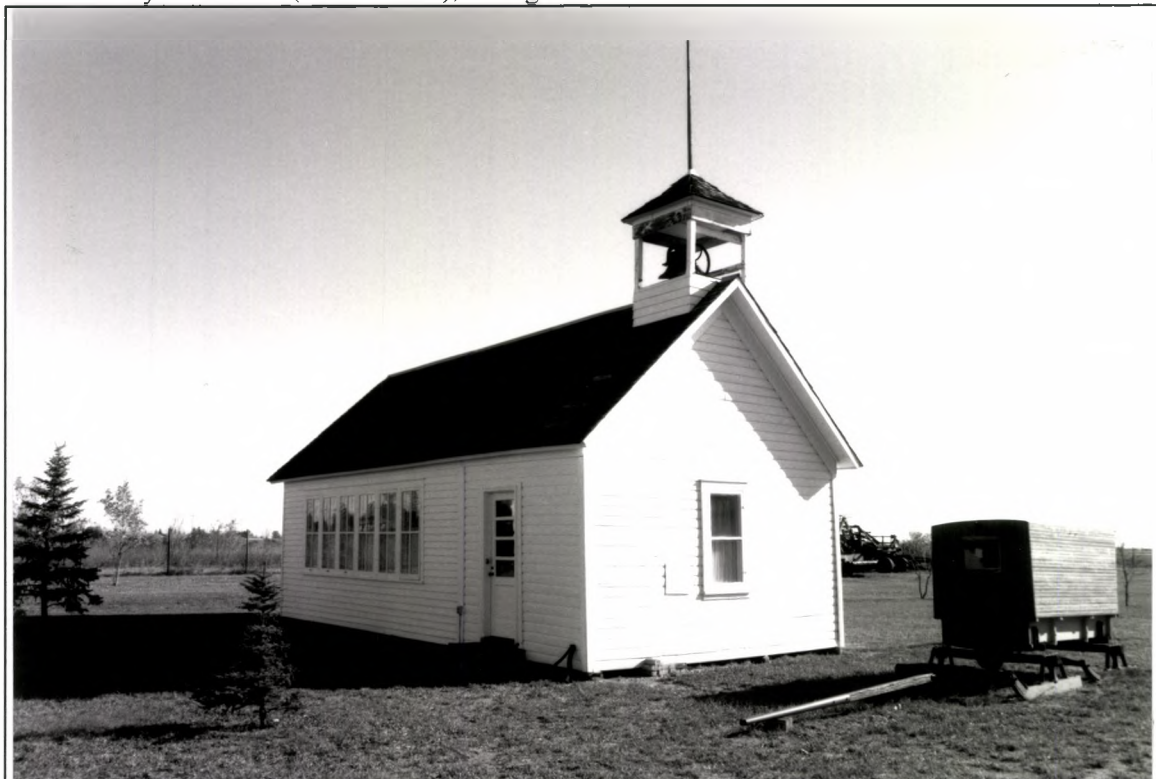
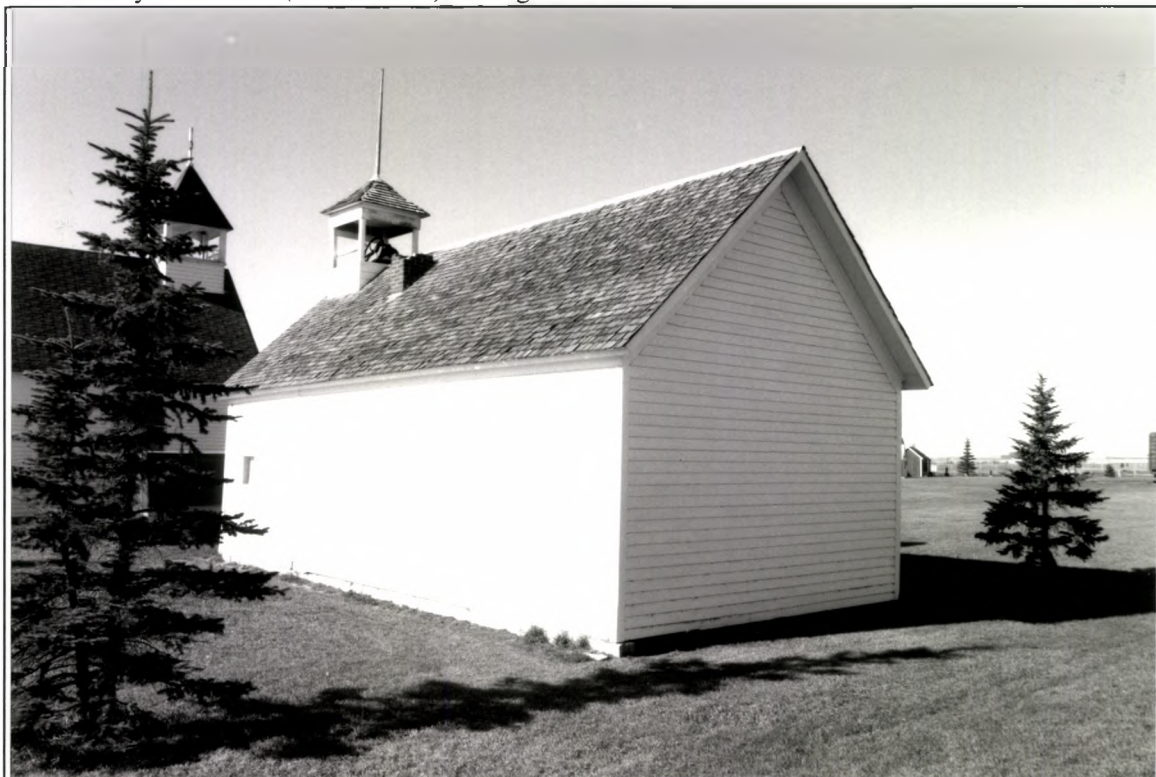
DESCRIPTION/INTEGRITY/ELIGIBILITY Feature #13 is a rural schoolhouse from Cottonwood Township that has been moved into Flickertail Village. It is interpreted as a schoolhouse as part of the museum and is located at the end of the "Main Street." The one-story wood-frame building is rectangular in plan and has a concrete block foundation. The building is clad with horizontal wood siding with corner boards; the siding is not original. The side-gable roof is clad with wood shakes. The windows are primarily wood-framed double-hung, although all of the openings on the east facade have been filled in. The front one-third of the building appears to be an addition. It has a bell tower and a wood plaque that reads "Third Class Standard School". The school has been severely altered, including the in-filling of windows and the bell-tower addition; it is not known when the alterations took place.

The building retains little integrity. Furthermore, its removal from its original location has damaged its eligibility. The building does not meet any of the considerations under Criteria Consideration B.

Front of Country School #3 (Feature #13), facing NE

Rear of Country School #3 (Feature #13), facing SW
