# NDCRS ARCHITECTURAL FORM PAGE 1

UPDATE 2020

Field Code Lindvig School	SITS# 32	MZ	2744
Complete one Page 2 for each architectural feature at the s	site.		
Architectural Feature #1			
Construction Date			
Feature Date <u>1915-1930</u>			
Structural System <u>Wood Frame</u>			
Original Owner's Ethnicity			
Feature Type 9 - School; Church school			
Context <u>Education</u>			
Primary Exterior <u>Wood, Horizontal Siding</u>			
Secondary Exterior			
Condition Excellent			
Plan Shape <u>Rectangular</u>			
Style Other Style			
Architect/Builder			
Foundation Poured Concrete	Stories <u>1</u>		
Roof/CorniceGable			
Window Replacement double hung, glass			
Dating Method(s) Previous documentation estimate			
Miscellaneous Information			
Feature Preservation Recommendation(s) (Check all that a	ipply):		
Individual nomination			
Contributes to a potential district			
No nomination potential			
Will not contribute to a district			
Potential district—feature would be a contributing elem	ent if other proper	ties c	onstitute a district

# Field Code Lindvig School

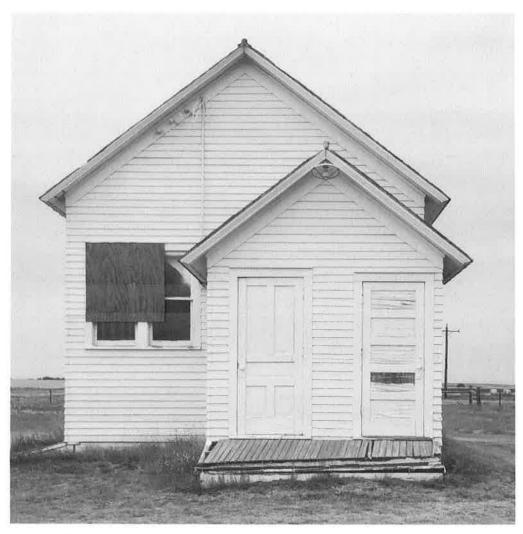
South Side

The story of th feature is included in the 2014 documentation. The only change I see since it was documented in 2014 is that the east side window in the entry and a window on the south side of the school have been boarded up.

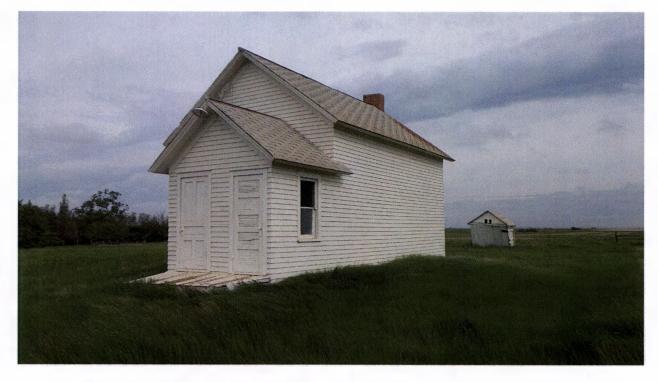
Figure 2: Overview of MAC-MNB-1009, view to the northwest (Image 3118).

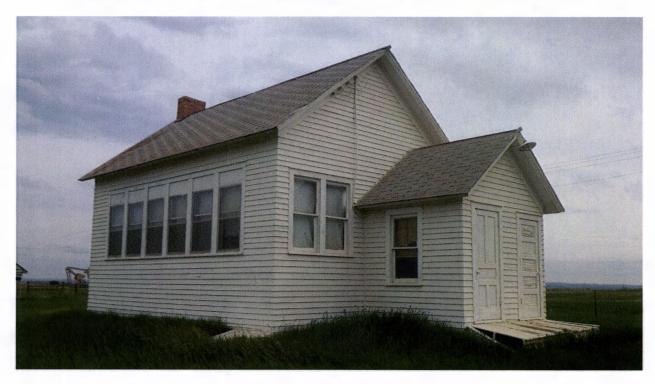
Figure 3: View to the northeast of MAC-MNB-1009, Feature 1 (Image 3122).

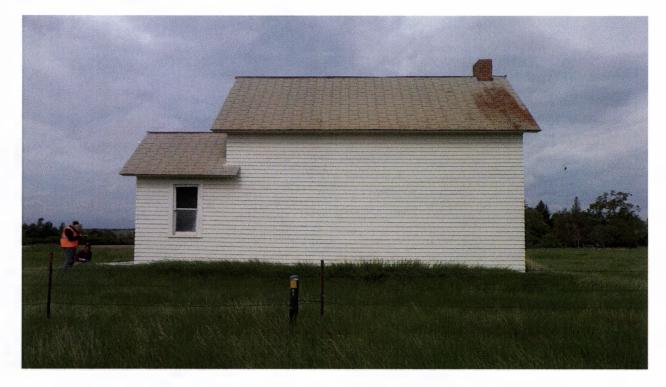
INTEGRITY: Feature 1 retains integrity of location, setting, design, workmanship, and feeling. Integrity of materials has been slightly impacted by the addition of new metal frames to the windows on the west facade. Overall, the feature in good condition and retains integrity.

Figure 4: View to the west of MAC-MNB-1009, Feature 1 (Image 3137).

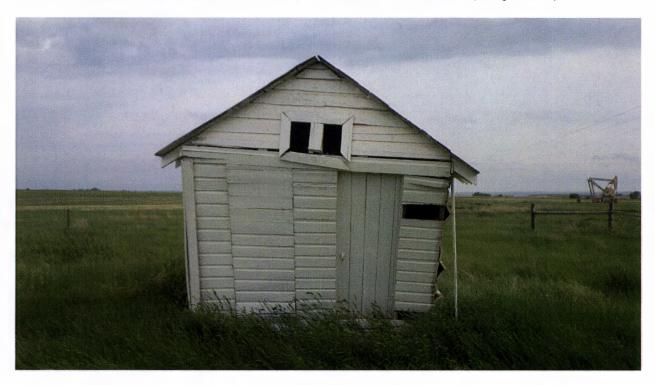
The site retains integrity of location, setting, design, and workmanship. Integrity of materials has been impacted by the addition of new metal frames to the windows in Feature 1, while integrity of feeling is reduced due to the overall poor condition of Feature 2.

Figure 5: View to the north of MAC-MNB-1009, Feature 2 (Image 3129).
