SITS# 32 MZ x1470

NDCRS ARCHITECTURAL FORM PAGE 2 – Feature Data

SITE IDENTIFICATION	PAGE 1	SITS# 32_	MZ X 1470
Field Code <u>MAC-NKL-56x</u> Map Quad <u>Schafer SE</u>	Site Name		
Map Quad 150 R97 SEC LTL TWP R SEC SEC LTL TWP R SEC SEC LTL TWP R SEC SEC	 C11 QQQ _ C QQQ _ C QQQ _ C QQQ _	8QQ 7 QQ QQ QQ	Q <u>7</u> Q Q
UTM5298228N UTM644625E	ZONE NAD 1	<u>13N</u> 927 NAD 1983 _	
City: Street Number:			$2 = E\frac{1}{2}$ 3 = S\frac{1}{2} 4 = W ¹ / ₂ 5 = NE ¹ / ₄
Street Name:			6 = SE¼ 7 = SW¼ 8 = NW¼
SITE DATA Total # <i>Architectural</i> Features:6 Fieldwork Date:10/15/2014			
Reconnaissance Survey <u> </u>	ensive Survey		
Project Title: Basin Electric- North Killdeer I Supervisor: Emily Sakariassen	Loop		
Report Title & Author(s): Report Title: Visual and Historic Sensitivity Transmission Project Author: Emily Sakaria	-	ed North Killdeer Loop) (NKL)
Additional Information: Site lead: Two school	olhouses, six grain b	oins, and one two-stall	garage.
SHSND USE Area of Significance Area of Significance Area of Significance Area of Significance	Verified Site Non-Site	С я ту	pe

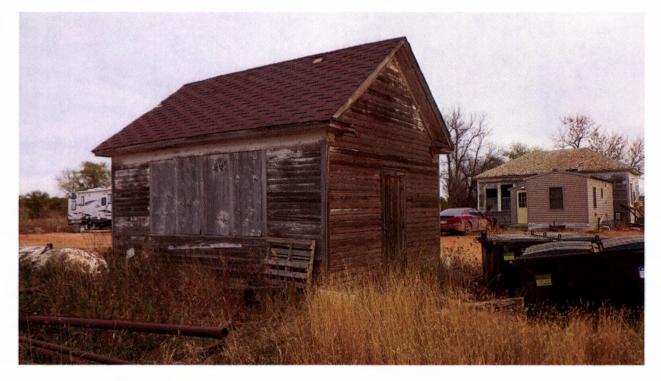
Figure 1: MAC-NKL-56x, Feature 1, view northeast (Image 5613).

DESCRIPTION: Feature 1 is a small one-room schoolhouse, likely moved from its original location. The structure has a front-gabled roof with eave returns and interlocking brown asphalt shingles. It is clad in horizontal wood clapboard siding, which was originally painted white. Wooden fascia boards are found beneath the roof on the east, south, and west facades. The structure also has wood cornering, though it is missing in places. It appears that a bank of windows was once located in the center of the west facade, but it has been boarded up with plywood. The primary entrance, a door with vertical wooden boards and metal hinges, is located in the center of the south facade. No fenestration is present on the east or north facades.

INTEGRITY: Feature 1 is in fair condition, and retains integrity of design, and workmanship. Integrity of materials is reduced by the structure's state of deterioration and the boarding up of windows on the west facade. Integrity of location and setting have been lost due to the fact that the structure was likely moved from its original location. Integrity of feeling has been impacted by the transformation of this area into a man camp.

ELIGIBILITY: Feature 1 has not been evaluated for eligibility to the National Register of Historic Places. Current survey data are not sufficient to determine significance. Until a deed search can be performed, avoidance is recommended.

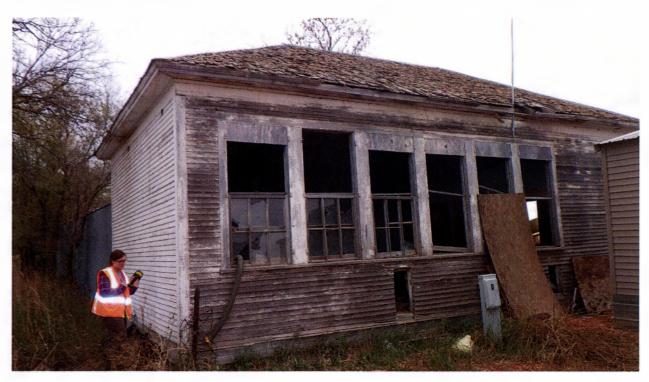
Figure 3: MAC-NKL-56x, Feature 2, view southwest (Image 5615).

DESCRIPTION: Feature 2 is a one-room schoolhouse. It currently sits on a wood sill, and was likely moved from its original location. The structure has a hipped roof with wood shingles, many of which are missing. Metal ridgepoles run along the edges of the roof, and part of the cornice on the west facade is missing. The schoolhouse has horizontal wood clapboard siding which was originally painted white, wood cornering, and wood fascia boards. A bank of six windows with wood frames is on the west facade, but most glass and muntins are now missing. It appears that they were six-over-six, double-hung windows. There are two rectangular openings on the bottom of the west facade. Paint on this facade is considerably more faded than it is on the others. No fenestration is present on the east and south facades. The primary entrance is located on the north facade. The door was either ajar or missing at the time of survey, with lumber protruding from the entrance, indicating that the structure is currently used for storage. A transom light was located above this entrance, but it has been boarded up with plywood. Double-hung windows are located on either side of the door. The easternmost window is missing all glass and muntins, while the westernmost window has been boarded up. A modern storage structure abuts the structure on the east side.

INTEGRITY: Feature 2 is in fair condition. Integrity of materials, workmanship, and design have been impacted by the loss and boarding up of windows, loss of shingles, and general deterioration. Integrity of location, setting, and feeling have been lost due to the fact that the structure was likely moved from its original location, and due to the growth of a man camp in the vicinity.

ELIGIBILITY: Feature 2 has not been evaluated for eligibility to the National Register of Historic Places. Current survey data are not sufficient to determine significance. Until a deed search can be performed, avoidance is recommended.

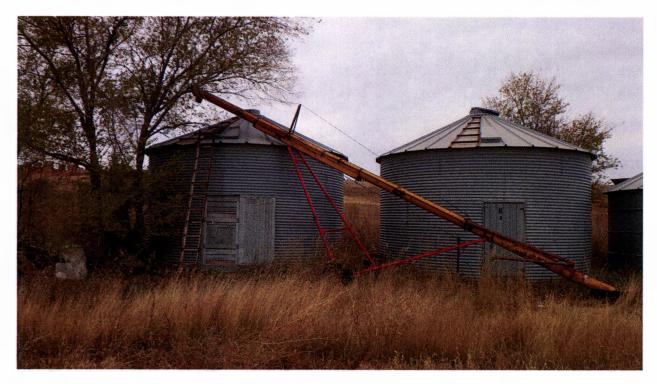
Figure 5: MAC-NKL-56x, Feature 3, view east (Image 5619).

DESCRIPTION: Feature 3 is a set of two identical grain bins at the south end of a linear grouping of six grain bins. Both bins are clad in corrugated metal, and stand approximately 20 feet tall. Each bin has a ribbed steel access door on its east facade. The northernmost of these bins is labeled "K2," while the door on the southernmost bin was ajar at the time of inventory, making it impossible to see its label. Secondary steel access doors and ladder rungs, quite rusted, are present on the roofs of both bins. The fill cap on the northernmost bin is damaged. A separate metal ladder leaned against the east side of the southernmost bin at the time of inventory, and a grain auger sat directly in front of both bins.

INTEGRITY: Feature 3 is in good condition and retains integrity of design, workmanship, and location. Integrity of materials has been impacted by the rusting of the ladder rungs, and the damaged fill cap on the northernmost bin. Integrity of setting and feeling have been reduced by the development of a man camp in the surrounding area.

ELIGIBILITY: Feature 3 has not been evaluated for eligibility to the National Register of Historic Places. Current survey data are not sufficient to determine significance. Until a deed search can be performed, avoidance is recommended.

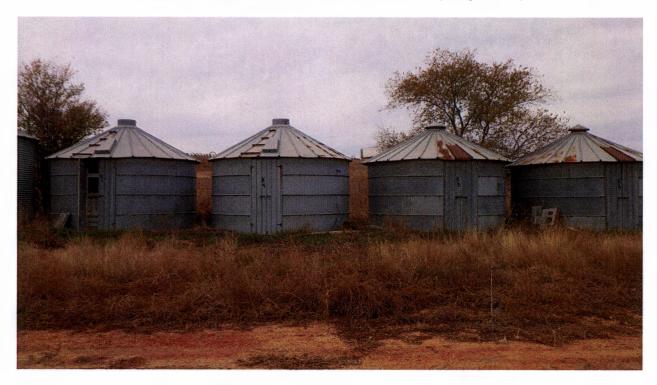
Figure 6: MAC-NKL-56x, Feature 4 (left) and Feature 5 (right), view east (Image 5618).

DESCRIPTION: Feature 4 is a set of two identical grain bins in the center of a linear grouping of six grain bins. Each cylindrical grain bin stands approximately 15 feet tall, and is clad in corrugated metal. Ribbed steel access doors are located on the east facade of each bin, with corresponding numbers written on them in black letters. These numbers begin with "K3" on the southernmost bin, while the bin directly to the north is labeled "K4." The access door on the southermost bin is ajar, exposing the interior of the structure to the elements. Both bins have secondary access doors on the east face of the roof, along with four ladder rungs leading to the fill hole. Cylindrical fill caps cover the fill holes on both bins. There is light rust present on the roofs.

INTEGRITY: Feature 4 is in fair condition and retains integrity of location, design, and workmanship. Integrity of materials is slightly impacted by rust on the roofs. Integrity of setting and feeling have been reduced by the development of a man camp in the surrounding area.

DESCRIPTION: Feature 5 is a set of two identical grain bins at the north end of a linear grouping of six grain bins. Each cylindrical grain bin stands about 15 feet tall, and is clad in corrugated metal. Access doors of ribbed steel are located on the east facade of each bin, with black numbering on them. The southernmost is labeled "K5," while the northernmost is labeled "K6." There are no secondary access doors or ladder rungs on the roofs of these bins, and the fill caps are conical, differentiating them from those found on Feature 4. Heavy rusting is present on the roof of both bins.

INTEGRITY: Feature 5 is in fair condition, and retains integrity of location, design, and workmanship. Integrity of materials has been impacted by the rust on the roofs of both bins, while integrity of setting and feeling have been reduced by the development of a man camp in the surrounding area.

ELIGIBILITY: Feature 4 has not been evaluated for eligibility to the National Register of Historic Places. Current survey data are not sufficient to determine significance. Until a deed search can be performed, avoidance is recommended.

ELIGIBILITY: Feature 5 has not been evaluated for eligibility to the National Register of Historic Places. Current survey data are not sufficient to determine significance. Until a deed search can be performed, avoidance is recommended.

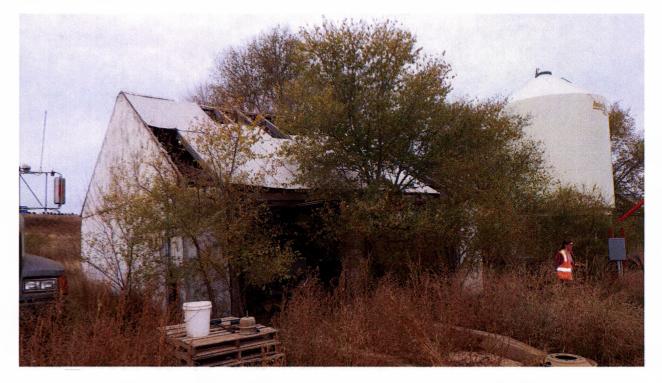
Figure 7: MAC-NKL-56x, Feature 6, view northwest (Image 5620).

DESCRIPTION: Feature 6 is a two-stall garage, which is partially collapsed and largely obscured by overgrown weeds, trees, and bushes. The structure has a wood frame, and concrete blocks serve as the exterior. A pile of these blocks, from the collapsed portion of the building, is found at the north end of the structure. The garage has a side-gabled roof covered with corrugated metal, with rafter tails exposed on the east and west facades. Two garage door openings are located on the east facade, but the doors themselves are missing, exposing the structure to the elements. Portions of the roof are missing on the east side. The south facade appears to be clad in plywood, painted white, rather than the concrete blocks found on the rest of the structure. One wood-framed window is located on the east facade. No glass remains, but it could possibly have been a three-light fixed window, as evidenced by one remaining muntin.

INTEGRITY: Feature 6 is in poor condition, and retains integrity of location only. Integrity of materials, design, and workmanship are profoundly impacted by the loss of garage doors, collapse of the structure at the north end, holes in the roof, and general state of deterioration. Integrity of setting and feeling are lost due to the development of a man camp in the surrounding area.

ELIGIBILITY: Feature 6 has not been evaluated for eligibility to the National Register of Historic Places. Current survey data are not sufficient to determine significance. Until a deed search can be performed, avoidance is recommended.
