NDCRS ARCHITECTURAL SITE FORM

Field Code RB1-249-ARCH

Project & Principal Investigator:
Red Butte Wind Energy Center; Melinda McCarthy

Report Title & Author(s):
A Class II/III Architectural Inventory for Red Butte Wind Energy Center in Mercer & Oliver Counties, North Dakota; Melinda McCarthy

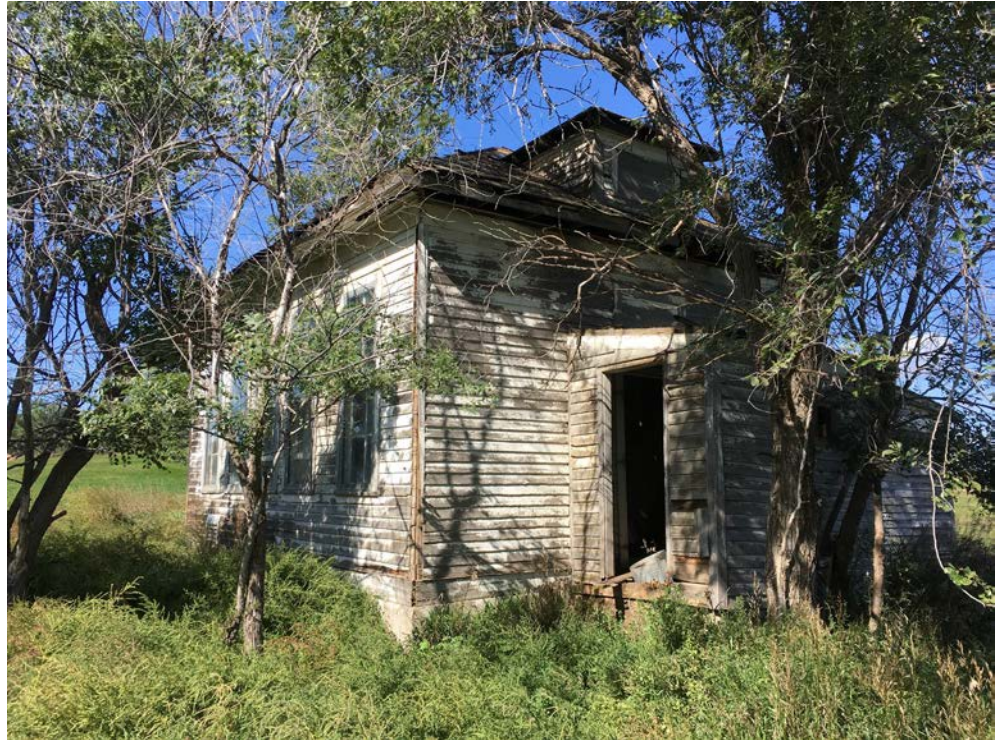
Photo No.:
IMG_6908

Feature (F.)1 is a rural schoolhouse in the Hipped roof box style. Originally documented as a site lead in 2012, the building features a hipped roof with moderate boxed eaves, clad in wooden shake (Lonski and Jackson 2012). The building features horizontal, wooden clapboard siding which is deteriorating across the structure. Wooden corner boards have been removed from southwestern and southeastern corners of the building, causing the siding on several elevations to start to pull away from the wall. The building has a mixture of 4:4 wooden, double-hung sash windows and horizontal casements. The sash windows on the southern elevation remain intact. All other windows on the building have been boarded over or are missing their window panes. The building features one-room, shed-roofed additions on the front (eastern) facade and northern elevation. Both are in very poor condition, with collapsing roofs and deteriorated interiors. Portions of the interior of the building were visible through the windows and the open front entrance door. The ceiling in the building is beginning to rot and fall to the floor, exposing the original lath underneath. Large portions of the floor have rotted away, exposing the support beams. A construction date for the school was not determined. However, records note this is the school building for District No. 15, and the Oliver County Centennial History book indicates the original Pleasant Valley School (District No. 15) burned down in 1925 (Nelson 1964; OCHS 1985). This building appears to be one of two schoolhouse buildings constructed several years later to replace that school. Further, no school is depicted at the feature's location on a 1917 plat map (Geo. A. Ogle & Co. 1917). Based on the historical records and the building's design, the year of construction is estimated to be from the late 1920s to mid-1930s. The building is in poor condition. The collapse of the roof and interior, the condition of the building's siding, and the removal of some of the building's windows and a door have severely impacted the school's integrity of design, materials, workmanship, and feeling. The abandonment of the site and overgrowth of the area have impacted the school's integrity of feeling, association, and setting.

Description:
The front (eastern) façade and southern elevation of F.1, a schoolhouse. View to the northwest.

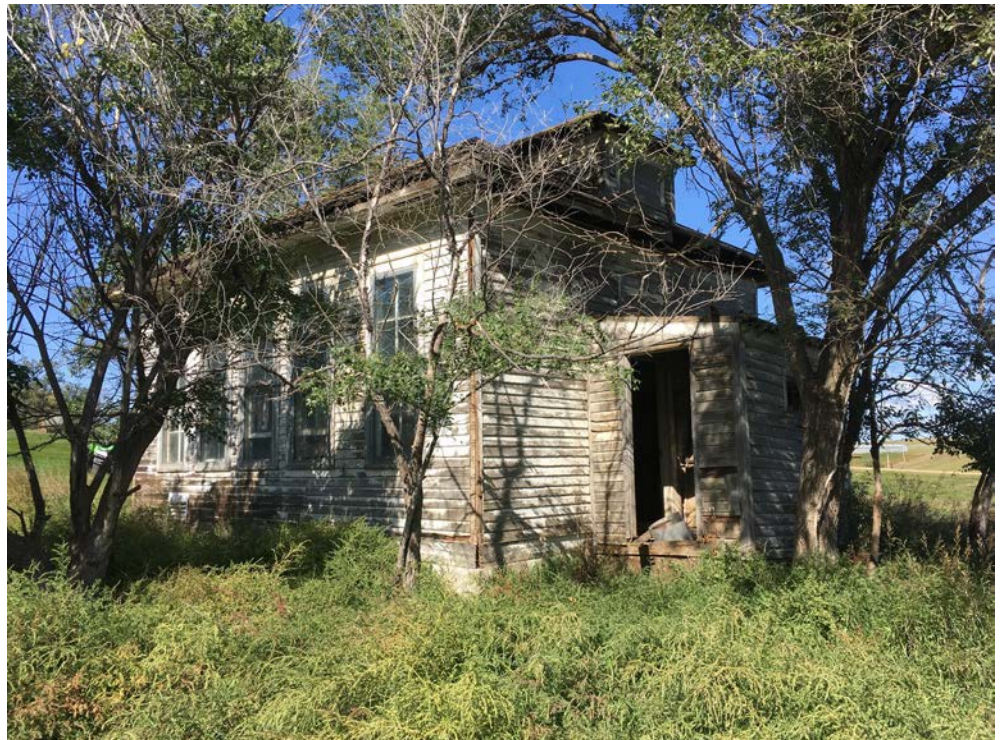
Photo No.:
IMG_6907

Description:
The front façade and southern elevation of F.1, looking northwest.

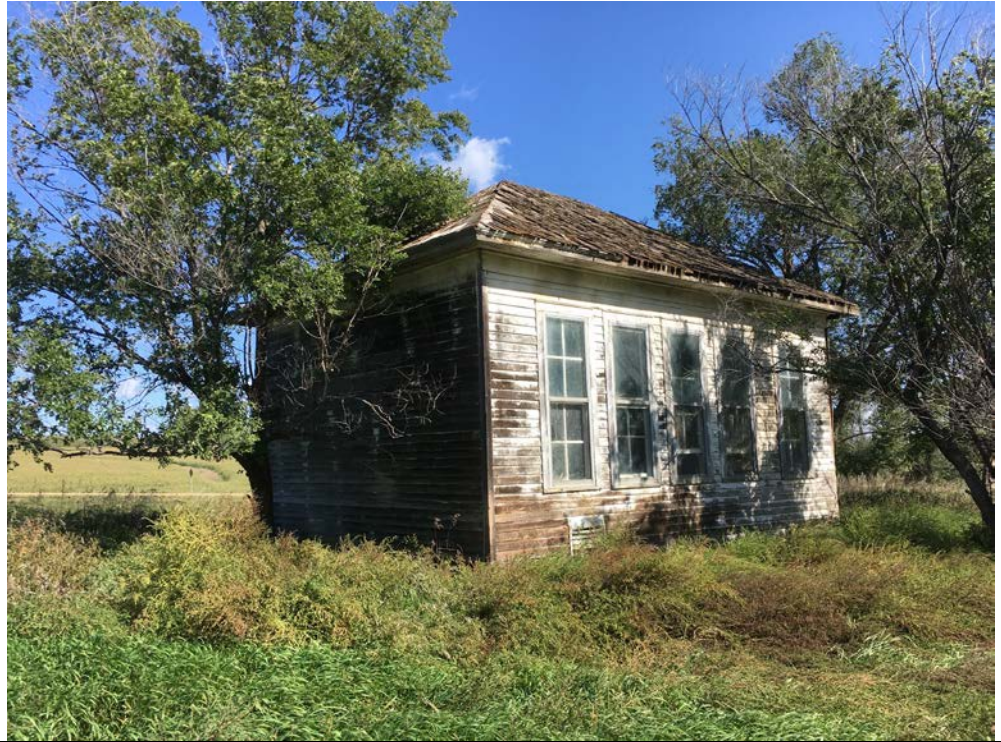
Photo No.:
IMG_6905

Description:
The rear (western) and southern elevation of F.1, view to the northeast.

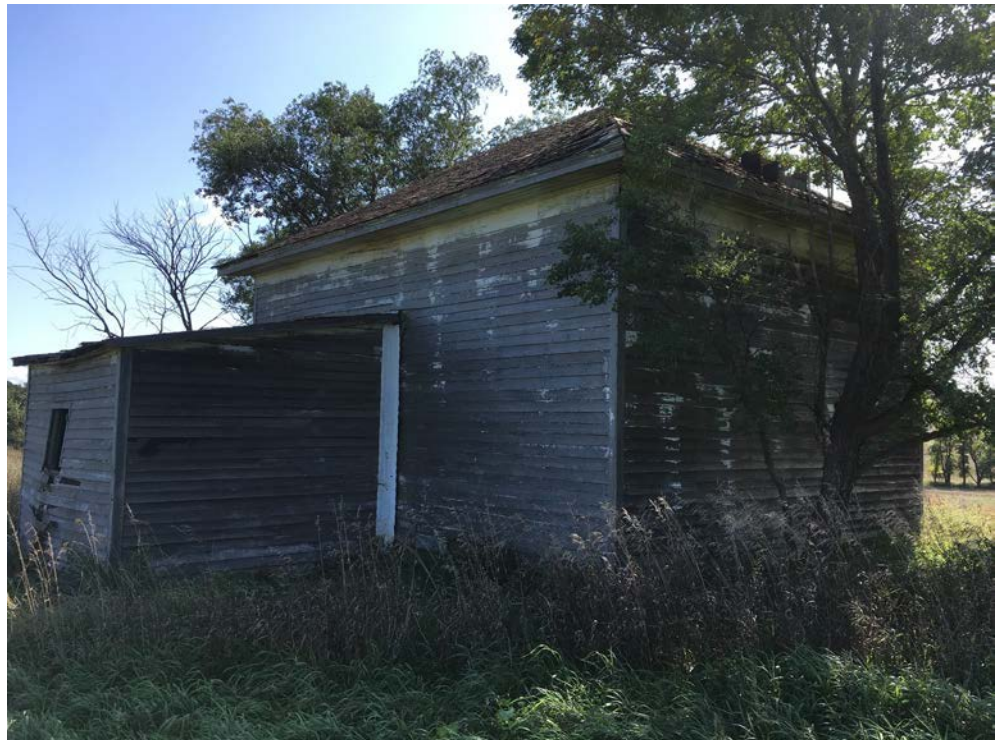
Photo No.:
IMG_6927

Description:
The rear and northern elevation of F.1, looking southeast.

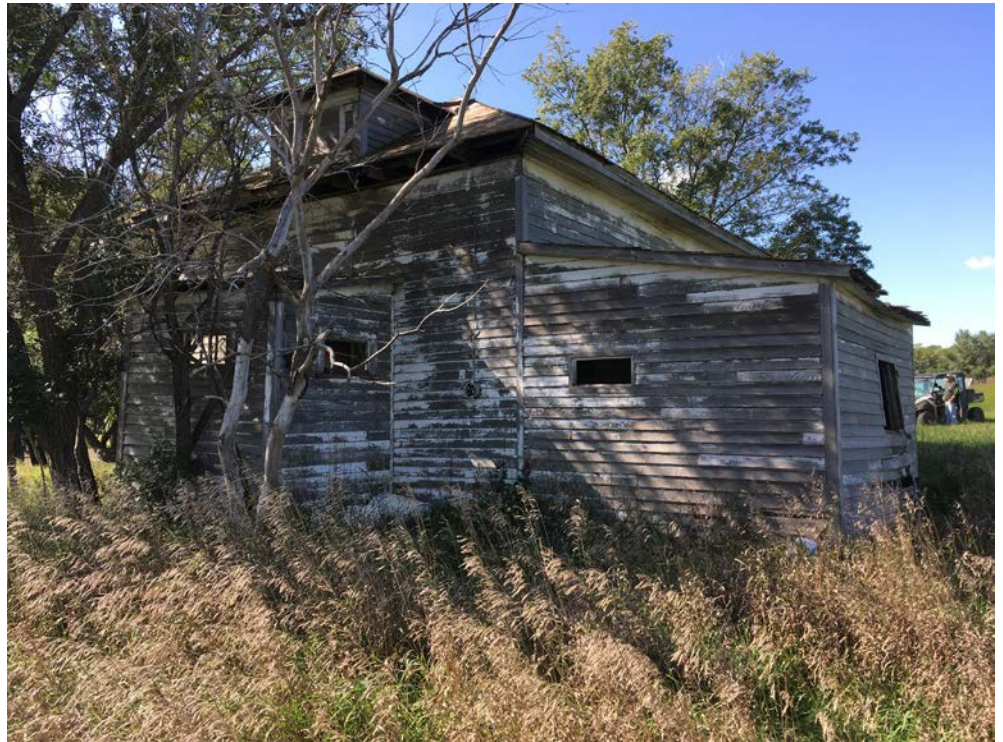
Photo No.:
IMG_6921

Description:
The front façade and northern elevation of F.1, looking southwest.

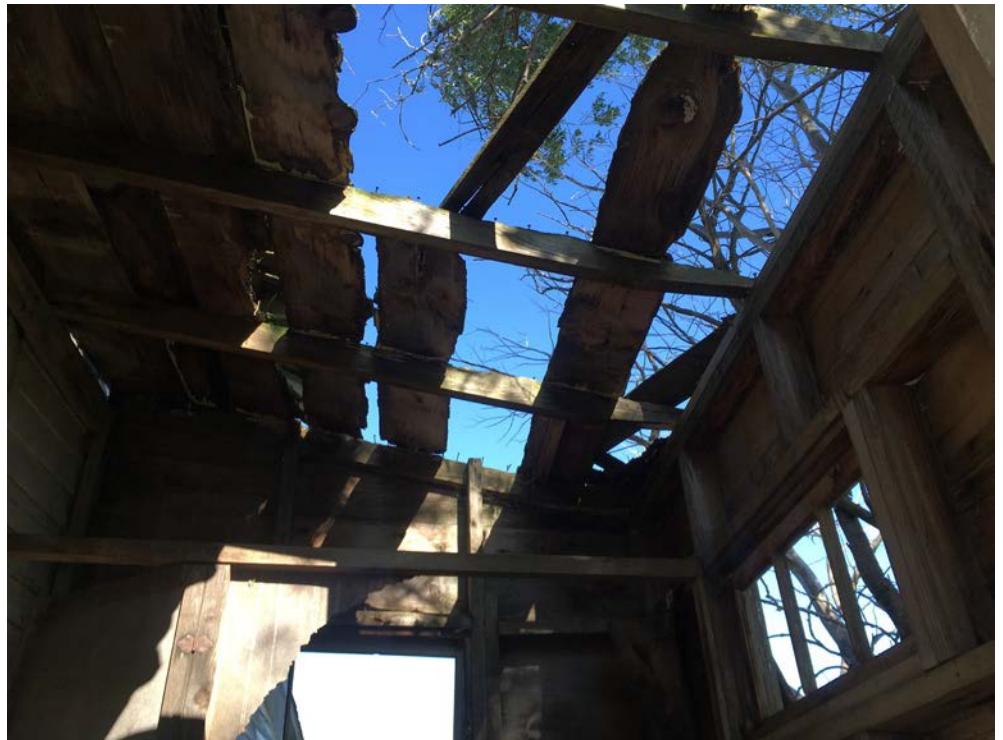
Photo No.:
IMG_6911

Description:
The interior of the façade addition, looking north.

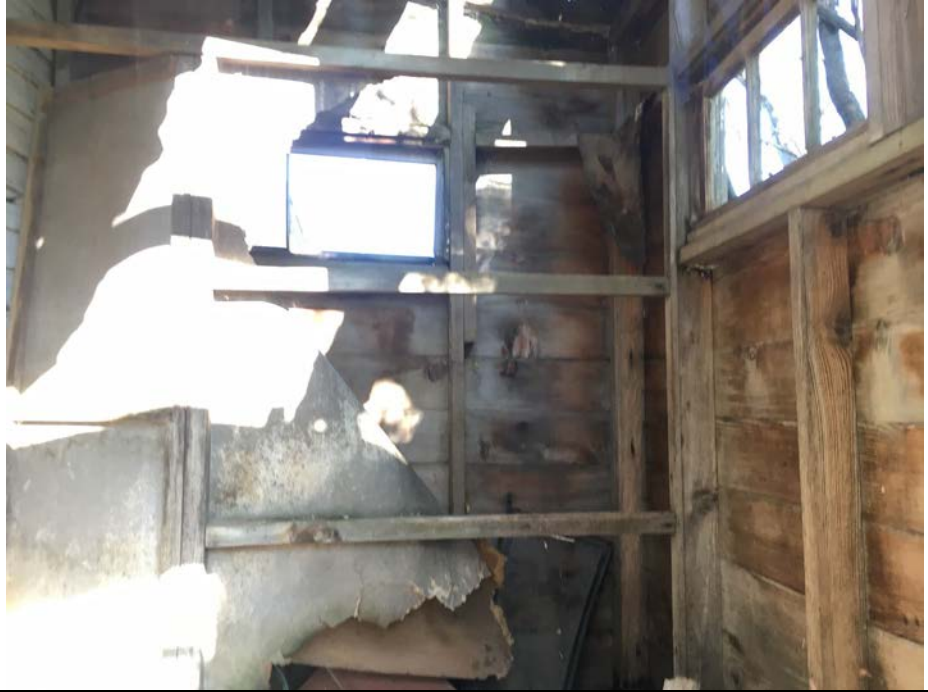
Photo No.:
IMG_6912

Description:
The interior of the façade addition, looking north.

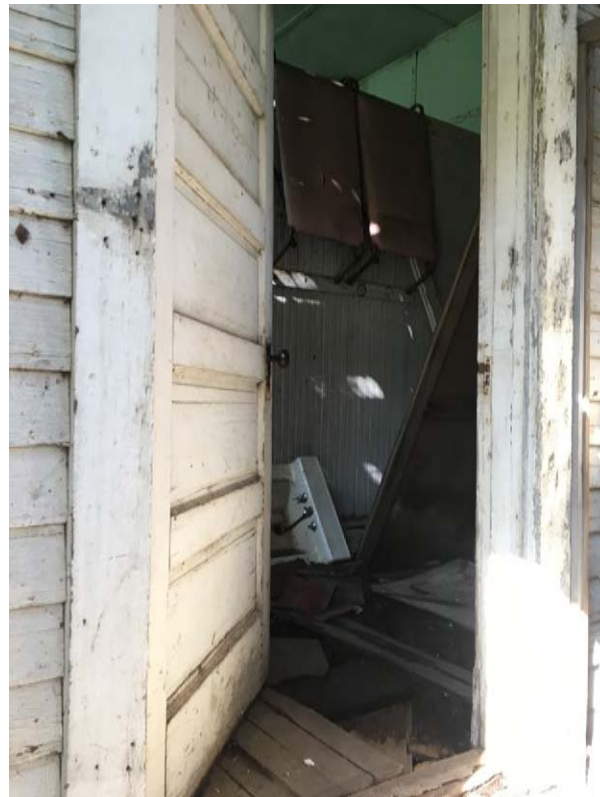
Photo No.:
IMG_6914

Although the feature is an example of a one-room schoolhouse constructed in a Hipped roof box style, the poor condition of the interior and the incorporation of two shed roofed additions on the building severely impacts the building's integrity of materials, workmanship, design, association, and feeling. The removal of the school's associated outbuilding, the abandonment of the site, and the conversion of the area into a hayfield with a nearby trash pit has further impacted the site's feeling and association. The schoolhouse lacks the integrity for NRHP nomination, and AECOM recommends the site as not eligible for listing in the NRHP under criteria A, B, or C. The site's eligibility under Criterion D was not assessed, as there will be no direct impacts to the site from this Project.

Description:
The interior of the schoolhouse from the front door, looking northwest. Note the missing floorboards.

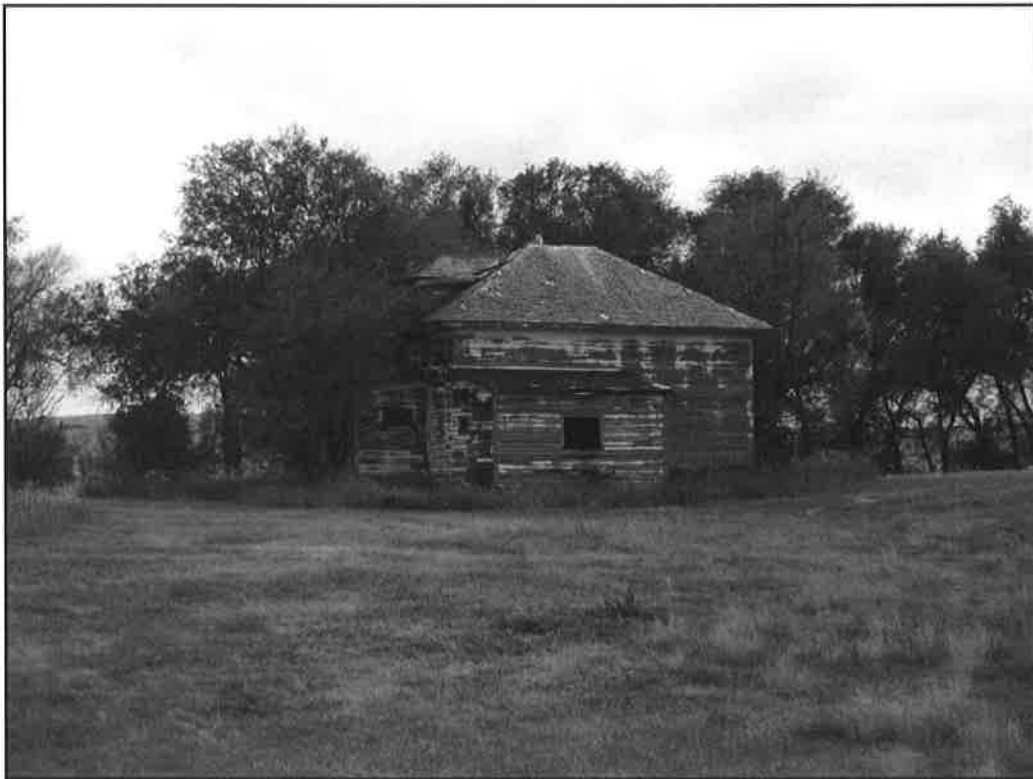
This site lead is for a standing rural school house. The structure has a poured concrete foundation. The schoolhouse is in poor condition and highly degraded. The wooden floor is rotting away and the roof is collapsing. A bed, books, and a lot of assorted detritus is present inside the school. This structure will likely entirely collapse within the next decade or two. It appears that it was used as someone's home prior to abandonment. A nearby depression, filled with modern trash, is located east of the school. These two features, and the open area surrounding them, were recorded as the site lead area.

Overview of the standing schoolhouse (view SSW; 79F-018).
