NDCRS ARCHITECTURAL FORM
PAGE 1

Field Code Lakeview School #3

Site Name Lakeview School #3
Site Name _____

Architectural Feature # 1

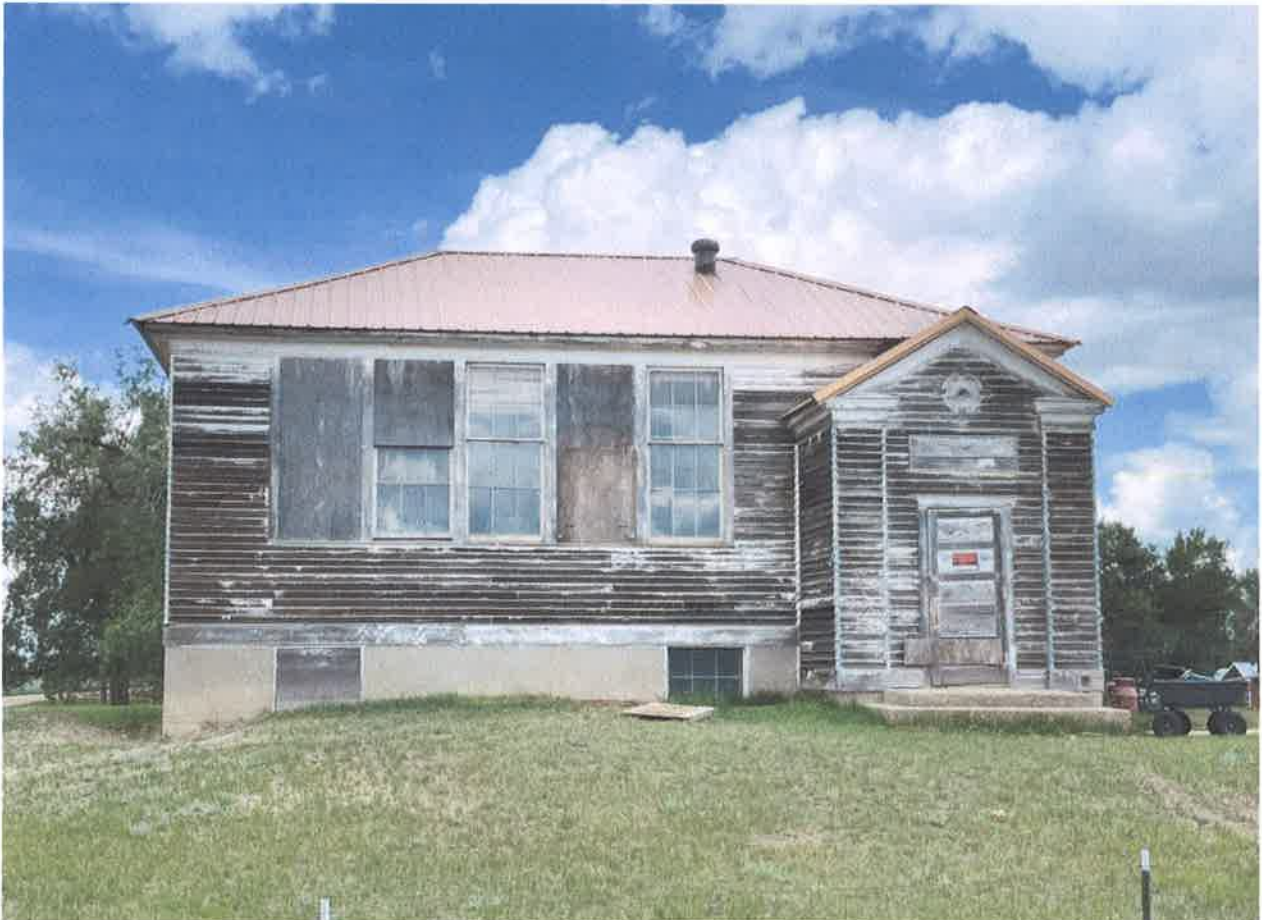
South Side – New Roof – June 2021
