NDCRS SITE FORM ARCHITECTURAL SITES

## SITS #32SA19

Page Two Field Code: CRM-Oakes12 ESCA-TECH Code OE-16

- 5. MAPS CONSULTED. U.S.G.S. Topographical map: Crete Quad. North Dakota Highway Department County Map: Sargent County.
- 6. <u>PROJECT TITLE</u>: Garrison Diversion Unit Project LaMoure-Oakes Resurvey

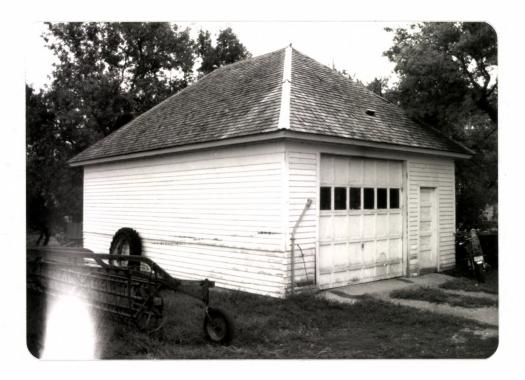
Roll#8 Frame# 2

Feature 16 is a hip-roofed, one story, wood frame school building which has been converted into a garage. The structure is set on a concrete slab foundation and has clapboard exterior siding. The roof is covered with wood shingles and metal flashing. (Photo ID: 8:2 from the southwest, 8:3 from the northeast)

Feature #16 View from: southwest

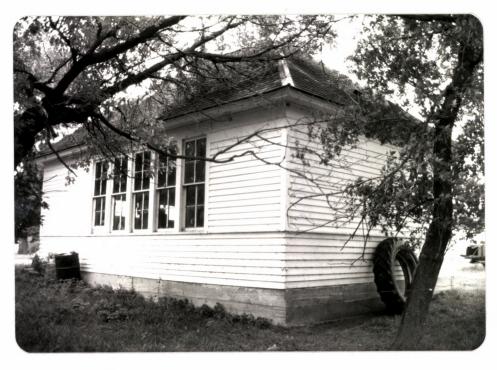
Roll# 8 Frame# 3

Feature #16 View from: northeast
