NDCRS ARCHITECTURAL SITE FORM

SITS# 32 SK ~~X~~356

Project: U.S. Highway 85, Belfield to Watford City Inventory; Principal Investigator: Duane Klinner

Report Title: U.S. Highway 85 From the I-94 Interchange at Belfield to the Watford City Bypass: A Class III Cultural Resource Inventory in Billings, McKenzie, and Stark Counties North Dakota;  
Authors: D. Klinner, A. Robinson, & E. Sakariassen

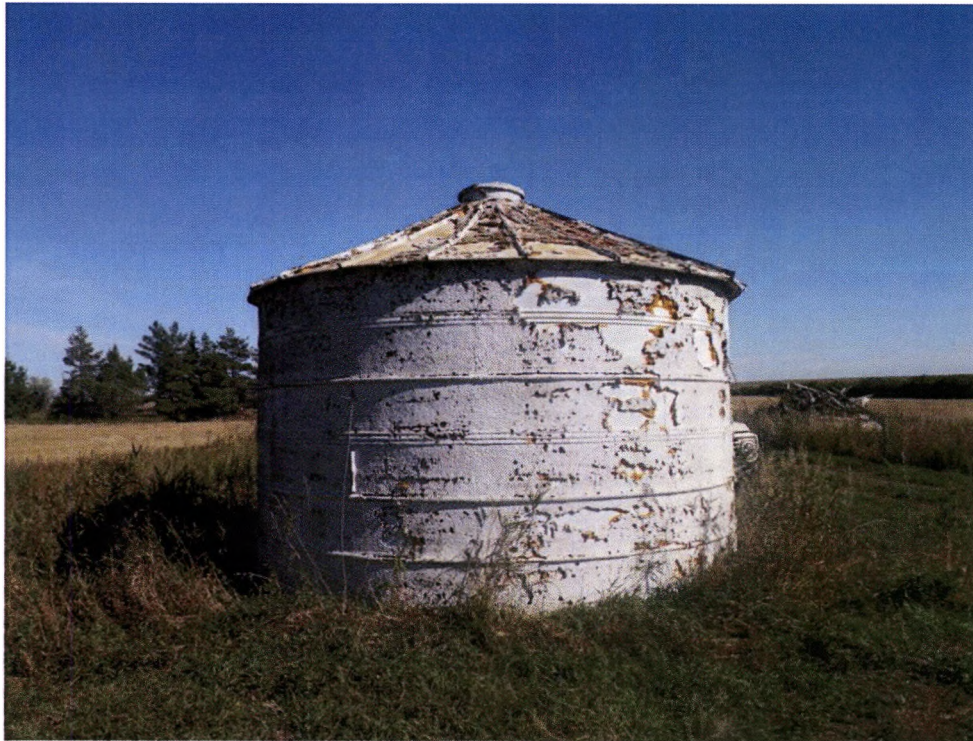
**Figure 14:** Site 32SKx356, Feature 8, view northeast (Image #0034).

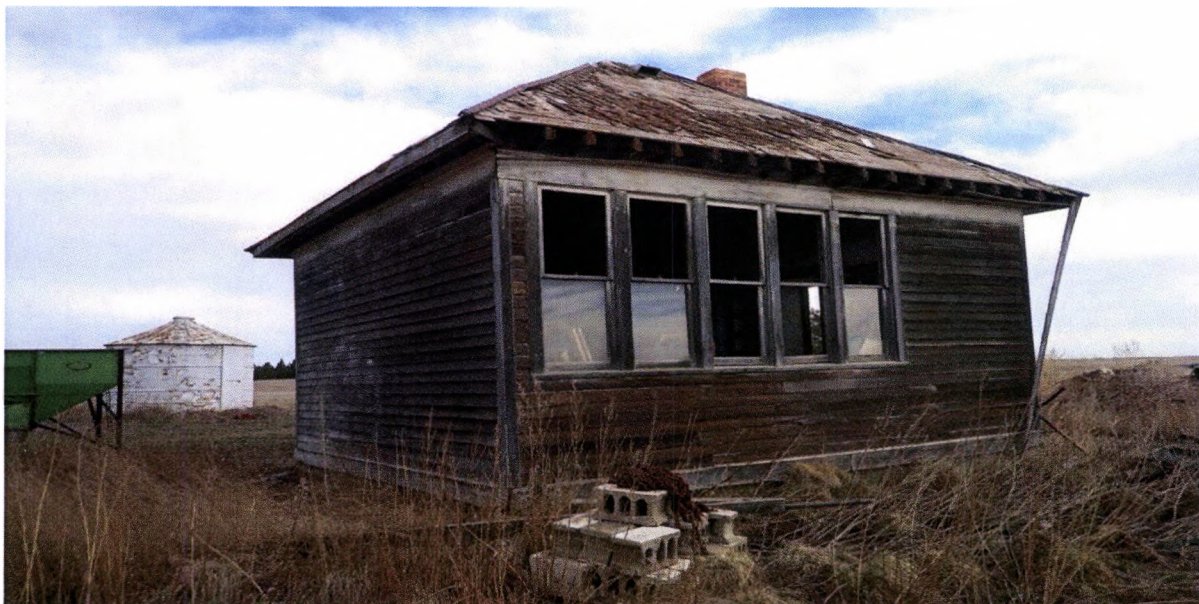
DESCRIPTION: Feature 9 is a former one-room school house, moved to its current location. The feature has a rectangular footprint and rests on stringers. The hipped roof is clad in wood shingles. Broken fascia boards along the south facade expose the rafter tails beneath. The exterior walls are clad in horizontal clapboards and the primary entry is located on the east facade. The entry consists of a standard doorway with a single-lite transom; no extant door. A one-over-one-lite window is to the north and to the south of the doorway. The north facade contains a small boarded up opening near center and no fenestration is located on the west facade. A bank of five one-over-one-lite single-hung windows are along the west end of the south facade. A chalkboard is visible through these windows and is mounted on the west wall. A brick chimney is at the east end of the feature.

INTEGRITY: Feature 9 is in fair condition and retains integrity of design, feeling, and workmanship. Integrity of materials has been impacted by the loss of wood shingles, window glass, damage to fascia boards, and the overall deterioration of the feature. The act of moving the structure from its original location has compromised integrity of setting and location.

**Figure 15:** Site 32SKx356, Feature 9, view southeast (Image #2592).

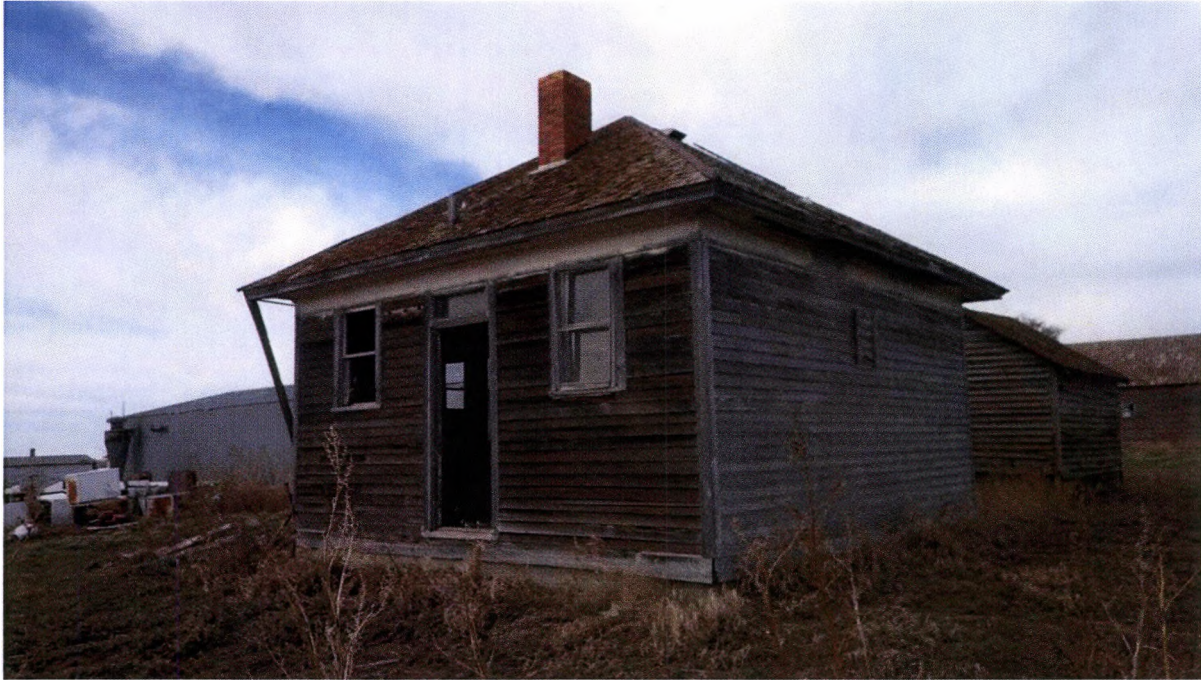
**Figure 16:** Site 32SKx356, Feature 9, view southwest (Image #2591).

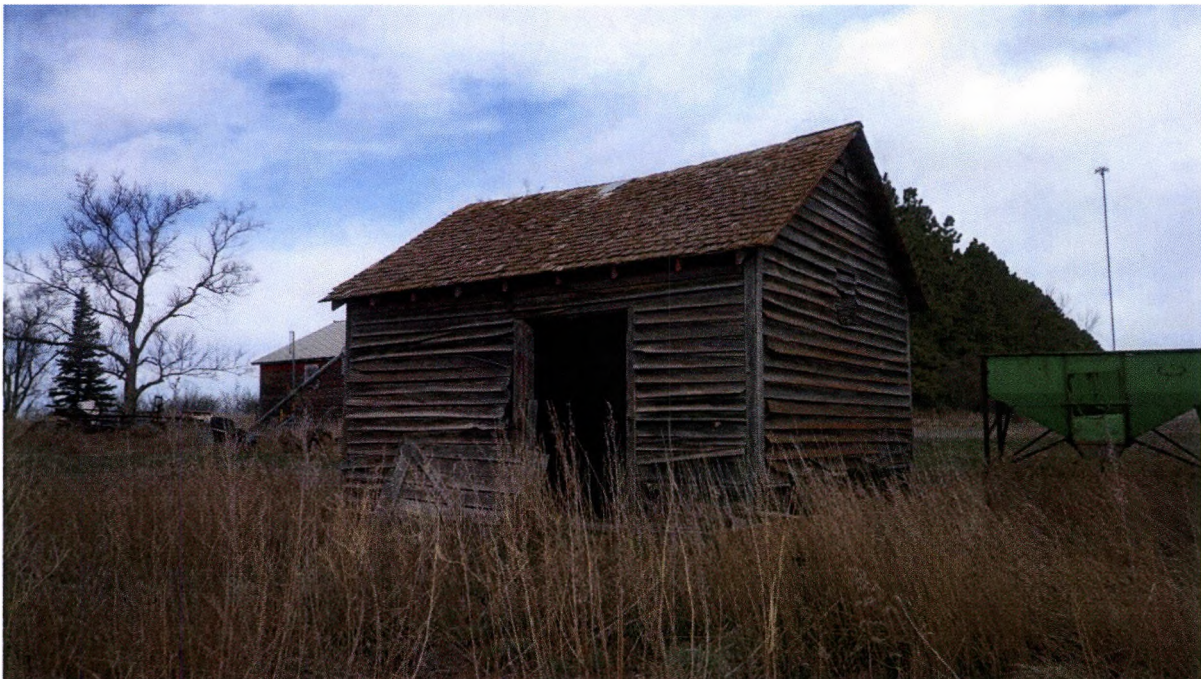
**Figure 17:** Site 32SKx356, Feature 10, view northwest (Image #2593).
