# NDCRS ARCHITECTURAL SITE FORM PAGE 1

Juniper, LLC Additional Information:					
School house, collapsed	structure, depress	sion, concrete	e pad, metal fra	mes.	
SHSND USE Area of Significance 2 Area of Significance 3 Area of Significance	Ecozone	21	Verified Site	1 CR Ty	/pe <u>2</u>
Recorded By	Kaelyn Ol	son	Date	Recorded	06/13/2016
(First Nam	e & Last Name)				(mm/dd/year)

Field Code JUP-16015-605	SITS# 32 WI

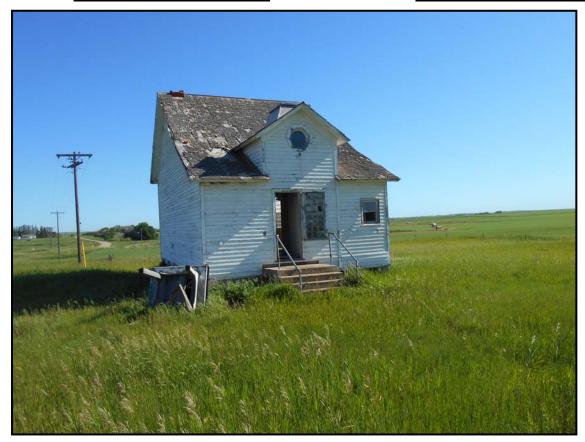
Feature 1 is in fair condition. Feature 1 maintains aspects of structural integrity, including workmanship and materials, and shows no signs of having been moved. Feature 1 maintains a rural, agricultural setting. Further work is recommended to better understand the relationship of Feature 1 to other historic sties in the area.

Figure 4: Overview of Feature 1 facing northeast.

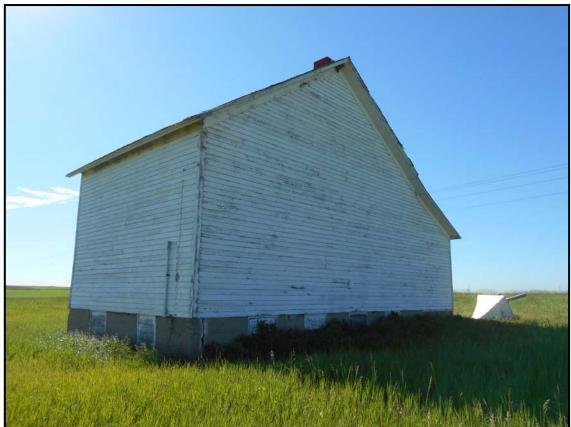
Figure 5: Overview of Feature 1 facing southeast.

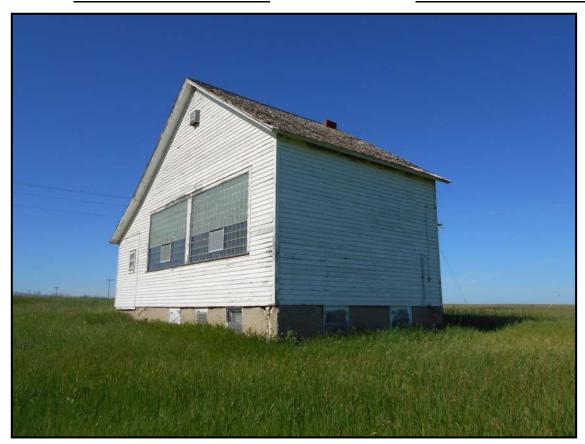
Figure 6: Overview of Feature 1 facing southwest.

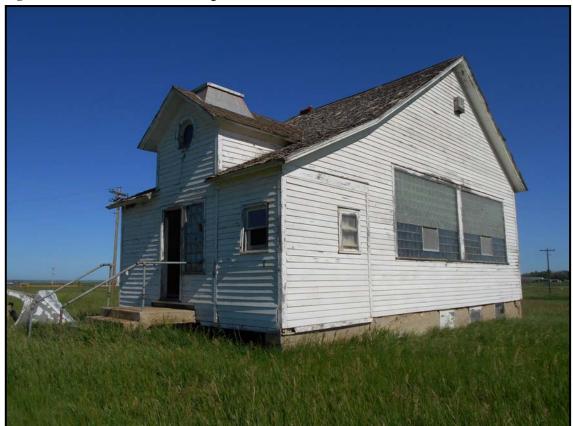
Figure 7: Overview of Feature 1 facing northwest.

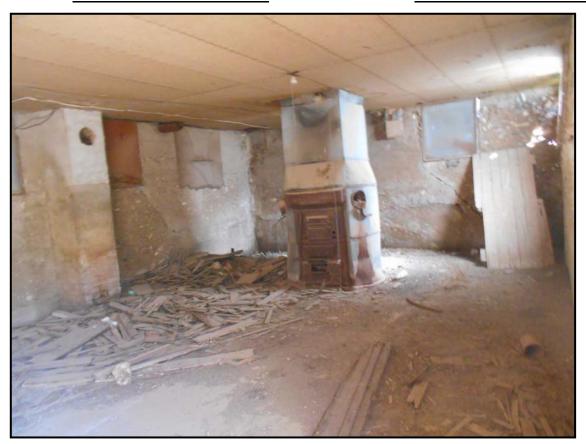
**Figure 8:** Overview of the furnace in the basement of Feature 1.

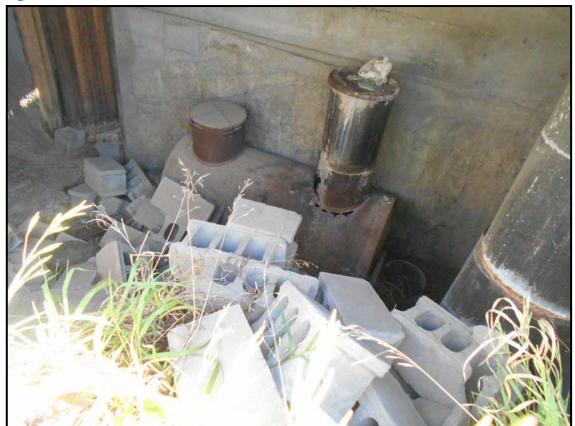
**Figure 9:** Overview of the boiler in Feature 1.

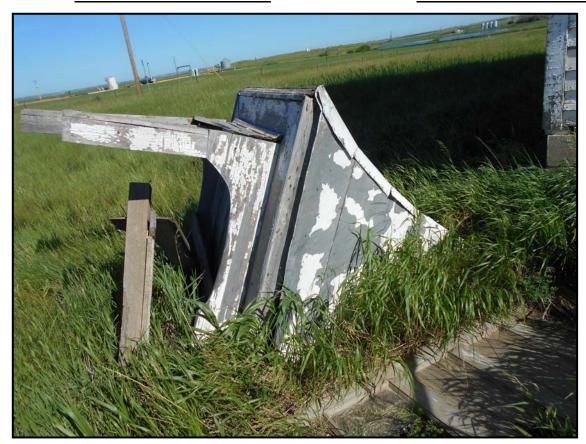
Figure 10: Close up of the fallen cupola next to Feature 1.

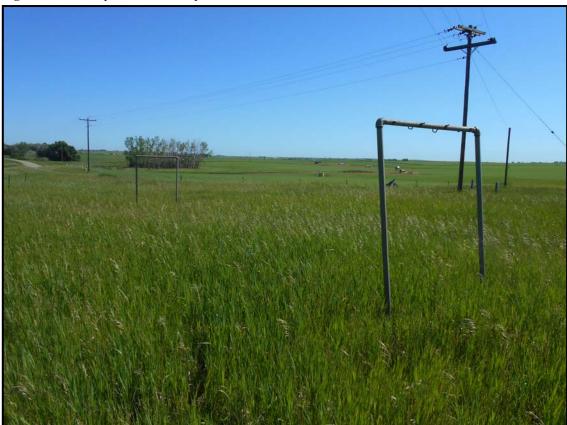
Figure 11: Overview of Feature 2, the clothes line frame facing southwest.
