TECTURAL SITI	E FORM	DATE
Field Code Lee School #3	PAGE 1	S# 32 DV 129	
SITE IDENTIFICATION			
Map Quad Colgan SE Map Quad	Site Name Lee Scho		
	11 QQQ 2		Q 5
	QQQ QQQ	QQ QQ	Q Q
	QQQ	QQ	Q
NAD 1983 UTM 5404720 N	7015 121		
NAD 1983, UTM 5404720 N NAD 1983, UTM 601353 E	ZONE 13N		Subsection: $1 = N\frac{1}{2}$
			$2 = E\frac{1}{2}$
City:			3 = S½
Street Number:			4 = W½ 5 = NE¼
			6 = SE <sup>1</sup> / <sub>4</sub>
Street Name: Highway 85			7 = SW1/4
Urban Legal Description:			8 = NW¼
SITE DATA

NDCRS ARCHITECTURAL SITE FOR	
PAGE 3—Feature Data	UPDATE
a llee School #3	" ap DV 129

# NDCRS ARCHITECTURAL SITE FORM PAGE 1

## NDCRS ARCHITECTURAL SITE FORM PAGE 3—Feature Data

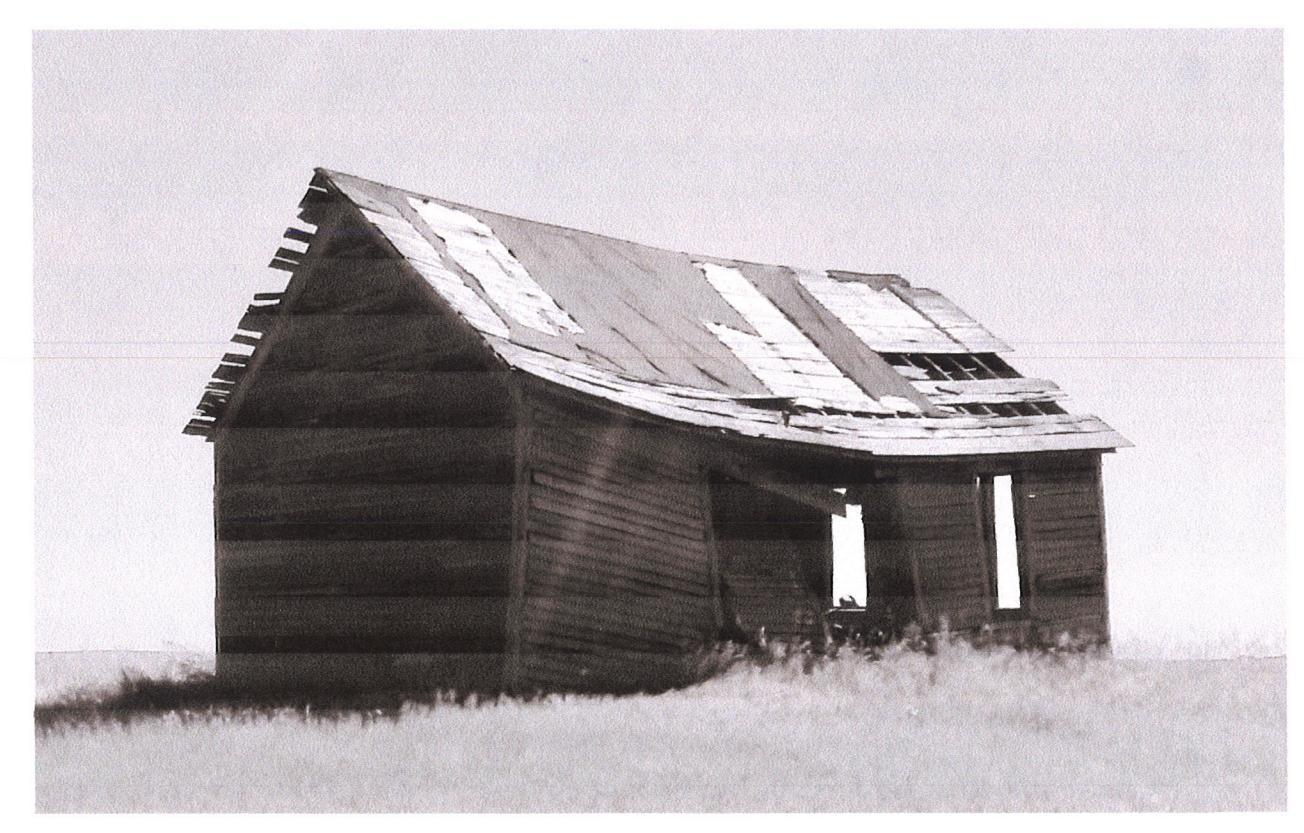
## North Side

The feature is a one room prairie school and this is a bit of an update on that school. It was previously recorded in 2013 and newer pictures indicate changes. The roof is continuing to sag and more holes are opening up as the weather continues to take a toll. The north wall window openings have deteriorated beyond the 2013 pictures with a large hole opening where framing used to be.

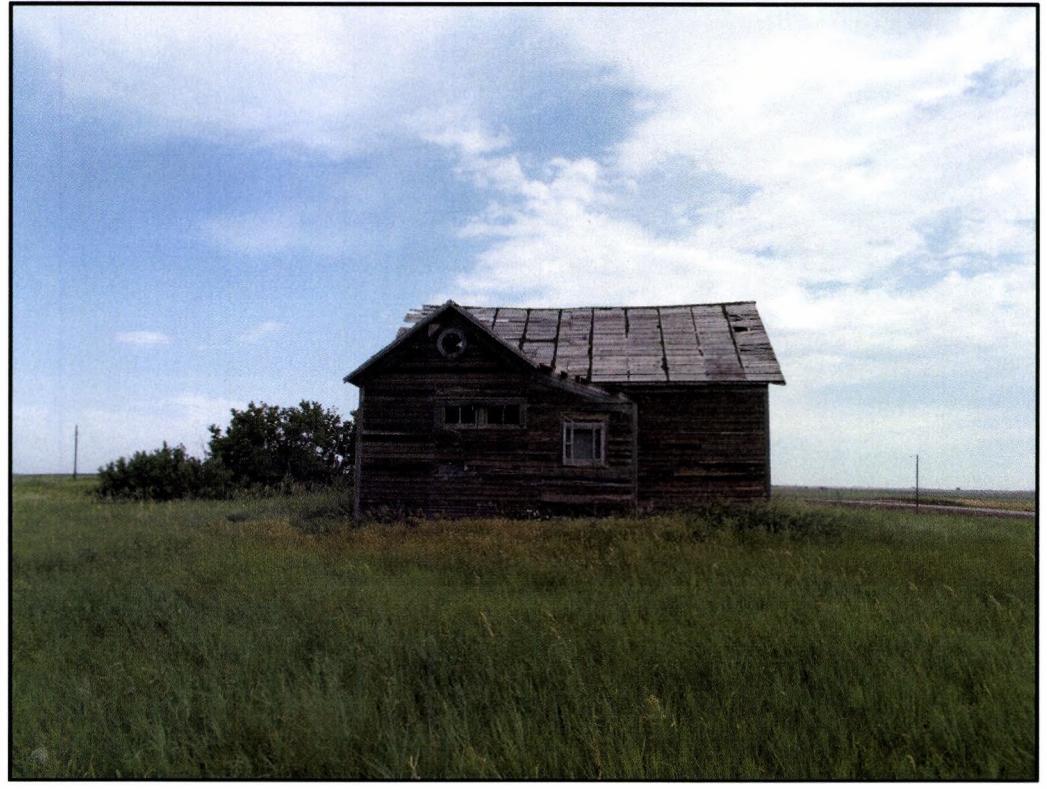
**Figure 13:** The south elevation of Feature 3. Evidence that the original schoolhouse entrance has been infilled and a shed (lean-to) foyer added to accommodate the new, east-facing door is visible.

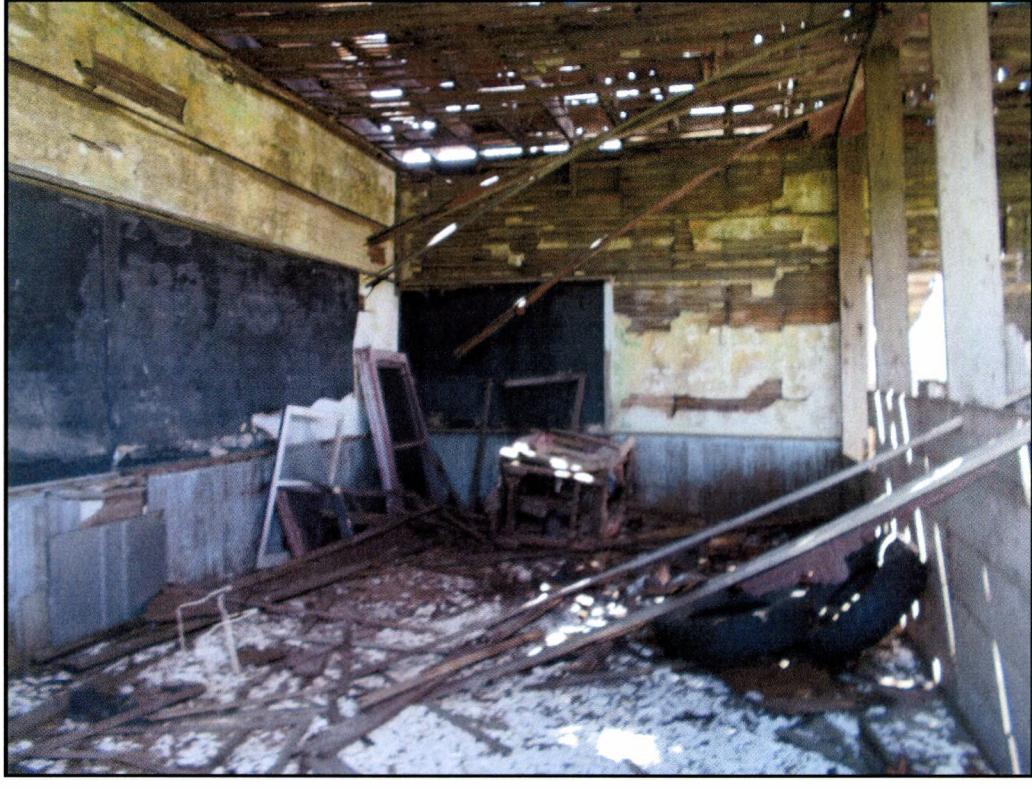
Figure 17: Interior of the former schoolhouse. Note chalkboards, deteriorating lathe and plaster, and wood-frame partition which is likely to have been constructed at a later date.
