NDCRS ARCHITECTURAL FORM PAGE 1

Field Code	SITS# 32 PI 85
Map Quad Map Quad	Site Name Meyer Township School #1Site Name
-	QQQ7of the QQ7of the Q7QQQof the QQof the QQof the Q $1 = N\frac{1}{2}$ QQQof the QQof the QQof the Q $2 = E\frac{1}{2}$ QQQof the QQof the QQof the Q $3 = S\frac{1}{2}$
NAD UTM NAD UTM City:	6 = SE¼ 7 = SW¼
Street Number:	8 = NW¼
Street Name:	
Urban Legal Description:	
Total Number of Architectural Features: Fieldwork Date:08/08/2024	1
Reconnaissance Survey	Intensive Survey
Project & Principal Investigator:	
Contracting Firm or Agency Completing the F SHSND	orm:
Additional Information: Photo provided by Hunter Andes via Kathy Wilr	ner. Photo taken in August 2024.
SHSND USE Component Component Component	Verified Site CR Type

NDCRS ARCHITECTURAL FORM

NDCRS ARCHITECTURAL SITE FORM PAGE 1

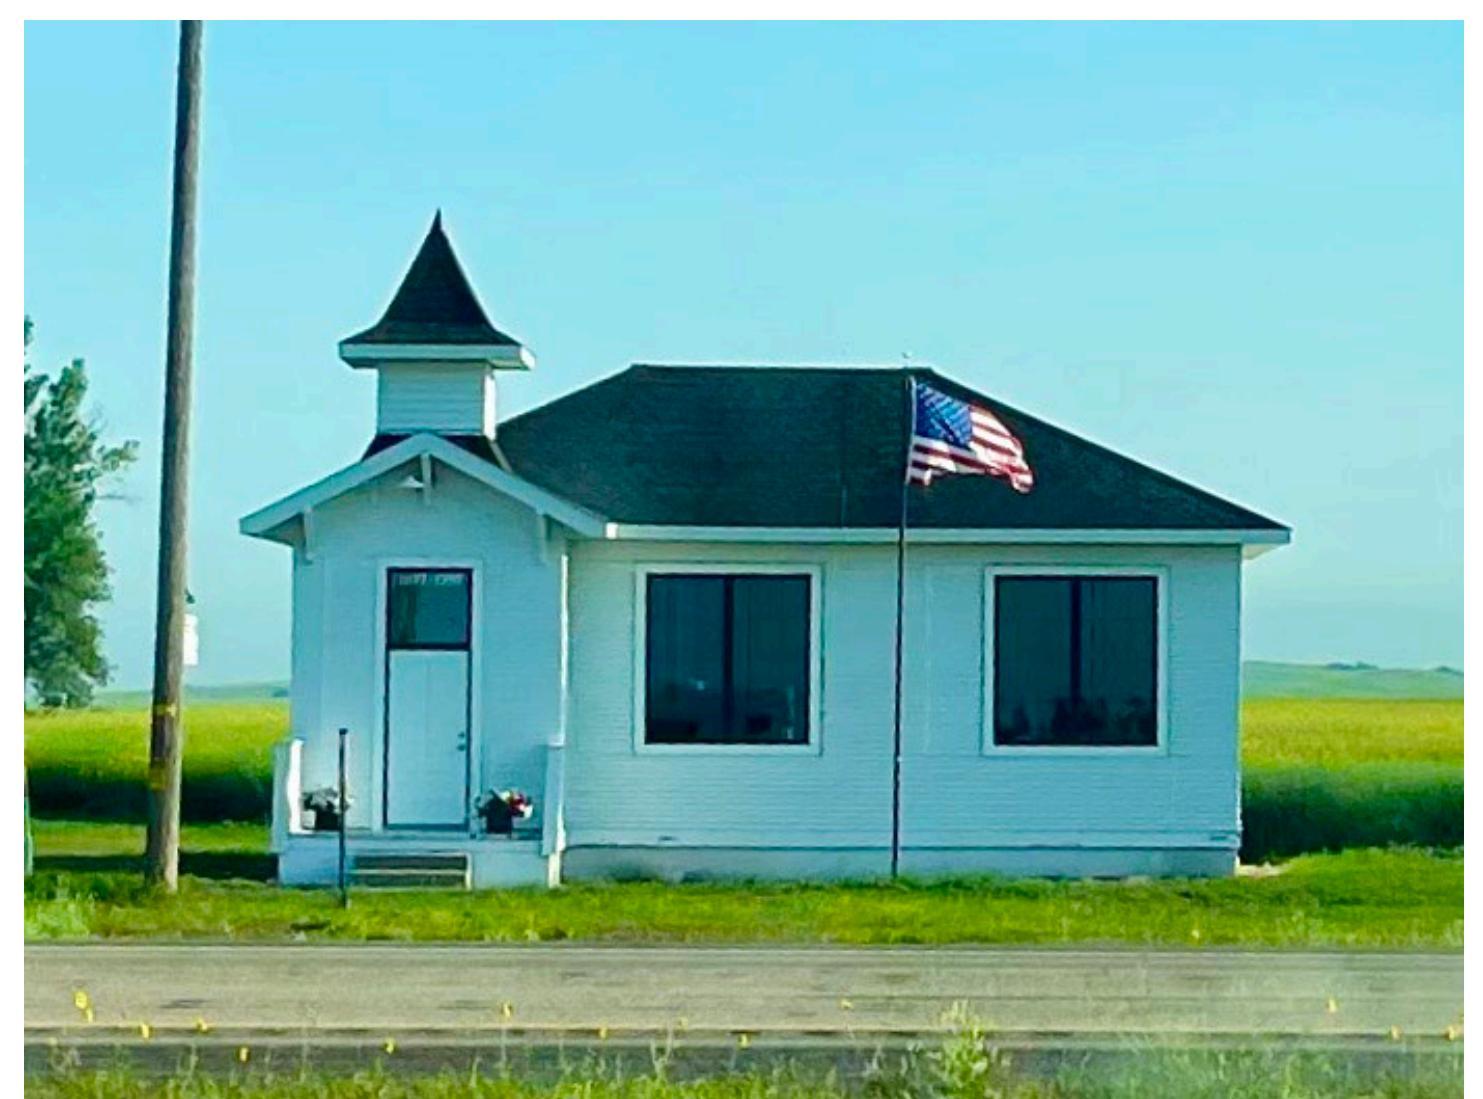
Figure 1: 32PI85, view north. Photo captured by Hunter Andes in August 2024.

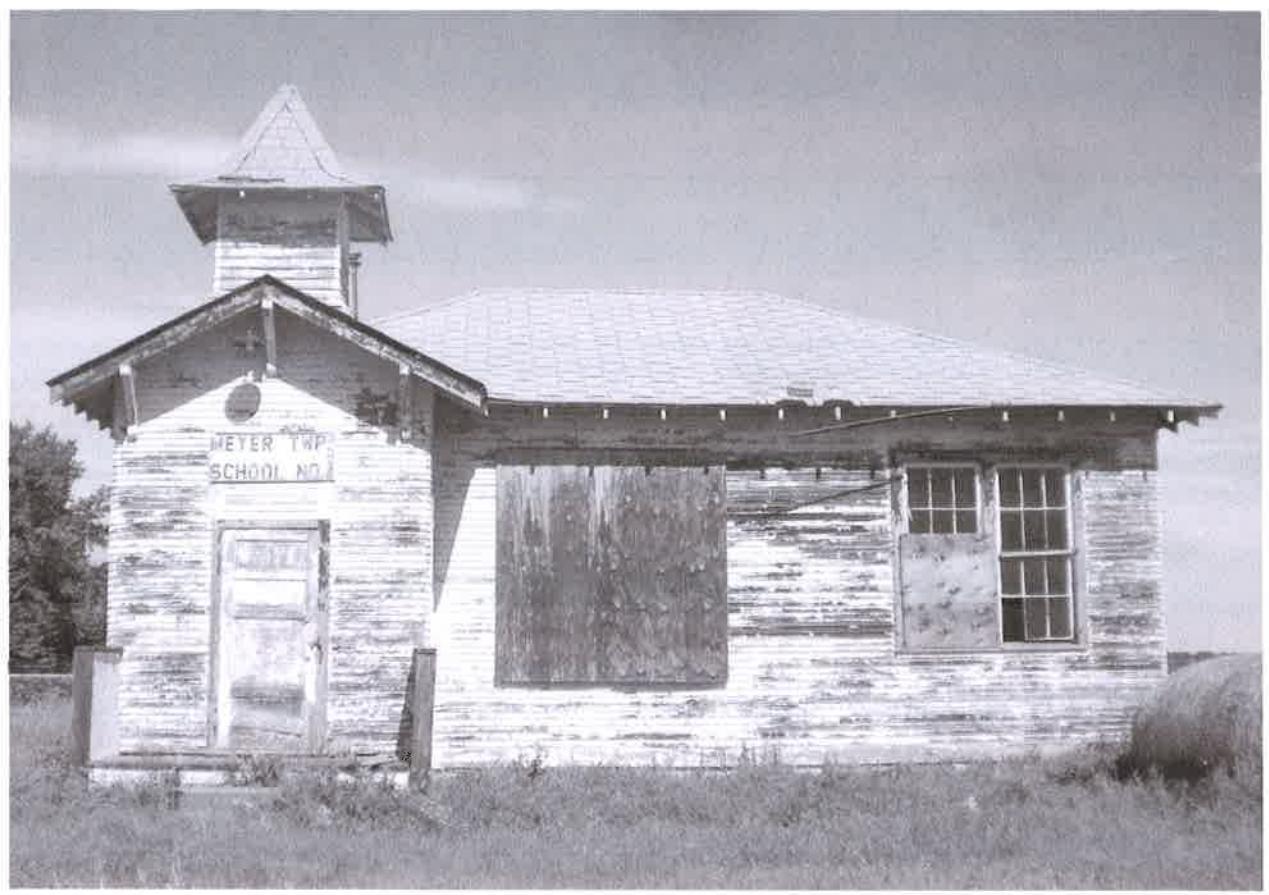
South Side

Meyer Township School #1 4/4/2016 Kathy Wilner PI

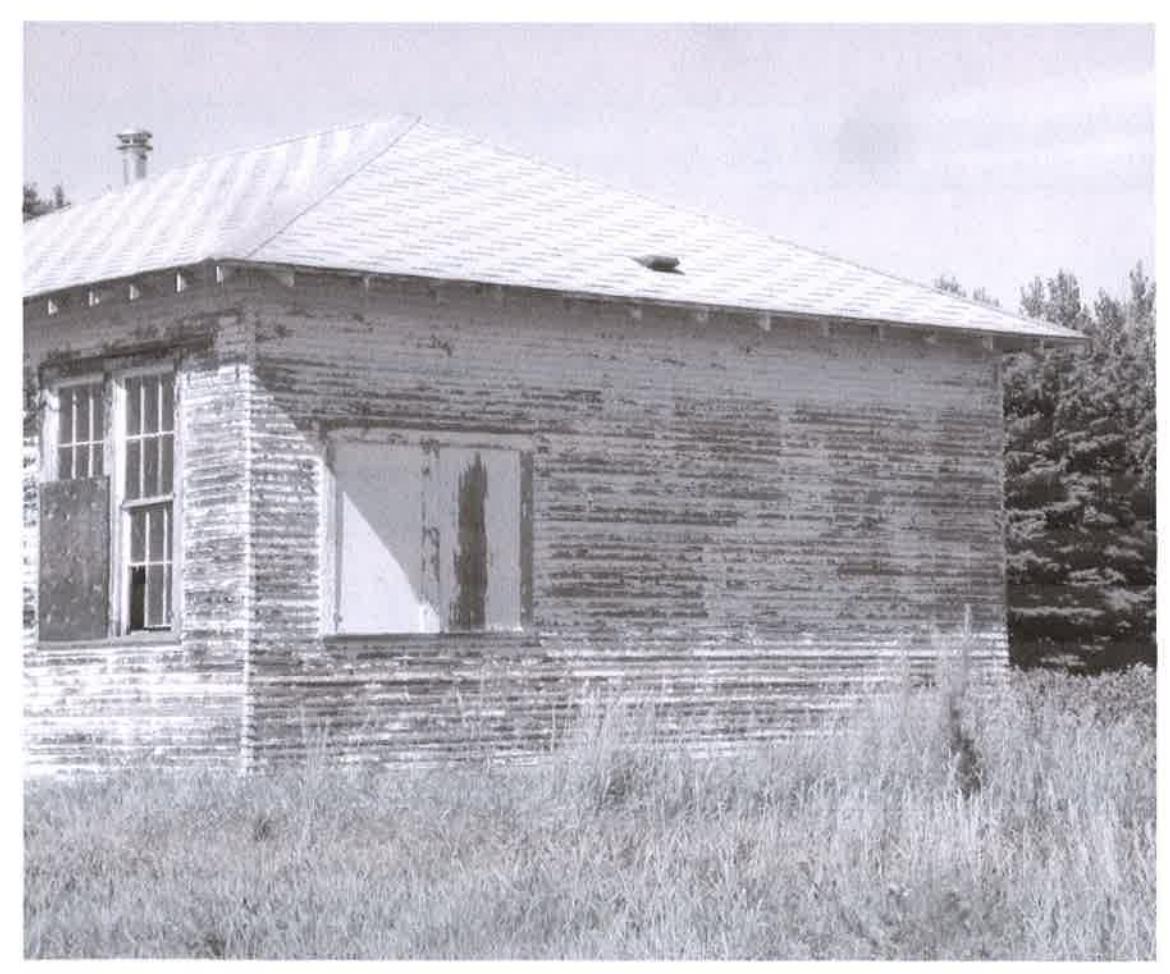
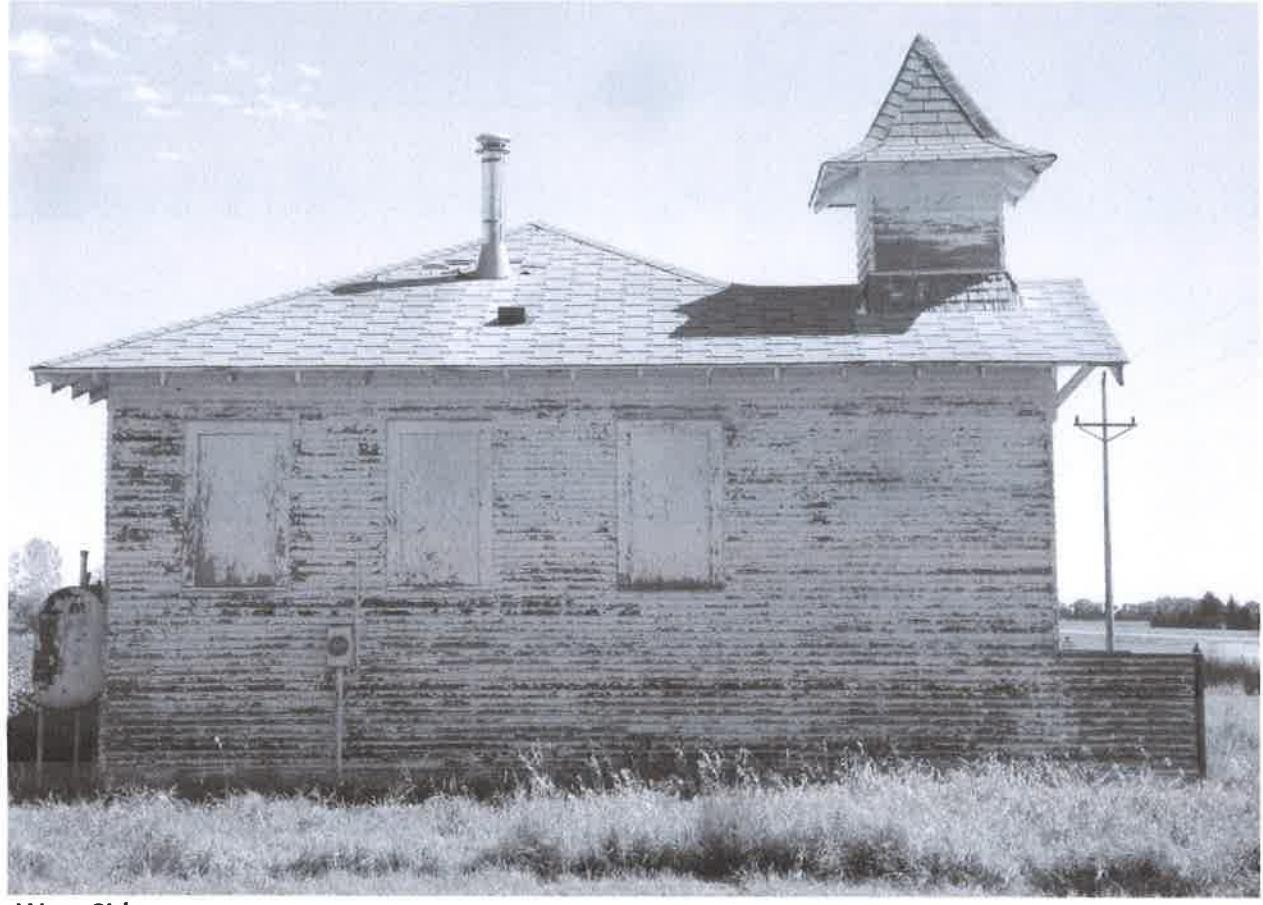
West Side

Meyer Township School #14/4/2016Kathy WilnerP1North Side

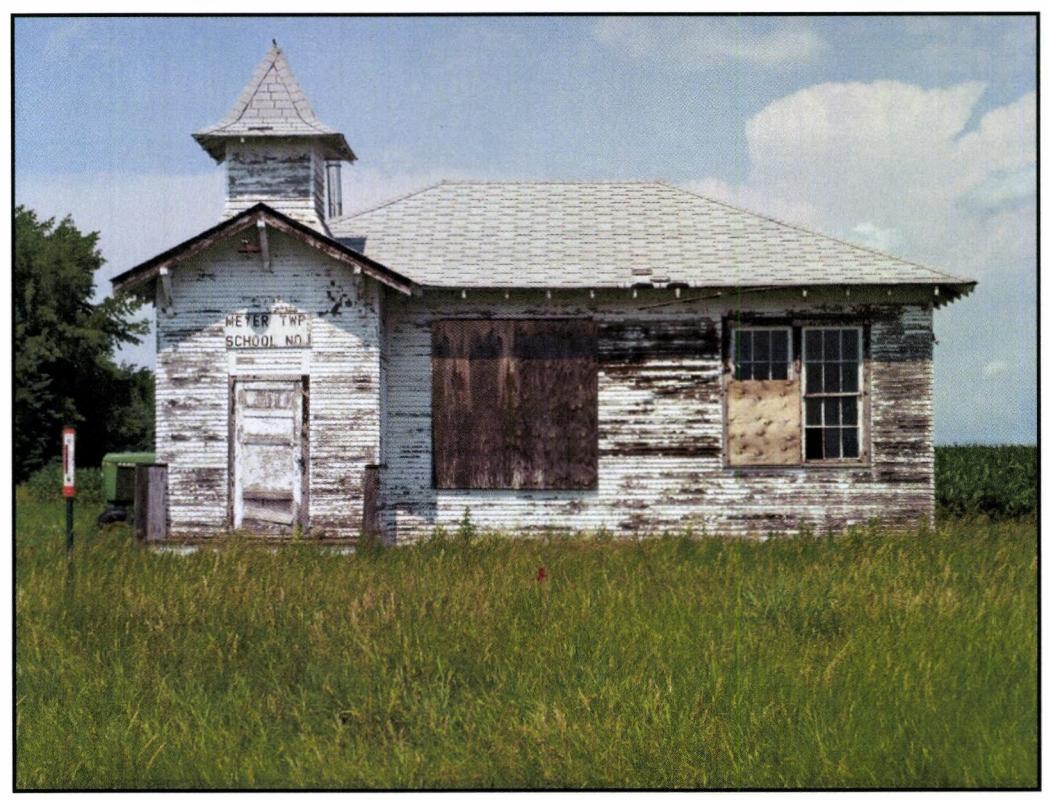
Figure 3: Site Lead 32PIx79, a historic, one-room schoolhouse (Meyer Township School No. 1). View of the south elevation from the US Highway 2 right-of-way.

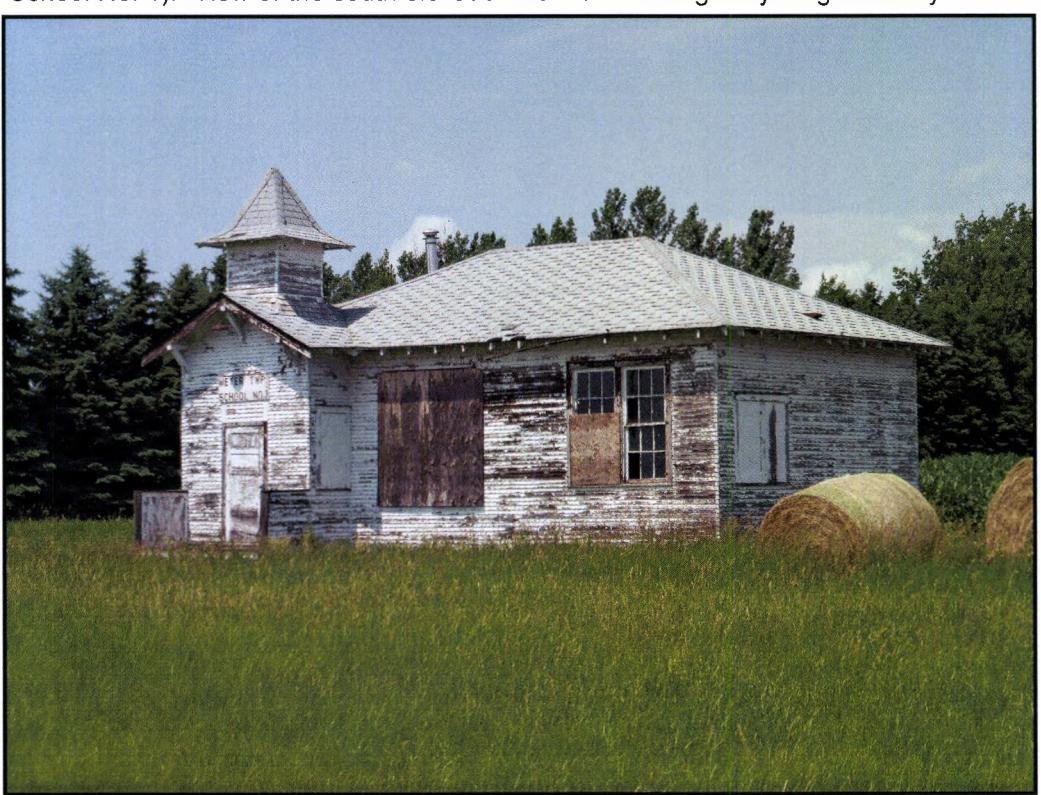
Figure 4: South (front) and east (side) elevations of the schoolhouse.

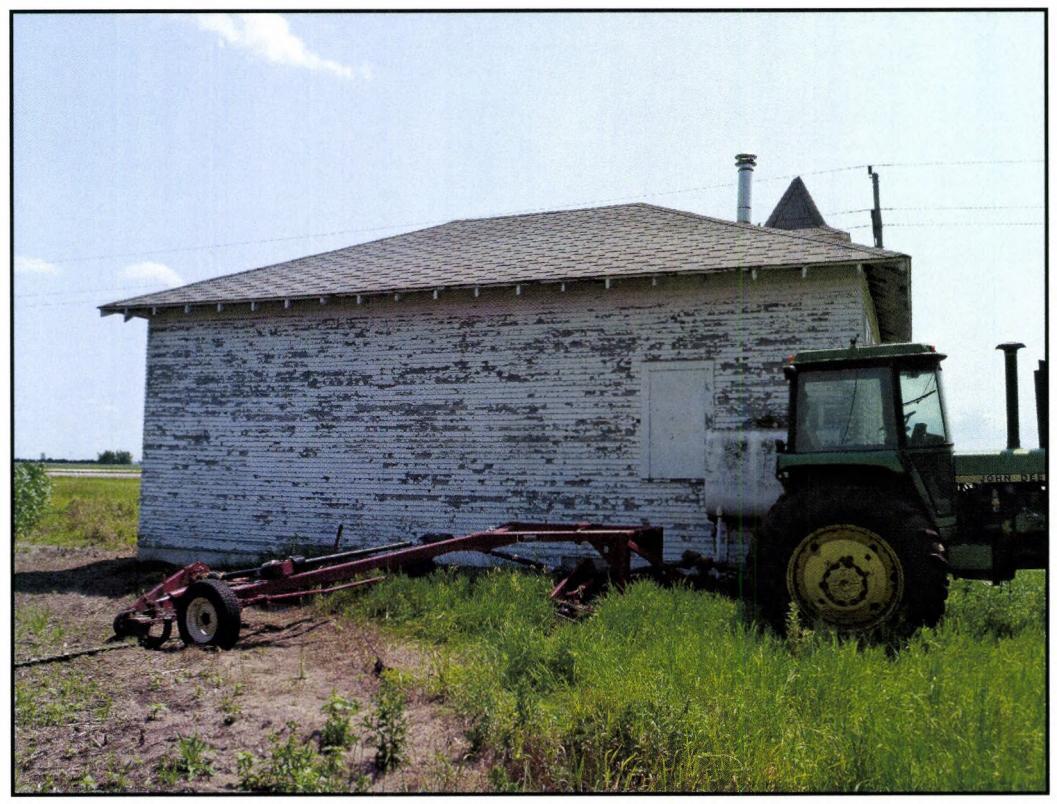
Figure 5: North (rear) elevation of this Meyer Township school in US Highway 2.

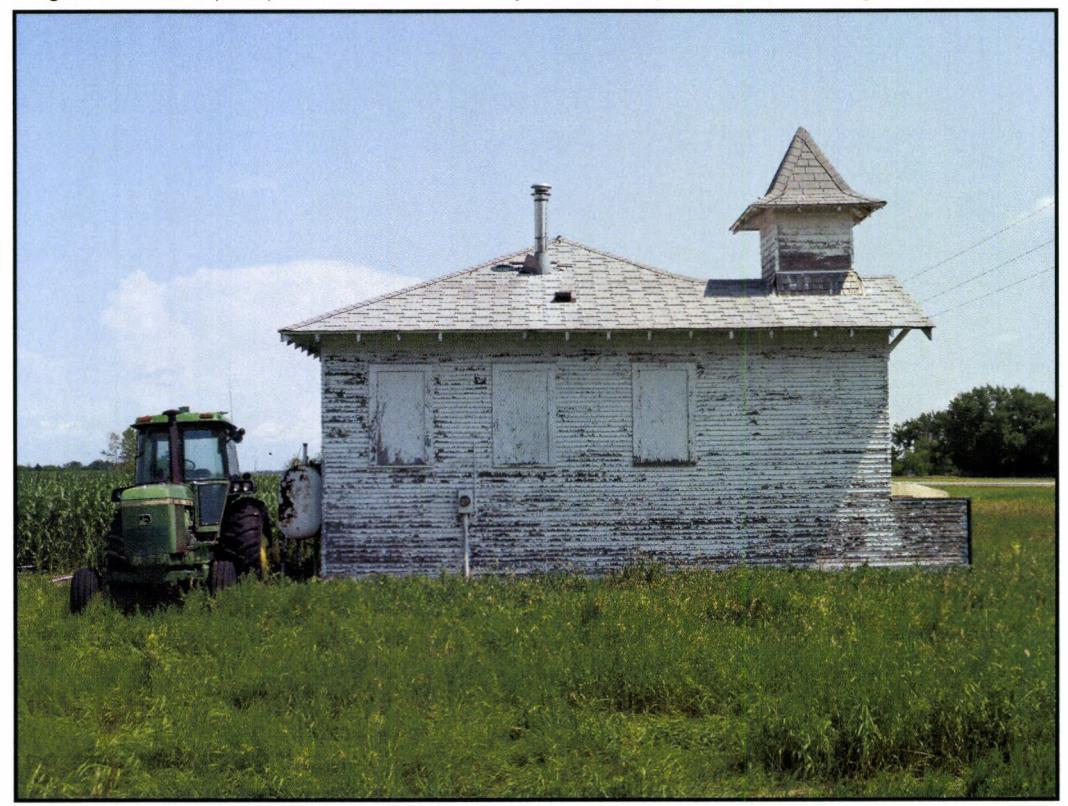
Figure 6: West elevation of the schoolhouse.

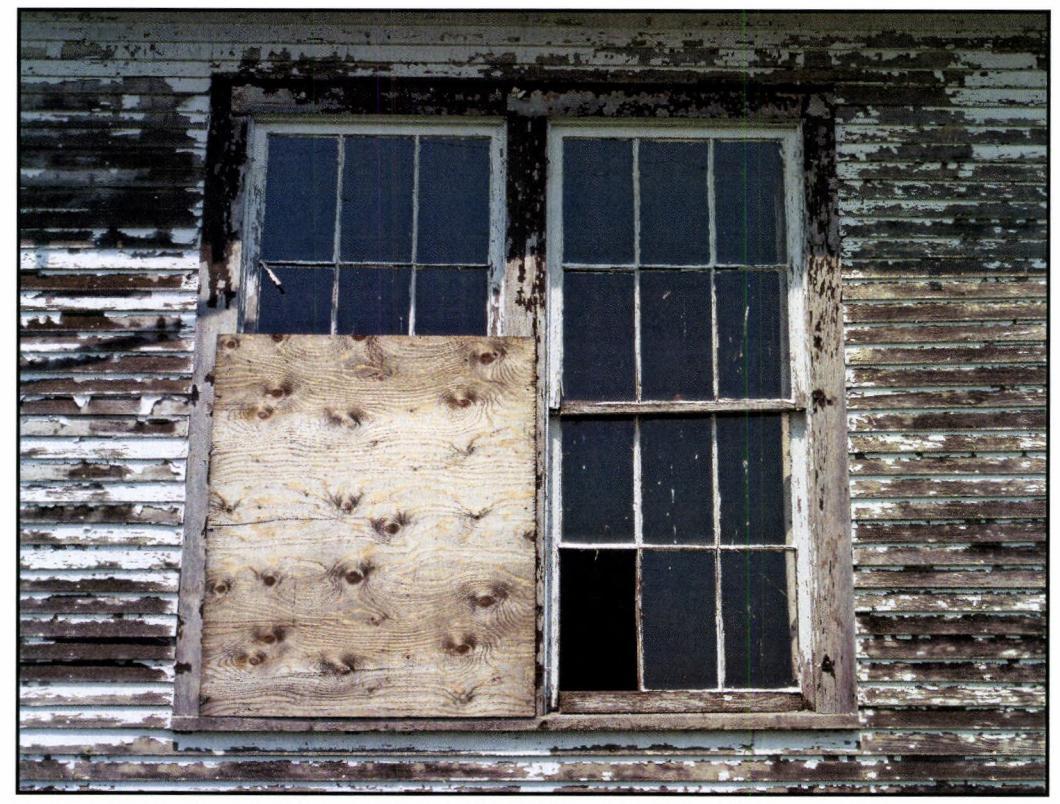
Fenestration is mostly boarded over and the presence of original/early window units could not be confirmed for most openings. Based on photographs included with the 32PIx79 site form and the appearance of unboarded windows, those to the south elevation appear to be two pairs of six-over-six, double-hung, sash windows. One pair is currently boarded over while the second is only partially so. This change has occurred since the building was originally recorded. All other windows were boarded over prior to original recording. These include what may be a pair of windows on the east elevation, one window on the north (rear) elevation, three windows on the west elevation, and one window on the east elevation of the entrance vestible. The building contains only one door, which faces south. It is a wood paneled unit and is currently in a state of deterioration. Fenestration has unornamented surrounds and sills.

Figure 7: Windows on the south elevation at the east end of the building.

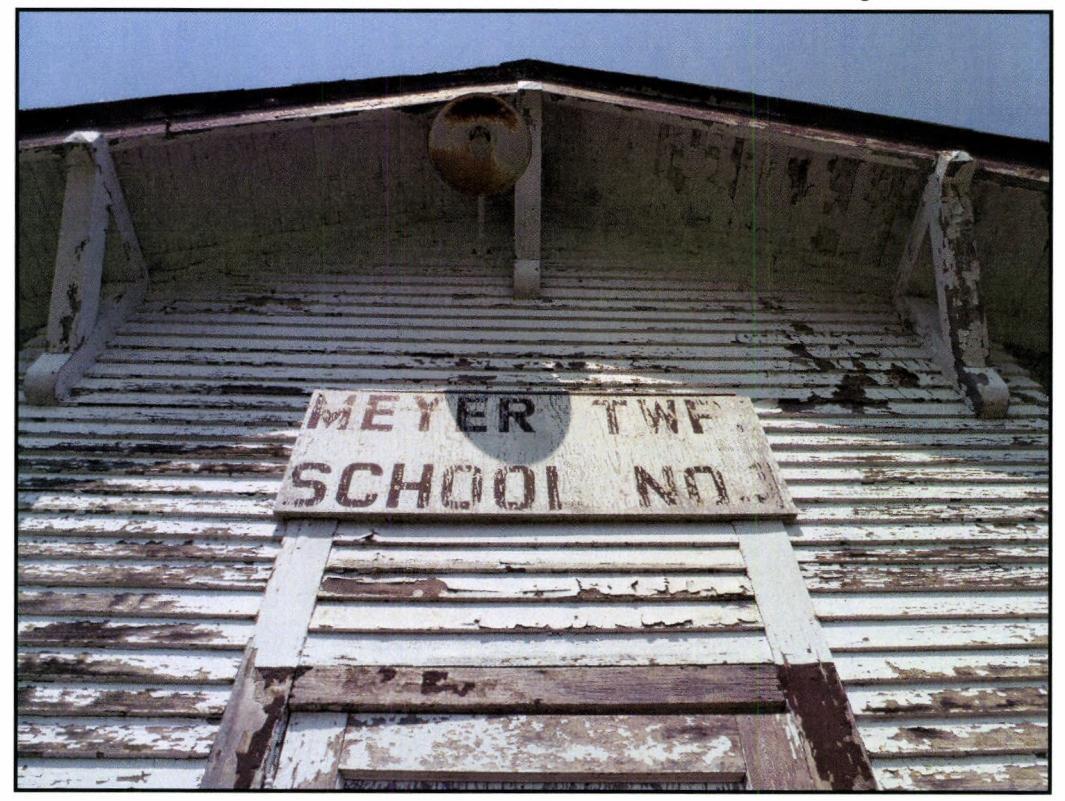
Figure 8: Eaves detail to the entrance vestibule.

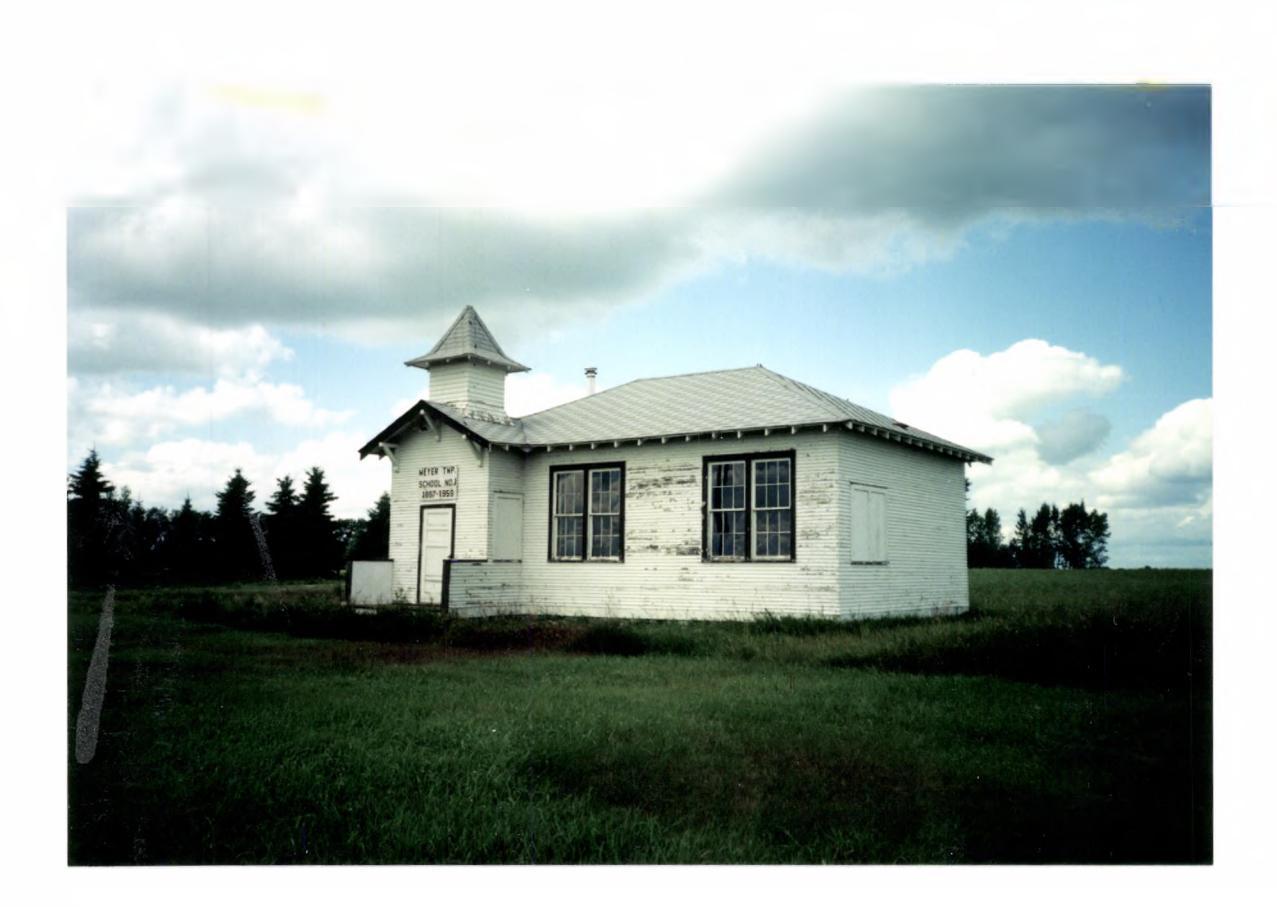
View to north-northwest over school (exposure 7, roll 8-1-01).

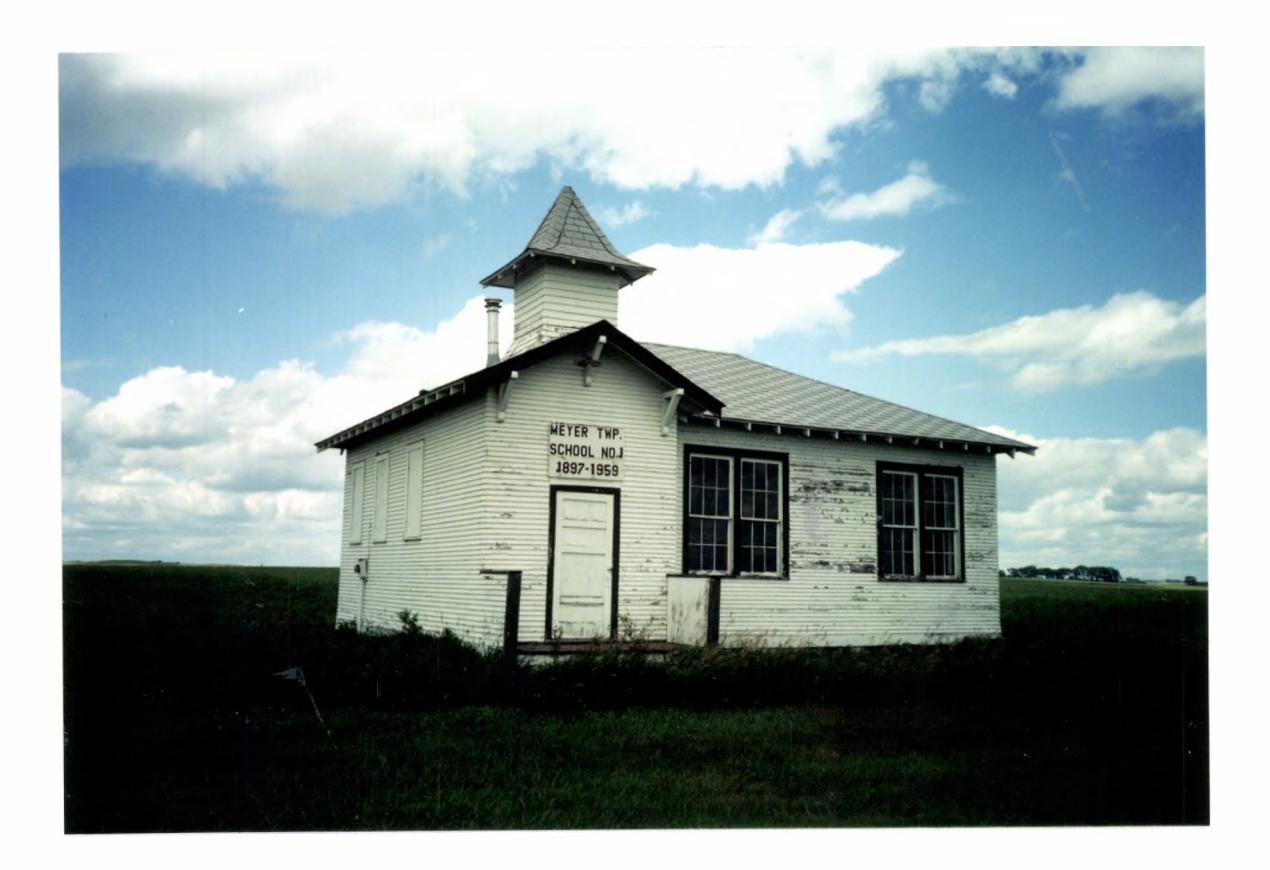
View to north-northeast over school (exposure 5, roll 8-1-01).
