NDCRS SITE FORM
ARCHITECTURAL SITES

SITS # 32 A.D. 87

PROJECT TITLE 970528a, Southwest Pipeline, Bucyrus Service Area and Pocket Areas.

REPORT TITLE Results of Class I, Class II and Class III Cultural Resource Investigations for the Southwest Pipeline Project; Bucyrus Service Area and Pocket Areas.

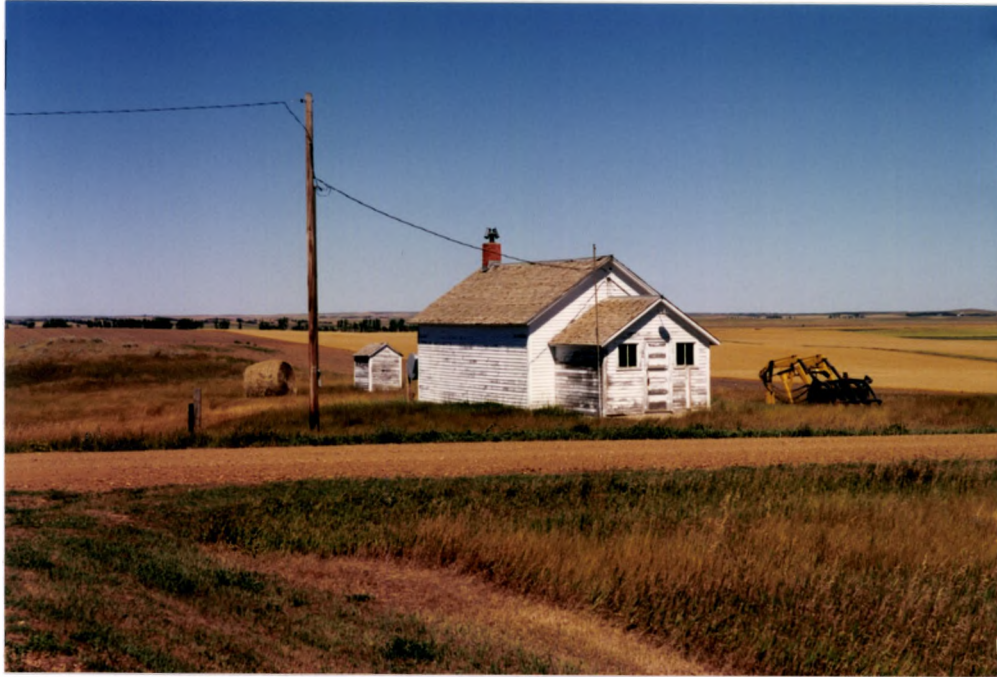
Site overview, view to the northeast; 970528a, Roll 7, Negative 7.

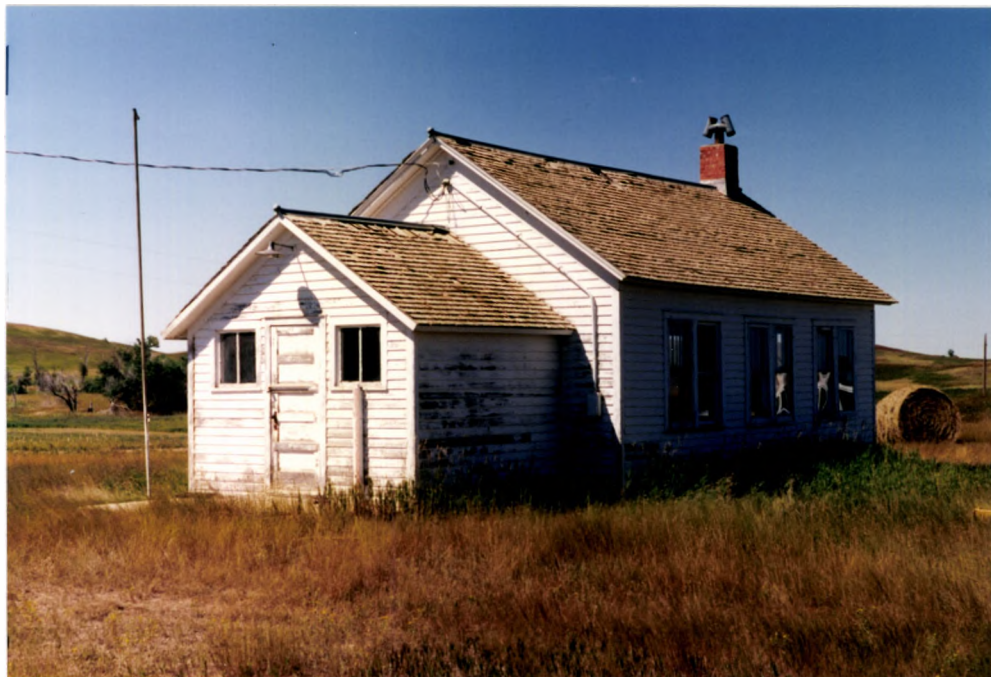
DESCRIPTION/INTEGRITY/ELIGIBILITY Feature 1 is a rural schoolhouse. It is 20-by-30 foot wood frame building with a 10-by-14 foot entryway on its south elevation. The building is sheathed by horizontal clapboard siding. The windows in the main part of the building are double hung 3/1. The gable roof is covered by wood shingles. The building appears to be on a poured concrete slab.

Although not presently in use, the building appears to be structurally sound and in a reasonably good state of repair.

Feature 1, south and east elevations, view to the northwest; 970528a, Roll 7, Negative 11.

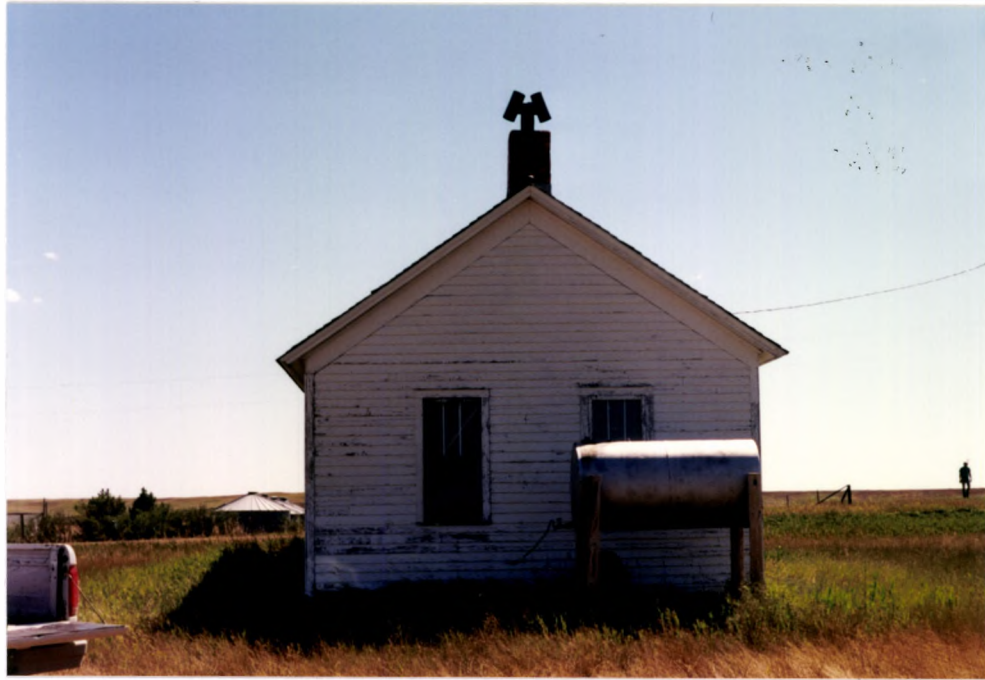
Feature 1, north elevation, view to the south; 970528a, Roll 7, Negative 15.

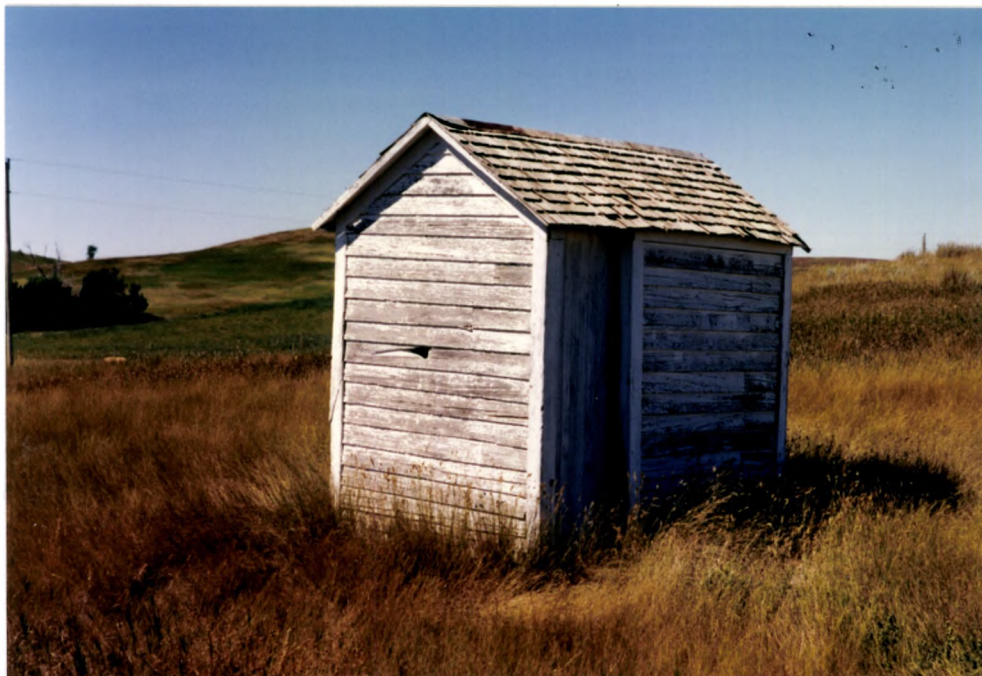
DESCRIPTION/INTEGRITY/ELIGIBILITY Feature 2 is a 5-by-8 foot wood frame privy. The privy is sheathed in horizontal clapboard siding. It has a gable roof with wood shingles. The privy is on a wood sill foundation. This building does not have any exceptional architectural characteristics.

Feature 2, south and east elevations, view to the northwest; 970528a, Roll 7, Negative 19.
