## National Register of Historic Places Registration Form

Historic name: Alderman School District #78

Street & number: Eleven Miles North of Valley City on County Route 21

City or town: Valley City State: ND County: Barnes

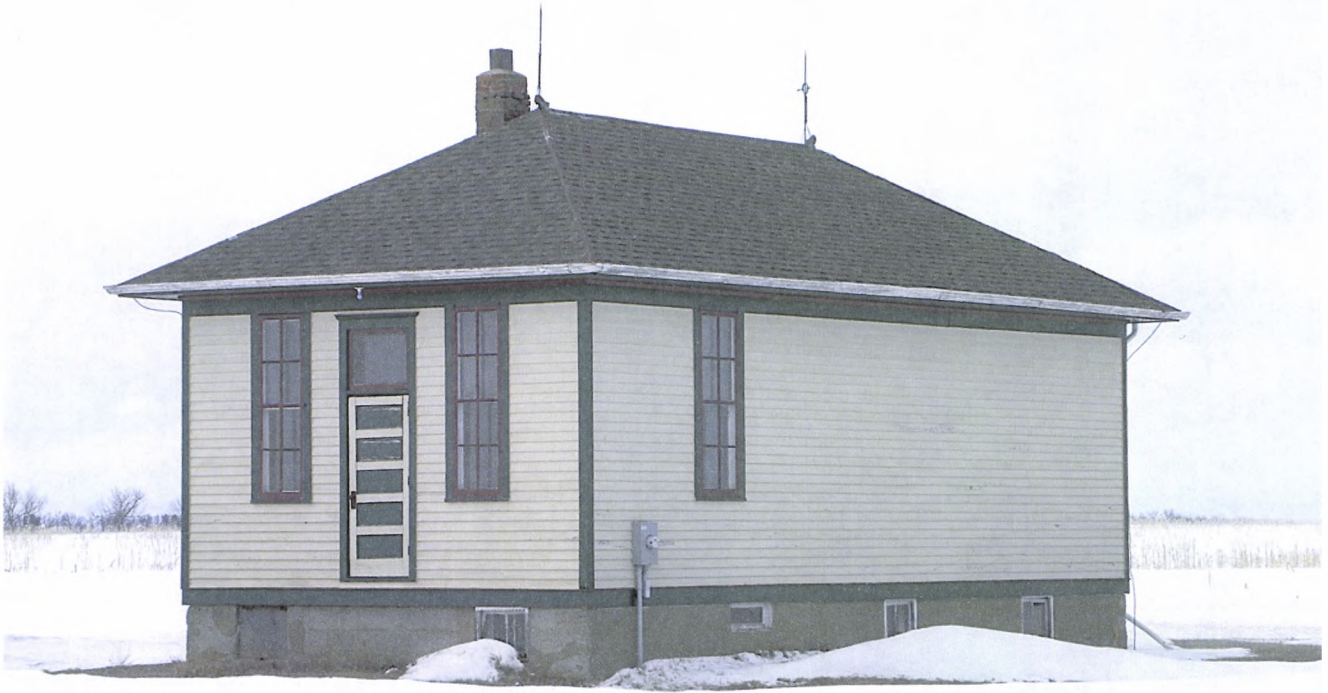
1 of 3 Camera view SW front elevation and north side with single window

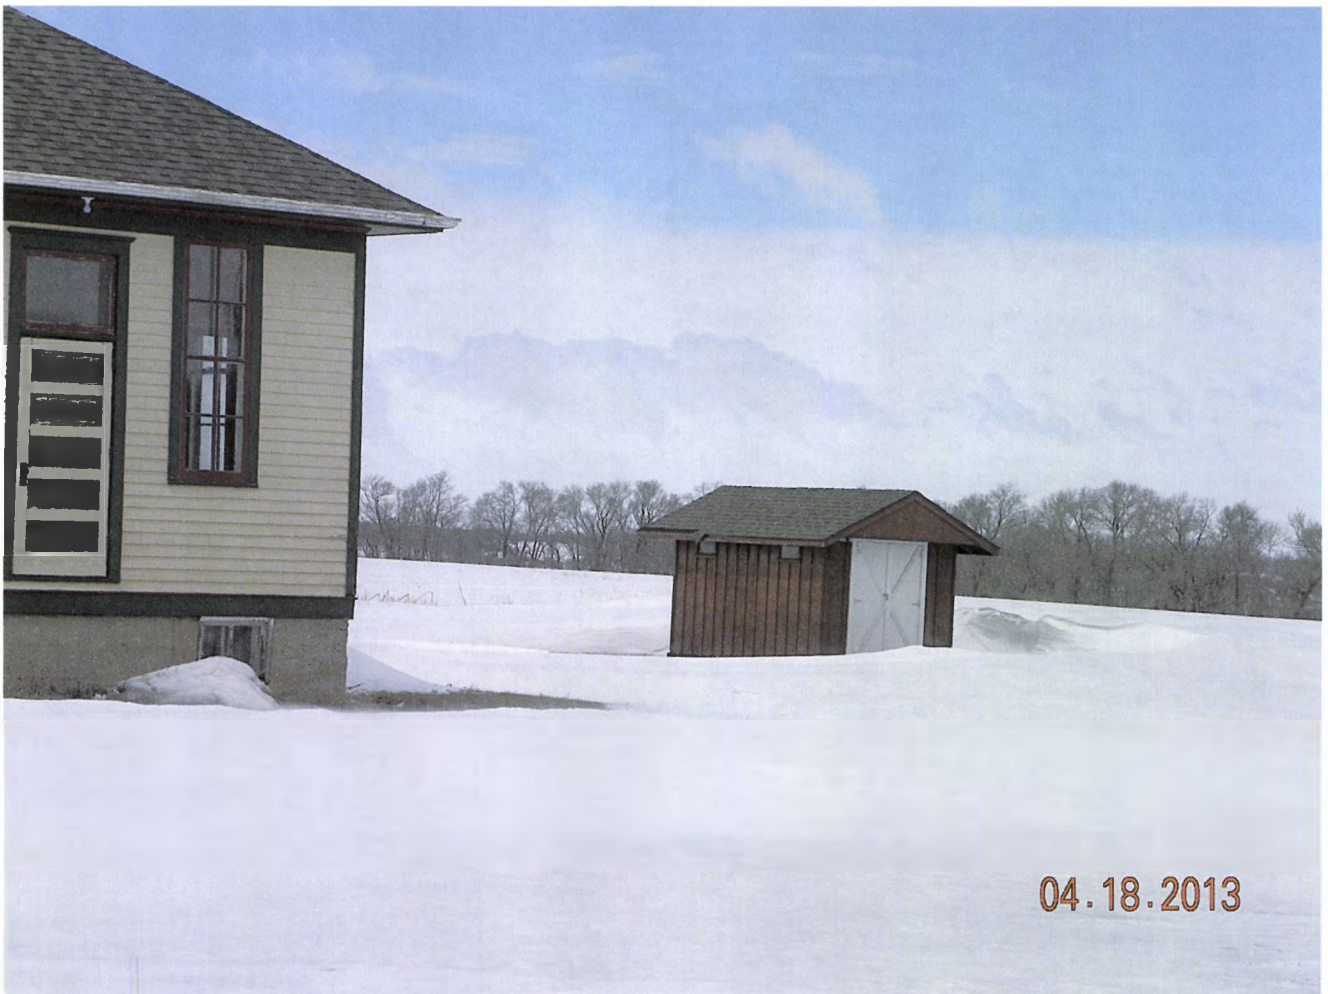
2 of 3 Camera view NW with shed

The noncontributing shed/restroom in the northwest corner of the site was built in the general location of the former outdoor privies. The former privies were used only during last year the school remained in session. The chemical toilets and collection chamber in the basement were used the other years the school was in session.

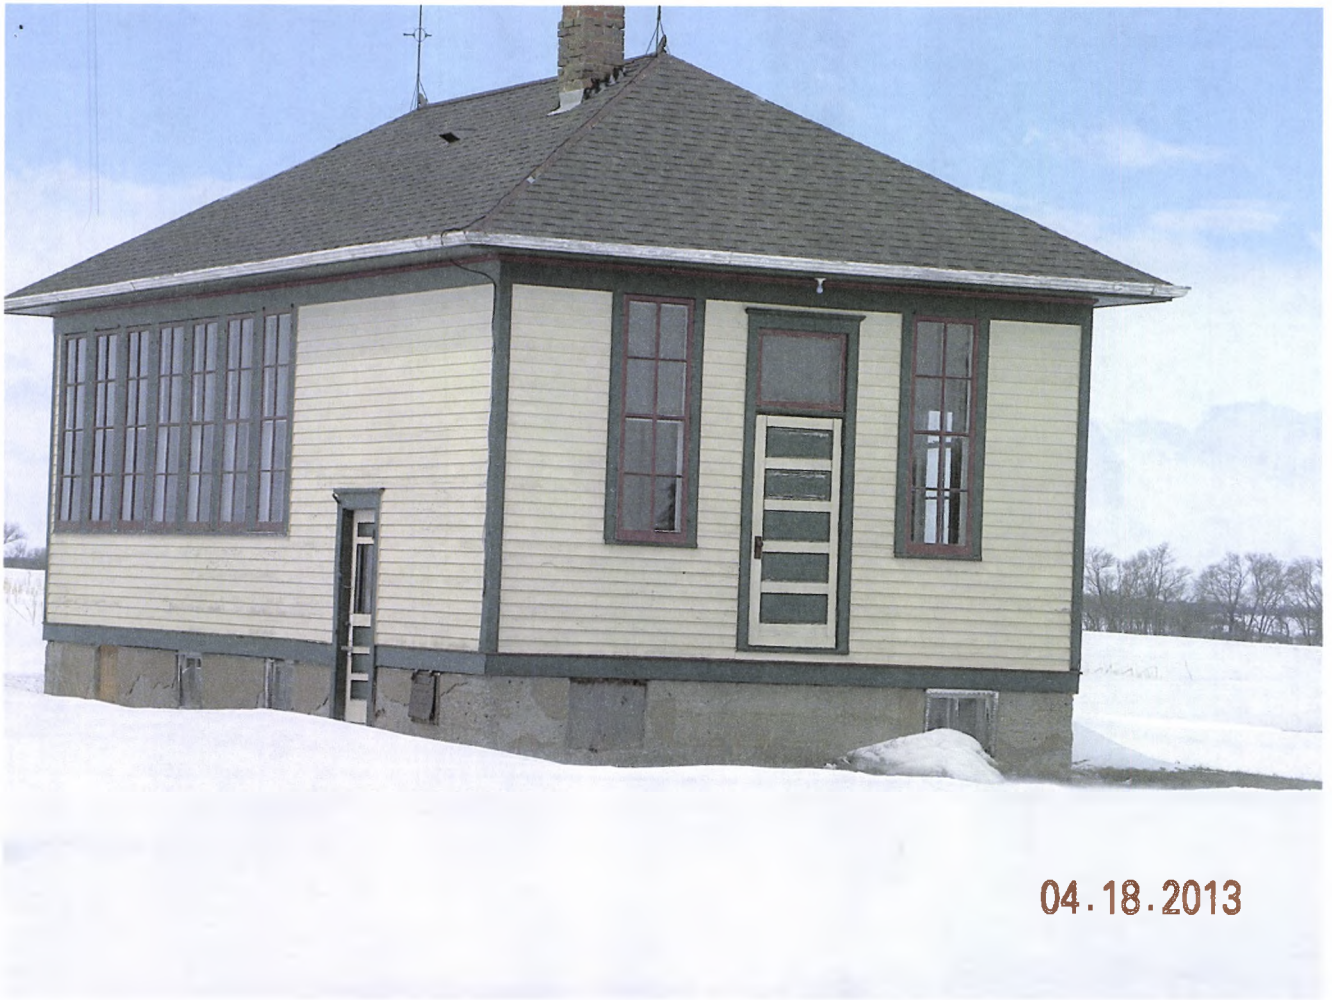
3 of 3 Camera View NW, front elevation and south side with ribbon windows

The one-room classroom occupies about two-thirds of the first floor. It has ample light from the band of seven one-over-one windows on the south elevation, which warms the room somewhat, even in winter temperatures of about 15 degrees F., without additional heat. Fir wainscoting adorns all walls. Blackboards are on the east (front) and north sides of the classroom. There are two heating grates: a return grate in the floor in the hallway and a large supply air grate high on the back wall of the classroom. Two 1950s fluorescent light fixtures still function.

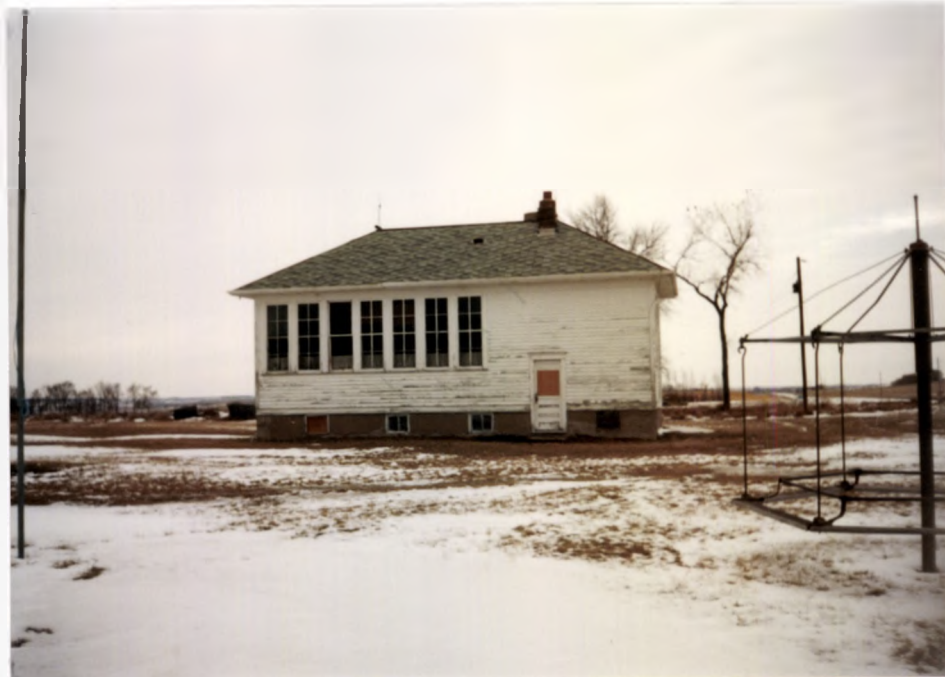
Feature 1-Side Elevation-View From South

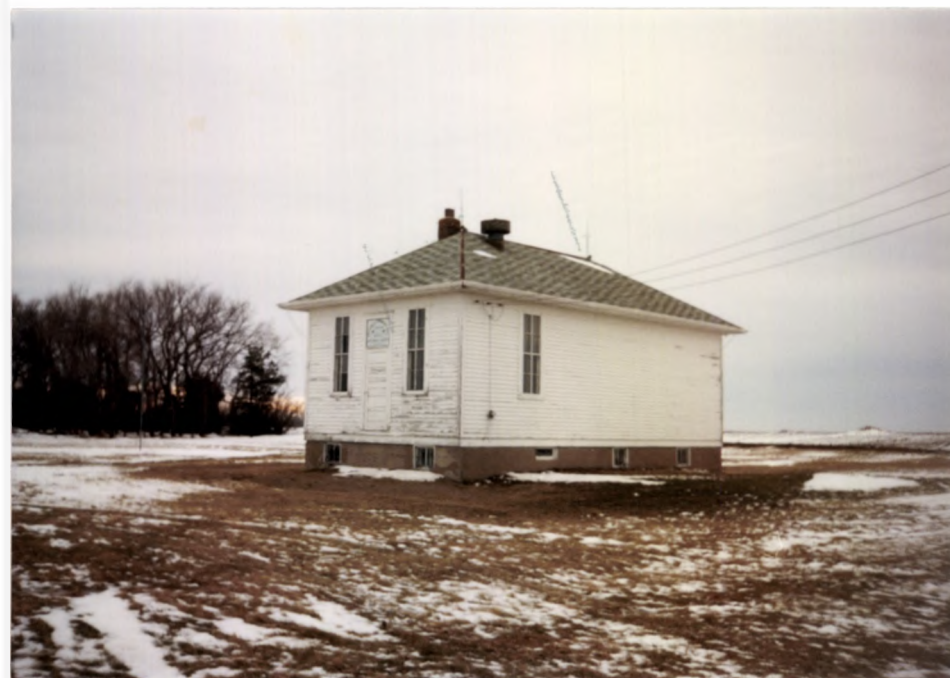
Feature 1-Front and Side Elevations-View From NE

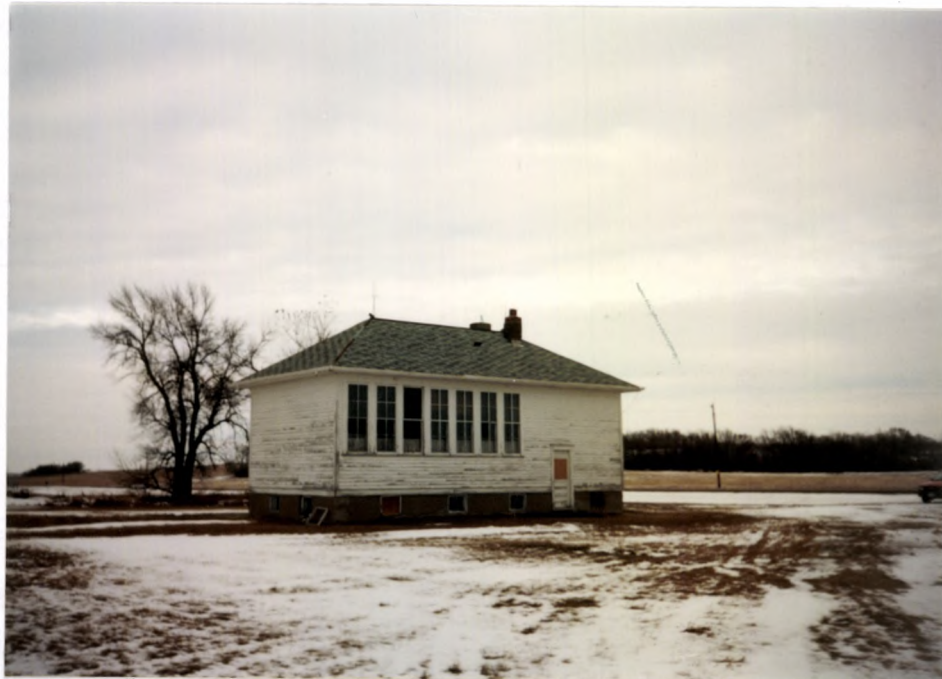
Feature 1-Rear and Side Elevations-View From SW

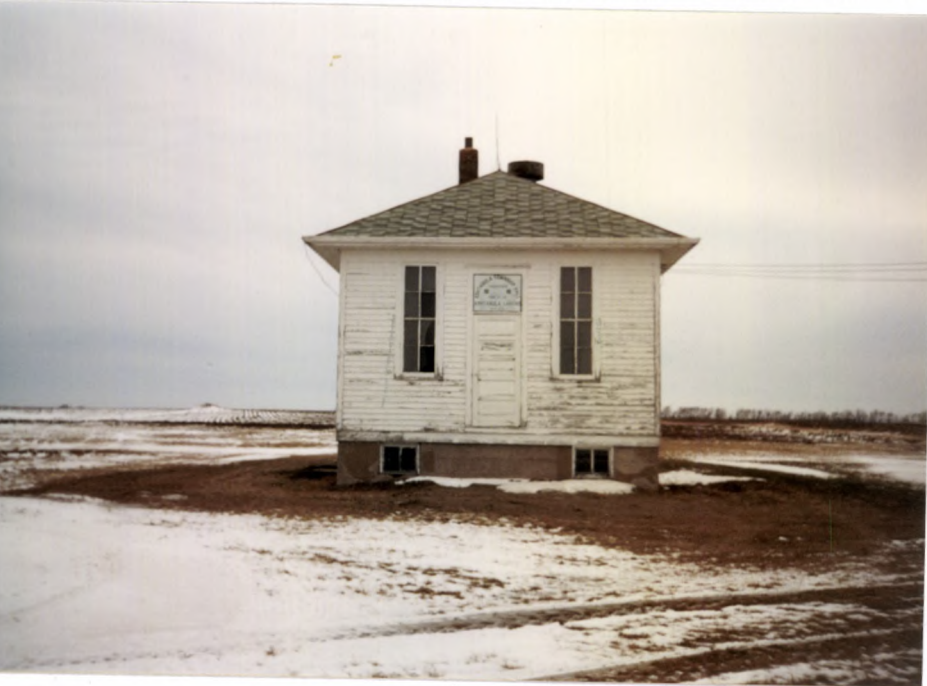
Feature 1-Front Elevation-View From E

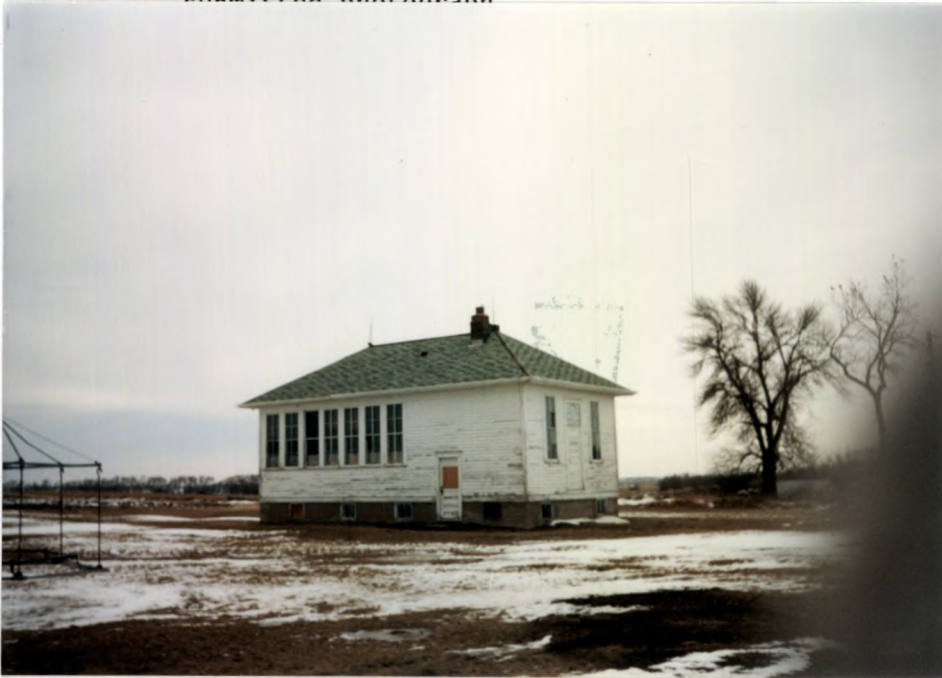
Feature 1-Front and Side Elevations-View From SE

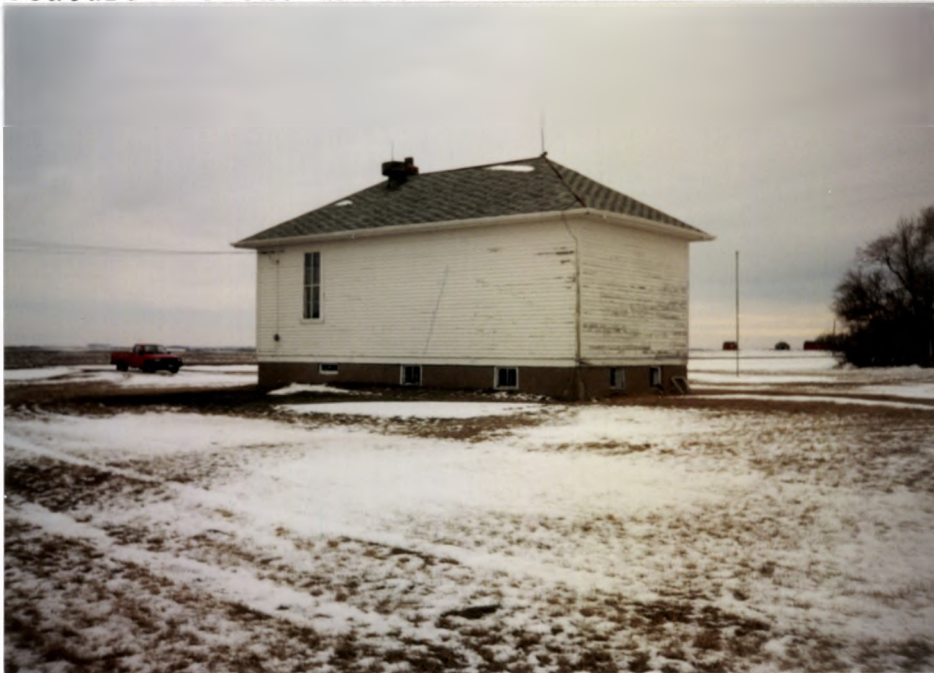
Feature 1-Rear and Side Elevation-View From NW

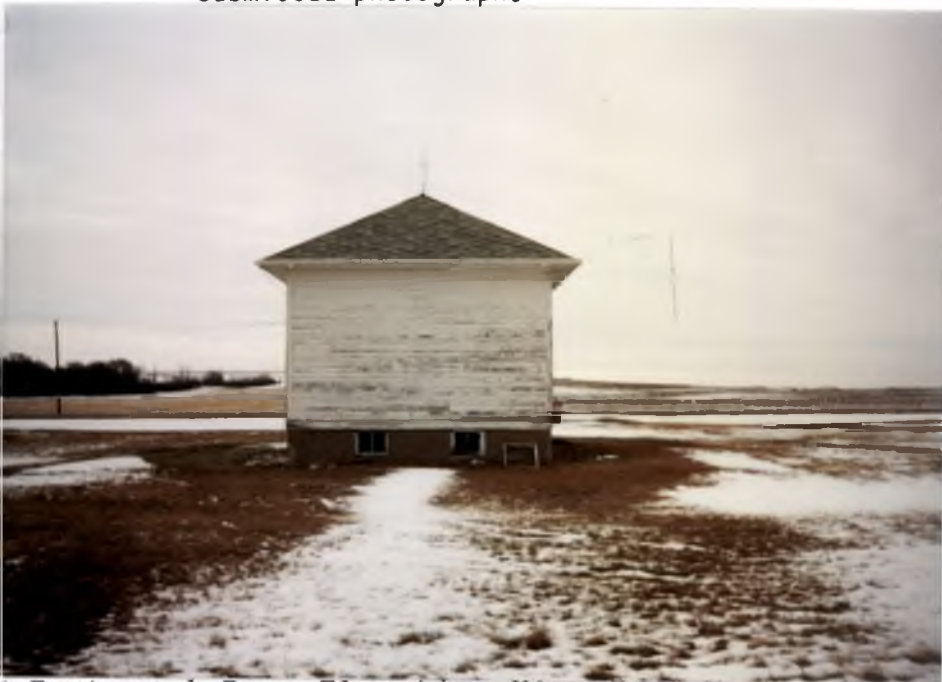
Feature 1-Rear Elevation-View From W

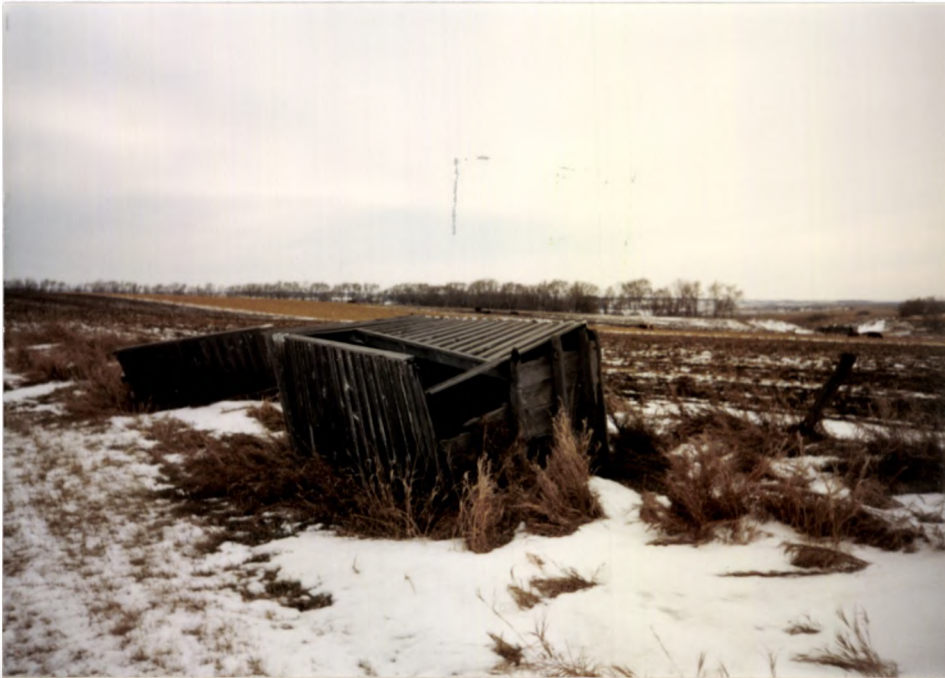
Feature 2-Privy Remains-View From SE

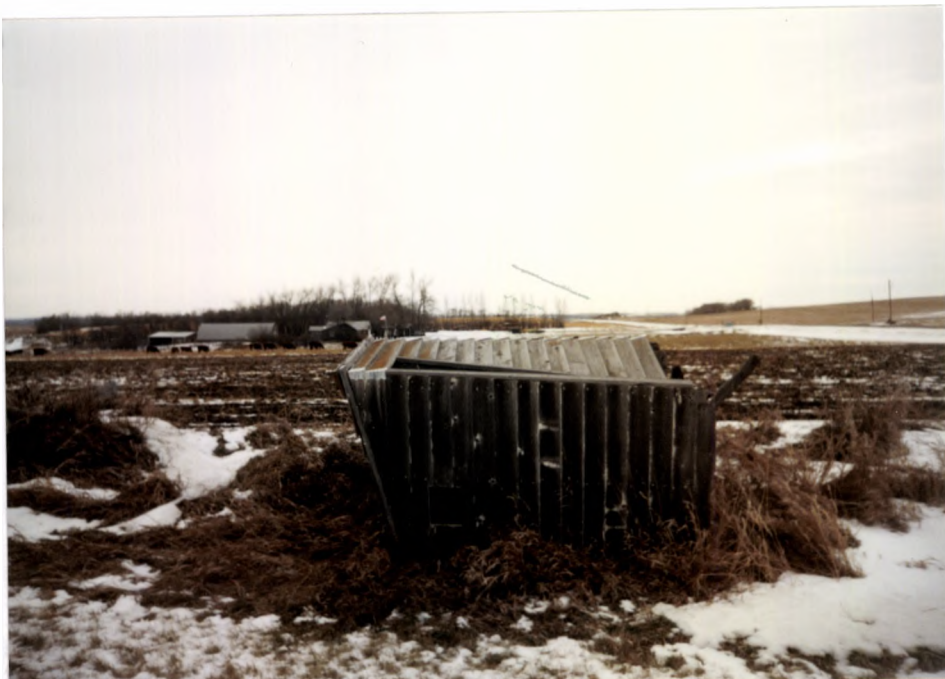
Feature 2-Privy Remains-View From South
