NDCRS ARCHITECTURAL SITE FORM PAGE 1

Site Name Heimes School #10

Site Name Hobart Township School

Project Title & Supervisor:
Country Schoolhouse Project

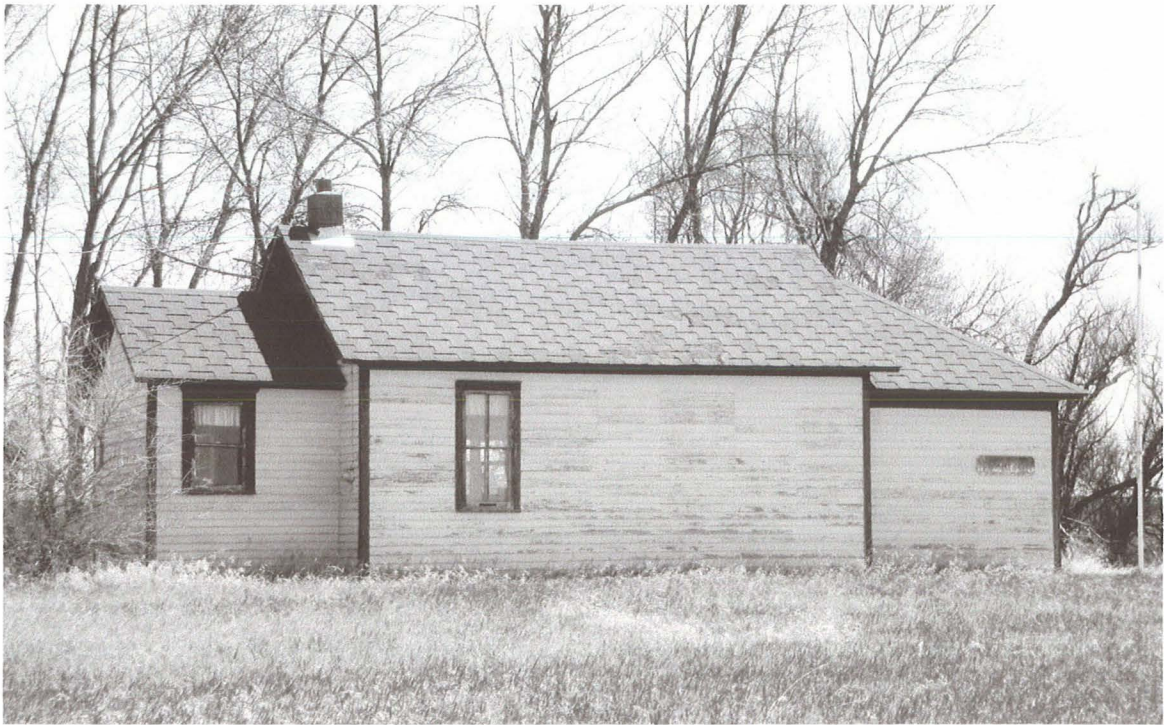
West Side

The siding is 6 inch wood lap with 6 inch corner trim. On the west side of the main body of the school there is one double hung window with a storm window and a couple areas where it looks like an opening might have been filled in with siding. On the north addition there is one double hung window on each side, east and west, also with storm windows. On the east wall of the school there is bank of double hung windows with storms. Two more double hung windows are either side of the newer, solid core entry door. Glass intact with the exception of the upper window to the right of the entry door, it was shot out during hunting season. There is a concrete apron at the entry. The interior of the school is very well kept. There is a 5 panel wood door leading into the school from the entry/coat room and another 5 panel wood door leading into the north addition. There is a transom window over the door into the addition. It looks like that addition was used as a kitchen at some point. The walls in the entry are finished with beadboard. The floor is tongue and groove throughout. Inside the main room of the school as well as the north addition the walls are covered with wallboard and there is no wainscot. The ceiling is also finished with wallboard. There is oil burning stove at the north end of the main room of the school. There are valances on the windows. There is a blackboard on most of the west wall. There are electric light fixtures inside the school as well as a small electric heater over the door coming in from the entry.
