NDCRS ARCHITECTURAL FORM

Field Code Plainview School #2

Site Name Plainview School #2
Site Name

Project & Principal Investigator:
Country School House Project
Kathy Wilner
366 43rd Ave SE
Bowdon ND 58418

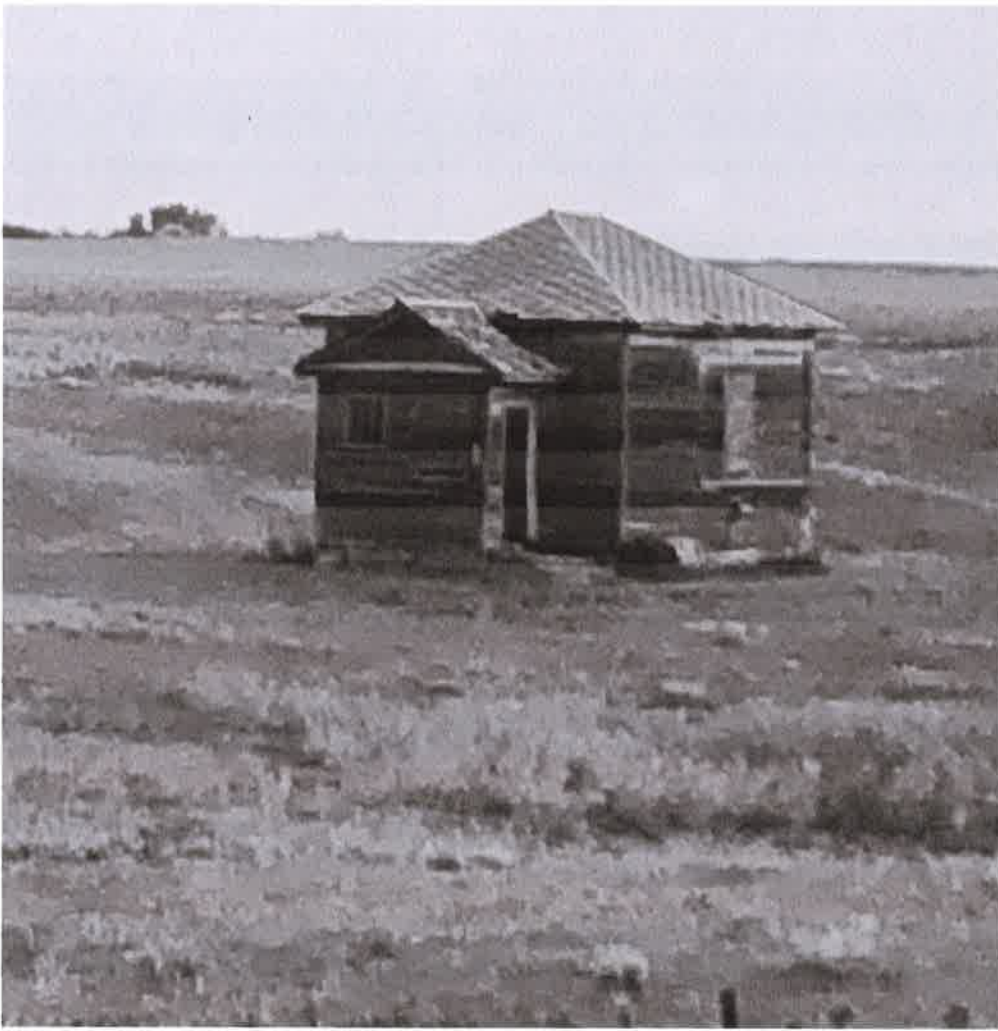
West Side

This feature is a one room prairie school on a concrete foundation. The hip roof of the school and gable roof of the entry are covered with asphalt shingles with metal capping and finials. The chimney is gone.

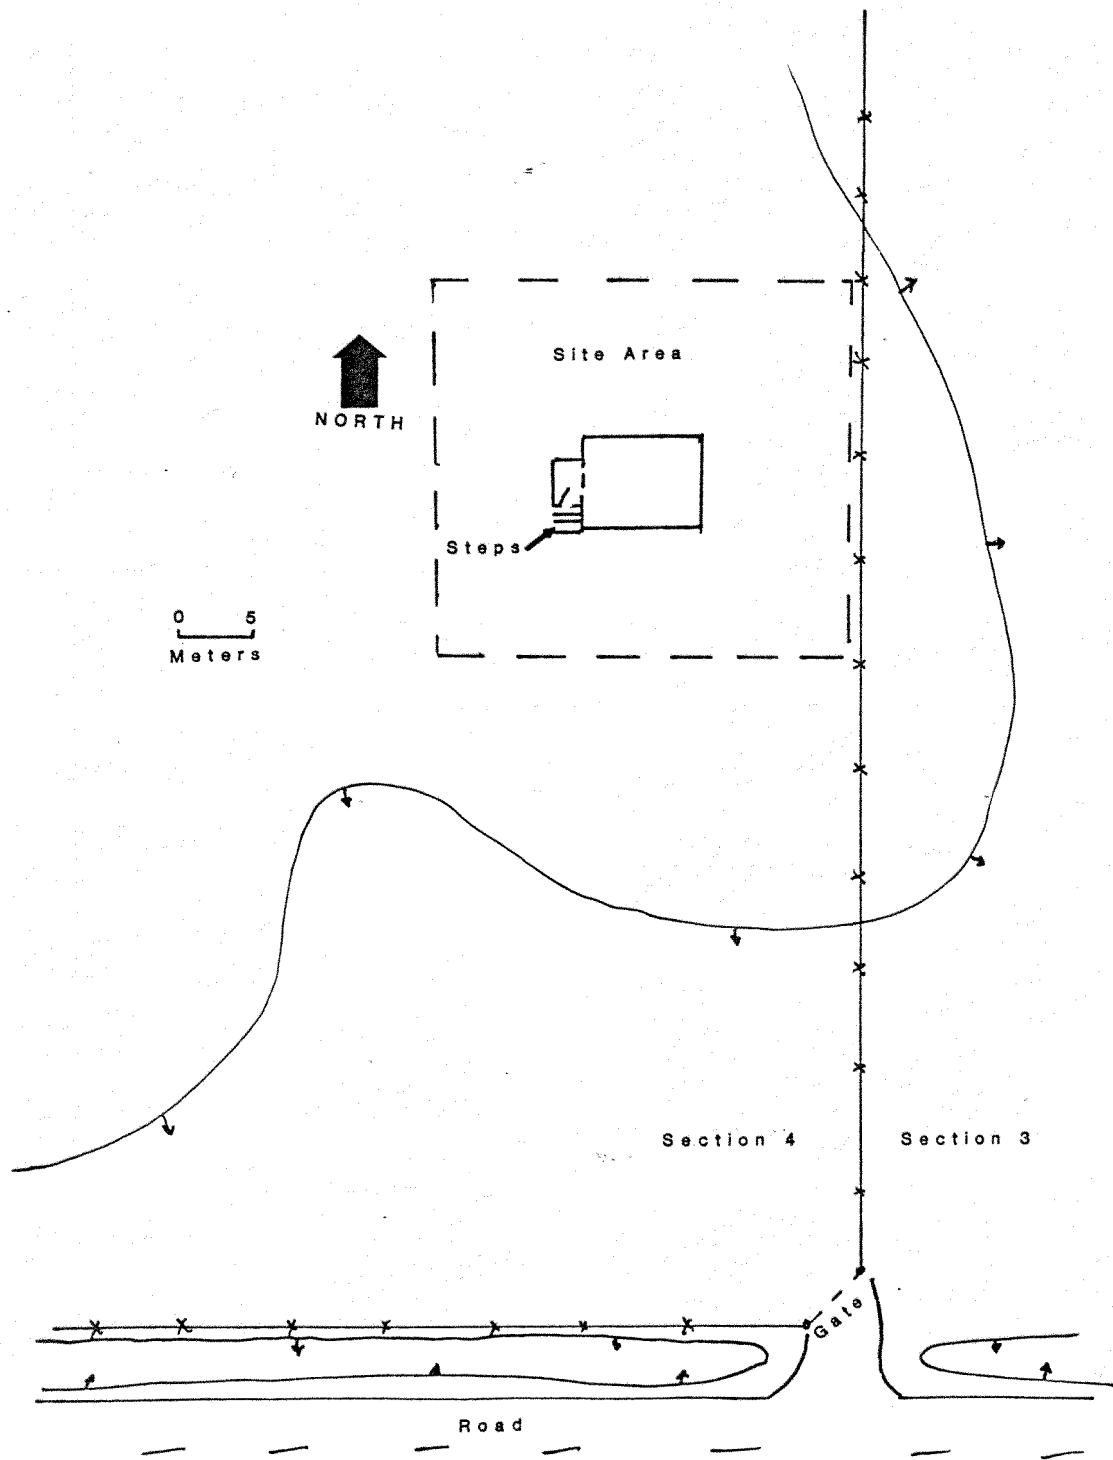
DESCRIPTION: This one room school sits on two acres of land deeded to the school district in 1937. An extremely sparse cultural material scatter surrounds the structure. The scatter is composed primarily of bricks although several pieces of miscellaneous metal, some glass fragments and two pieces of ceramic were also noted.

Sketch map of site.

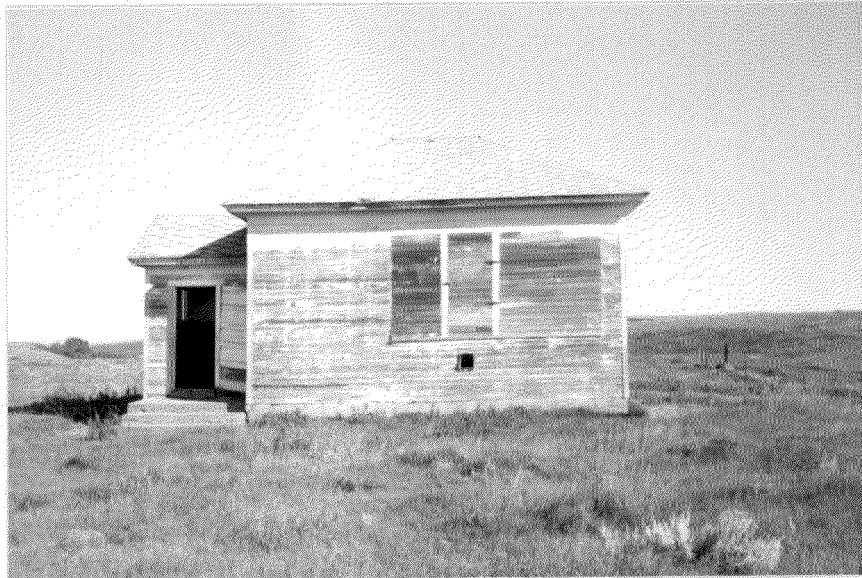
The chimney is absent and all openings - coal chute, chimney exit and windows - have been sealed and painted. The structure has been re-roofed with asphalt shingles; these have deteriorated and no longer offer much protection. The building was gutted and has been used to store sunflower seeds. According to the landowner, cattle using the field as pasture had gotten into the school and broken through the floor boards and caused other damage. The building is no longer used for seed storage and has further deteriorated. Some windows have been allowed to re-open and extensive weathering has resulted. Barn swallows use the interior for nests and the original plaster lathe walls are crumbling. The building and boarded up openings have been painted white, but the paint is flaking away. All the wood is quite weathered, some of it in very poor shape. Although the site retains integrity of location, it is otherwise lacking integrity. This type of one room school building is still common in rural North Dakota, but other examples of this type have more integrity.

View to north over Plainview School #2 (roll #8-31-95, exposure #13).

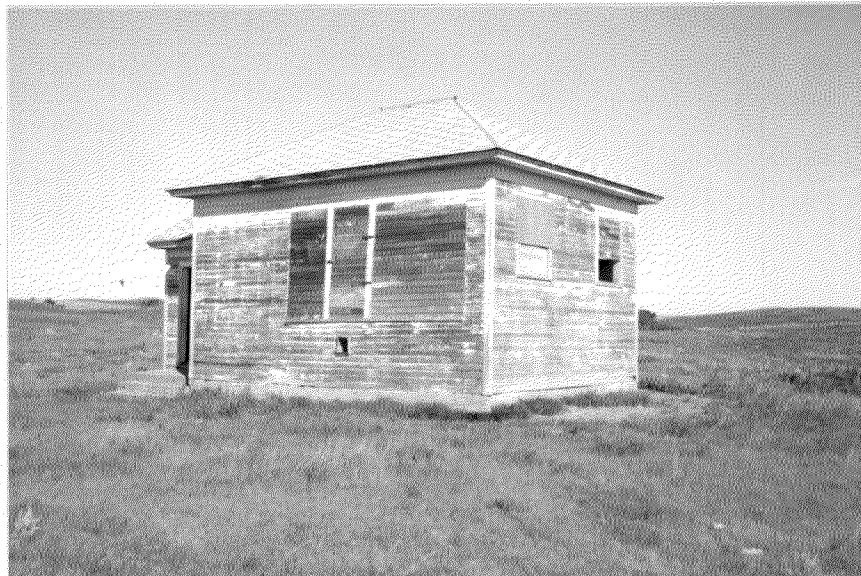
View to northeast over Plainview School #2 (roll #8-31-95, exposure #14).
