NDCRS ARCHITECTURAL FORM
PAGE 1

Field Code Beaver Township School #2

Project & Principal Investigator:
Country School House Project
Kathy Wilner
366 43rd Ave SE
Bowdon ND 58418

Feature Type 9 - School; Church school

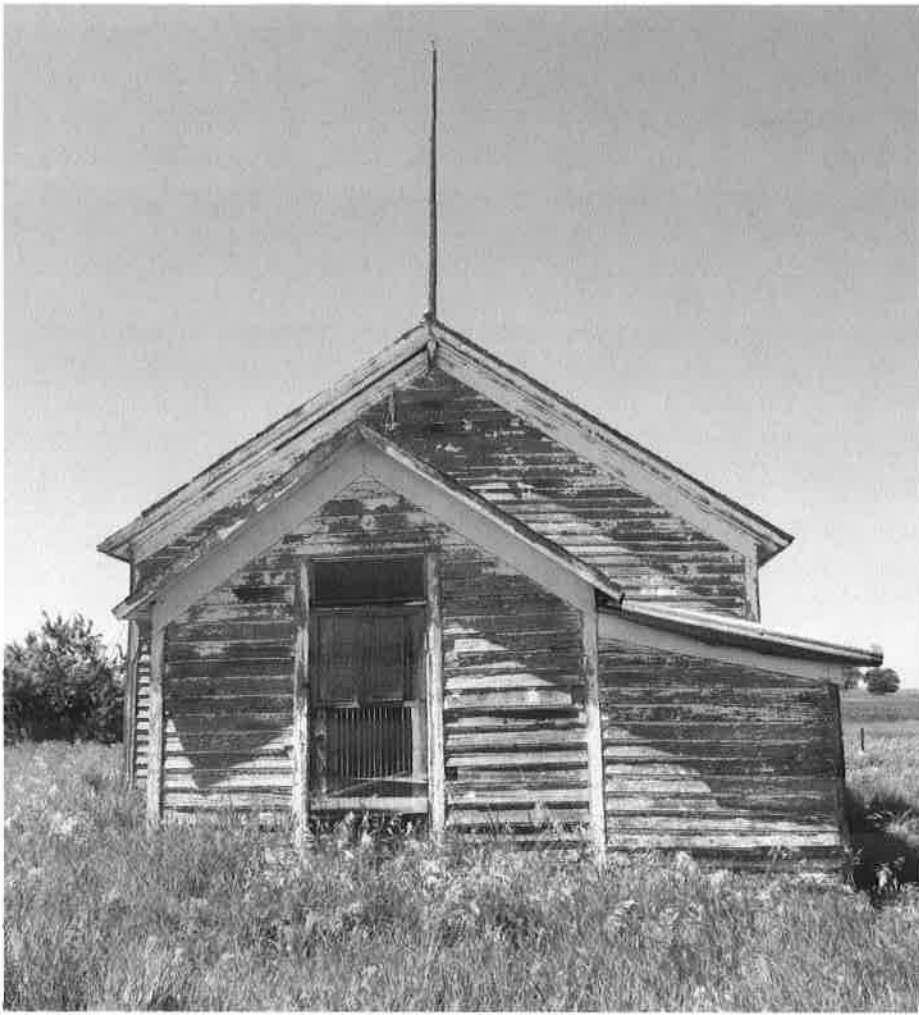
East Side

A rake board begins the siding under the peaked ends of the school and entry. The remaining siding is 6 inch wood lap with 4 inch corner trim. The school has an entry on the east side with a broken wood door. There are pieces of corrugated metal covering broken pieces. A transom window is above the door and the glass is intact. Also in the entry is one small, 4 pane window. The shed on the north side of the entry has broken lumber and junk in it and the walls are stripped. The entry walls are covered with panel and the floor is tongue and groove hard wood. A 6 panel wood door gives entry into the school room. The windows in the main body of the school are two over two double hung windows with a lot of broken glass. There are storm windows covering this bank of 5 windows that run along the south wall as well as another window at the east end of the north wall. There are decorative cornices above the windows and the school room door. Remnants of window shades remain on some of the windows. The interior walls of the school are covered with wallboard. The ceiling has rectangular tiles covering beadboard. The floor is tongue and groove hardwood. Black boards are on the south half of the west wall and along most of the north wall. A large stove stands in the northwest corner of the school room. Light fixtures over the door as well as in the school give evidence of electricity.
