NDCRS ARCHITECTURAL SITE FORM

Field Code Thompson School

SITS# 32 BI 1183

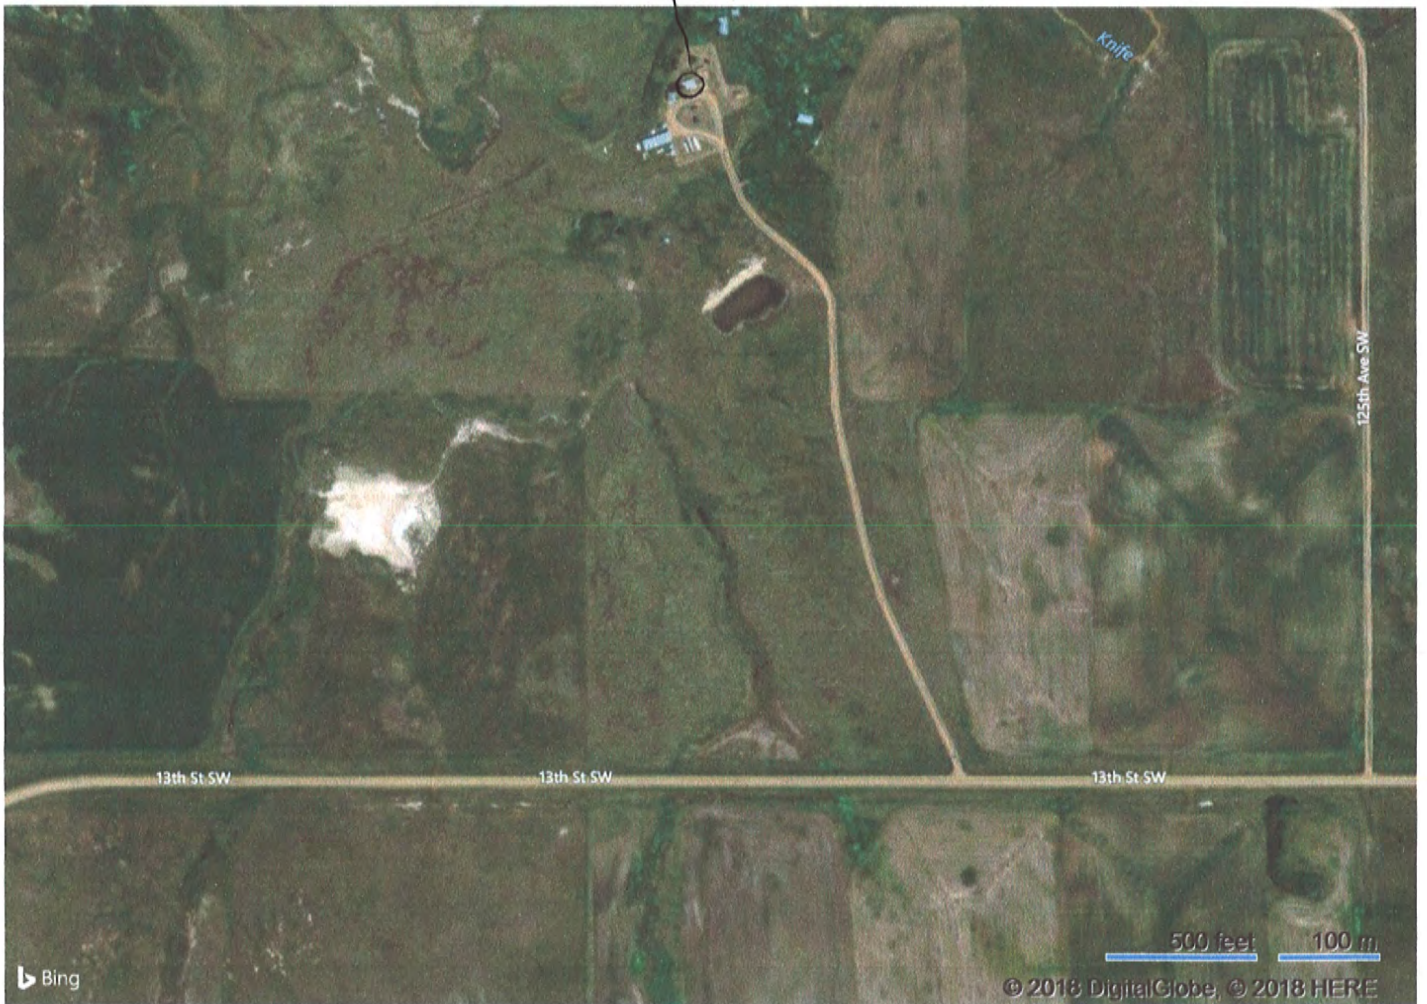
Feature

The feature is a newer one room prairie school, moved to its present location for storage and gathering place. The foundation is concrete blocks. The building is large, measuring 24 feet north to south and 53 feet east to west with a 10 foot by 8 foot entry/porch, half of which is the covered porch. The roof of this building is covered with asphalt shingles. There is no chimney. Soffits are closed.
