NDCRS ARCHITECTURAL SITE FORM

Field Code Upland School

Project & Principal Investigator:
Country Schoolhouse Project

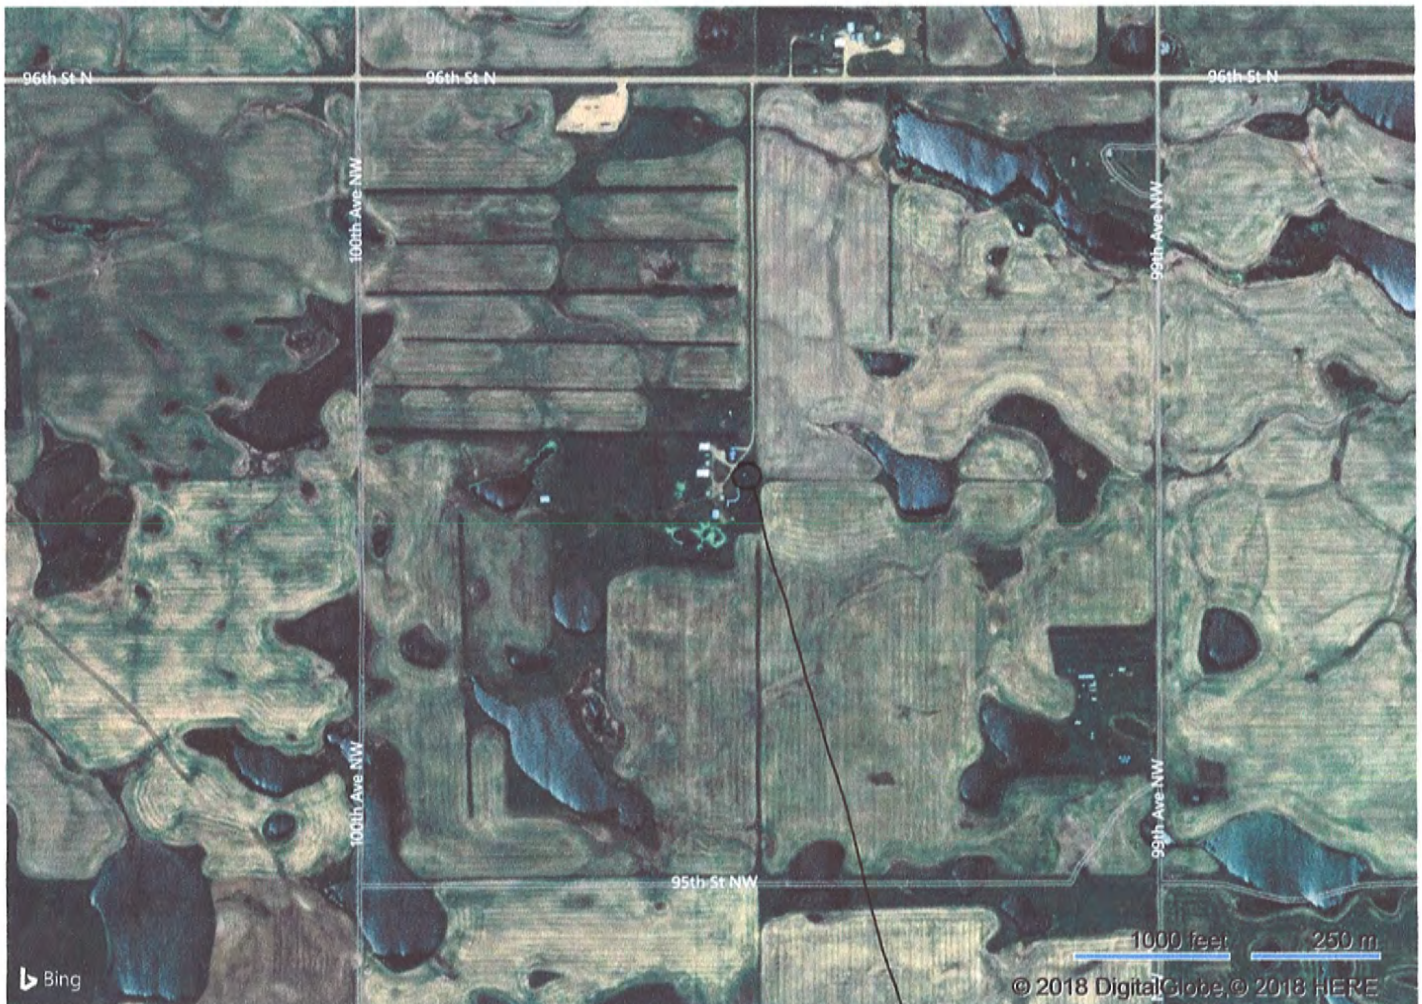
Feature

The feature is a one room prairie school located in a grove of trees. It rests on a poured concrete foundation. The school was moved to this location to be used for a house. Today it is used for storage. The roof of the school is covered with metal sheeting and the chimney is gone. The soffits are closed. The building measures 24 feet east to west and 18 feet north to south.

A wide trim board runs under the eaves at the peak ends of the school. The siding is 6 inch wood lap with 4 inch wood corner trim. The windows are replacement, double hung windows with storm/sceens. A rickety porch leads to an entry at the southwest corner of the building. A storm door protects the 5 panel wood door leading inside the entry. The entry floor is wood covered with tile. Walls in the porch are covered with wallboard and the school proper has fiberboard walls. Ceiling tile finishes the ceiling. The school has interior walls to make rooms for living space. The interior is in great shape, all walls painted. There are no blackboards or wainscot. After the school was moved it was wired for electricity.
