### NDCRS ARCHITECTURAL SITE FORM PAGE 1 SITS# 32

Field Code Frances Township School

Frances Township School

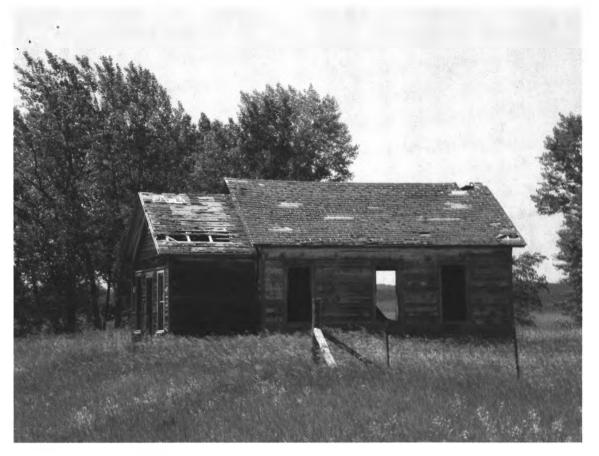
East Side

There are asphalt shingles over roof sheathing, much of which is missing. There are holes in the roofing of the entry as well as a hole where the chimney used to rest at the north end of the school. A wide header board can be seen under the eaves at the peaked end of the building. The siding is 6 inch wood lap with little or no paint. There are two vents at the north end of the building under the peak of the roof and one more at the south end.

The windows are all gone, very little framing left and no glass. There are three window openings on both the east and west walls of the school, one is covered with metal sheeting. Two more window openings face south, either side of the door opening.
