NDCRS ARCHITECTURAL FORM

SITS# 32BO 0163

Site Name Griffin Townsite

Bowman Wind Energy Project; Lindsay D.J. Scott

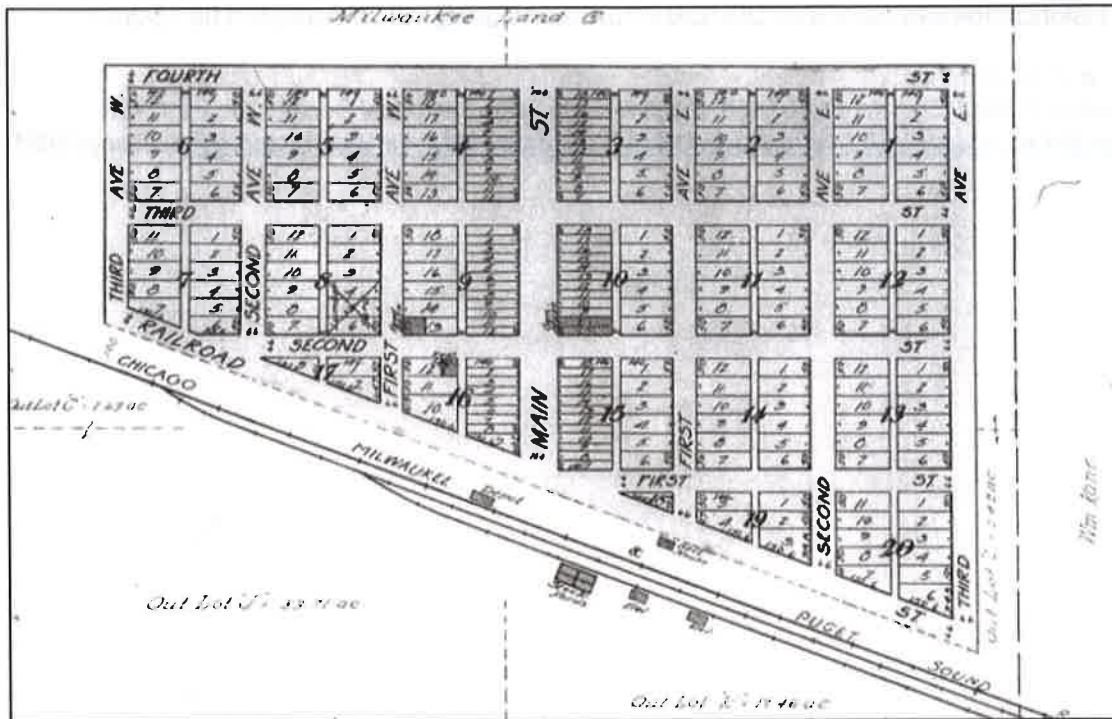
Figure 2. Ogle and Company 1917 map showing the town of Griffin.

Of the buildings in the town in 1917, only one may be present in its original location. Feature 3, noted as a house in the earlier recordings, is in the same location as the restaurant shown between what would have been First Avenue West and Main street, south of Second Street if the town were fully developed as planned. Meanwhile, the feed barn would have been about 60 feet east of Feature 4, and the lumber yard located at features 4 and 10. The general store would have been where Feature 24 was located (Ogle 1917)

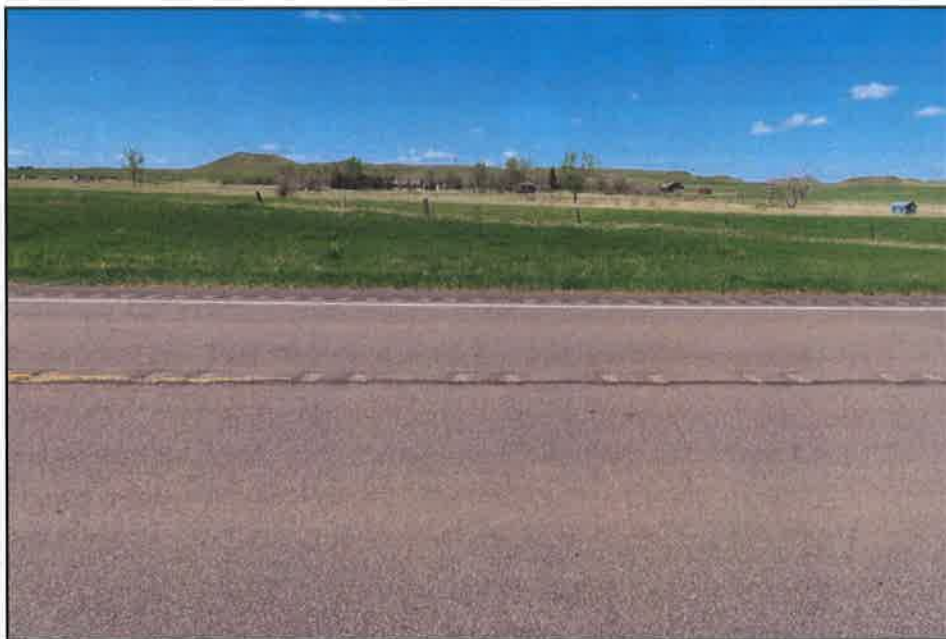
Figure 3. 32BO0163 site overview from U.S. Highway 12 facing north.
M. Carpenter 05/28/2020.

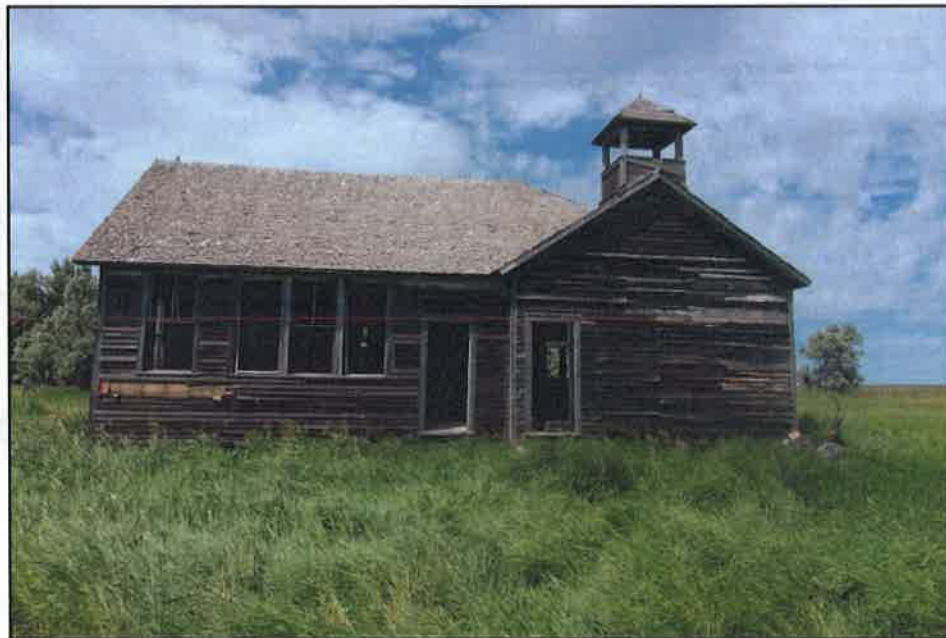
Figure 4. 32BO0163 Feature 1, Atkinson Schoolhouse facing west.
M. Woods 07/26/2020.

Feature 1, the Atkinson Schoolhouse, has been moved from its original location, as previously stated in the 1988 update. As such, the foundation is non-existent and the schoolhouse sits on raised railroad ties. This single story schoolhouse includes five rooms, an attic, and cupola. There are 11 windows, 10 are double hung and one is double on its side, three exterior entrances, and a skylight.

The exterior boards are degrading and many have fallen off exposing the underlying wood framing. Extensive graffiti was visible in two interior rooms. The location, setting, feeling, and association of this feature is completely gone. The design, materials, and workmanship has been altered and diminished integrity from the loss of foundation, graffiti, and modern additions. This feature is recommended not eligible for the NRHP under all criteria.

Several more changes to the site were noted during the 2020 revisit. Feature 1, the Atkinson School was in similar condition to the 1997 description but more weathered. The structural portion of Feature 2 (Soderstrom House) was no longer present. Only a poured concrete foundation was left, and an artifact scatter of domestic items was found on the south side of it. Feature 3 was also deteriorated from the previous description but was still standing, although the covered foyer entryway was gone. Feature 4, the tool shed, was still standing but was no longer in use and filled with cardboard boxes, broken furniture, and other items. Feature 5, the homestead shanty, had collapsed and the lumber left deteriorating in the grass. Feature 6, the animal shed, was also still standing, but had deteriorated considerably, with the roof in the center portion ready to collapse and damage to the corrugated sheet metal. The poles for features 7 and 10 were still present with noticeable changes except rotting due to weather exposure.

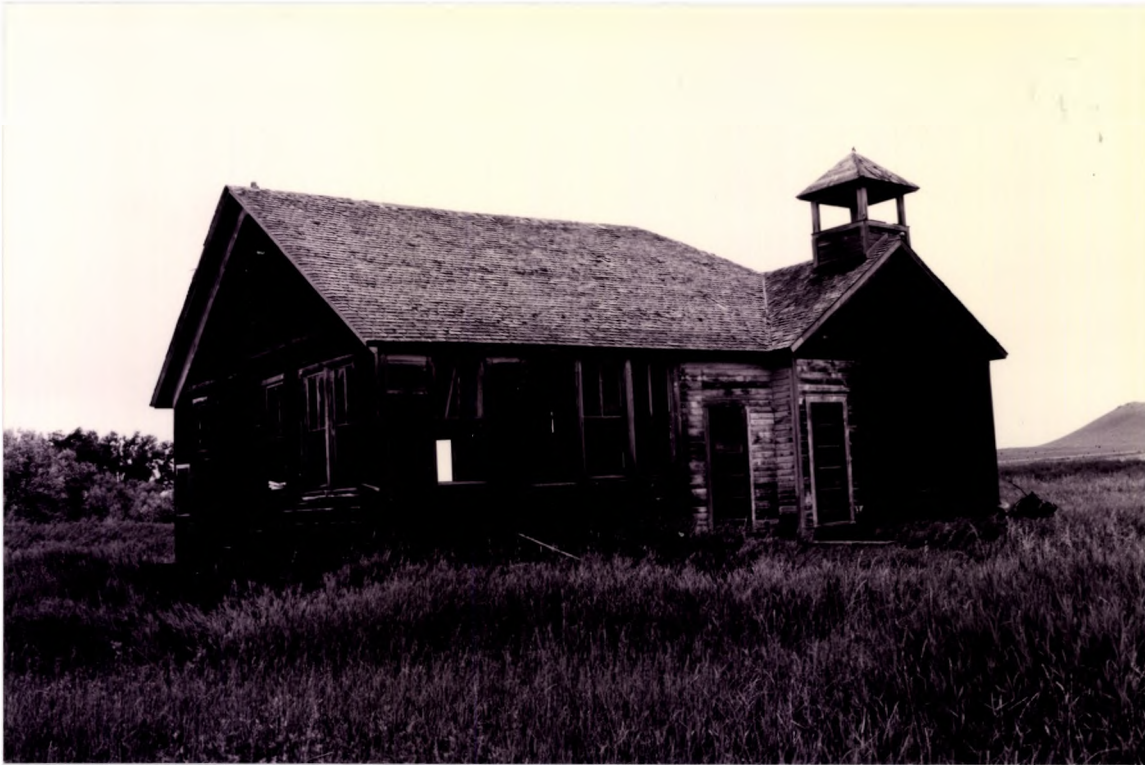
Roll *Y* Frame *24* Site *SU109* Feature *1* Date *7/30* View from *SE*

- 1. Soderstrom says that this school was the Atkinson School, moved here by his father from a site a mile west. His father never got around to putting a foundation under it, so it still sits on blocks.
- 2. Photographic coverage shows that Soderstrom continues to modify and add to the house.

Subject: *Schoolhouse*

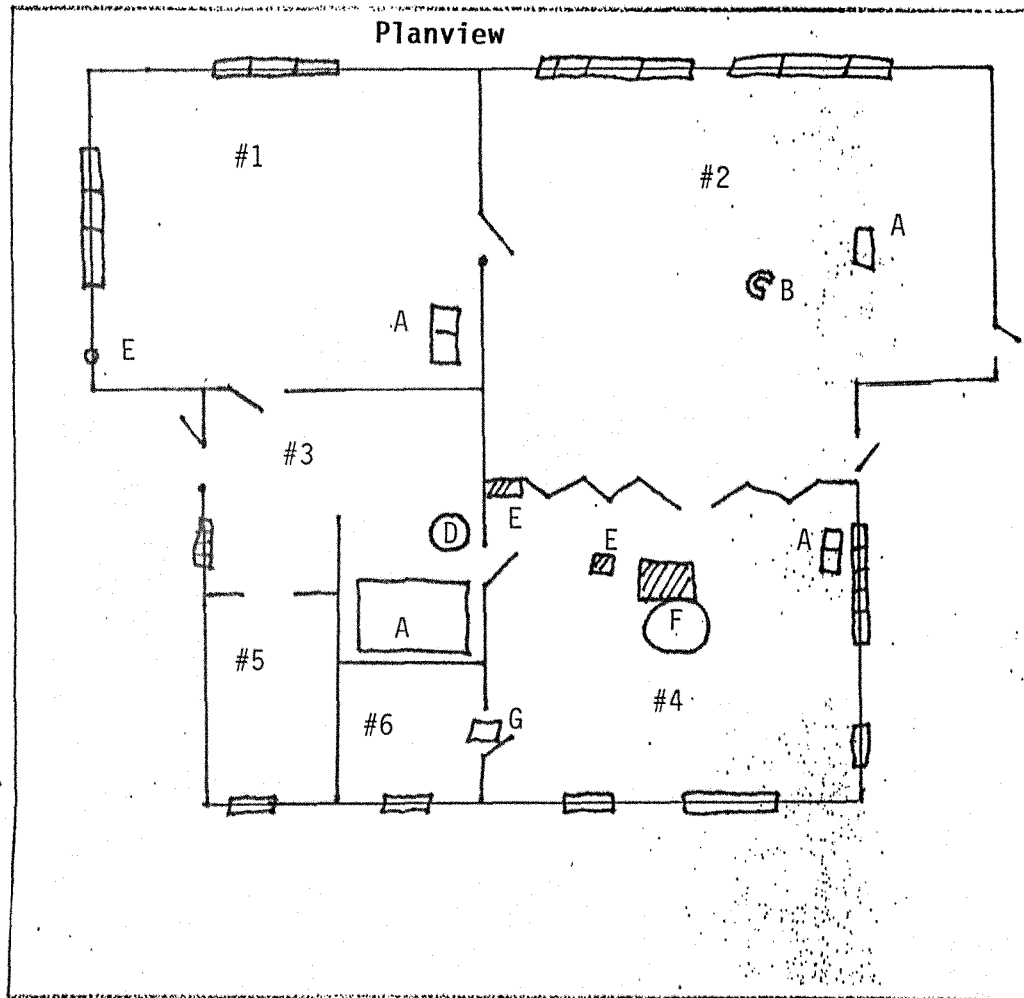
- #1-6 Room Designation
- A. School Desks
- B. Swivel Chair
- C. Holes in Floor
- D. Pot Bellied Stove
- E. Stove Exhaust
- F. Stove Shell w/o Burner
- G. Stairs

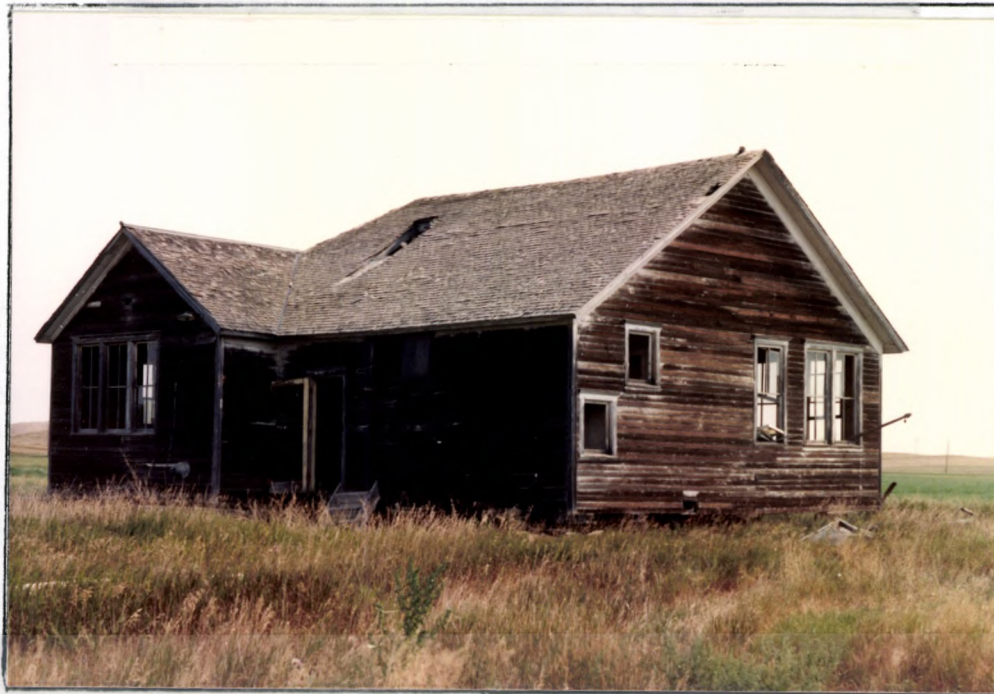
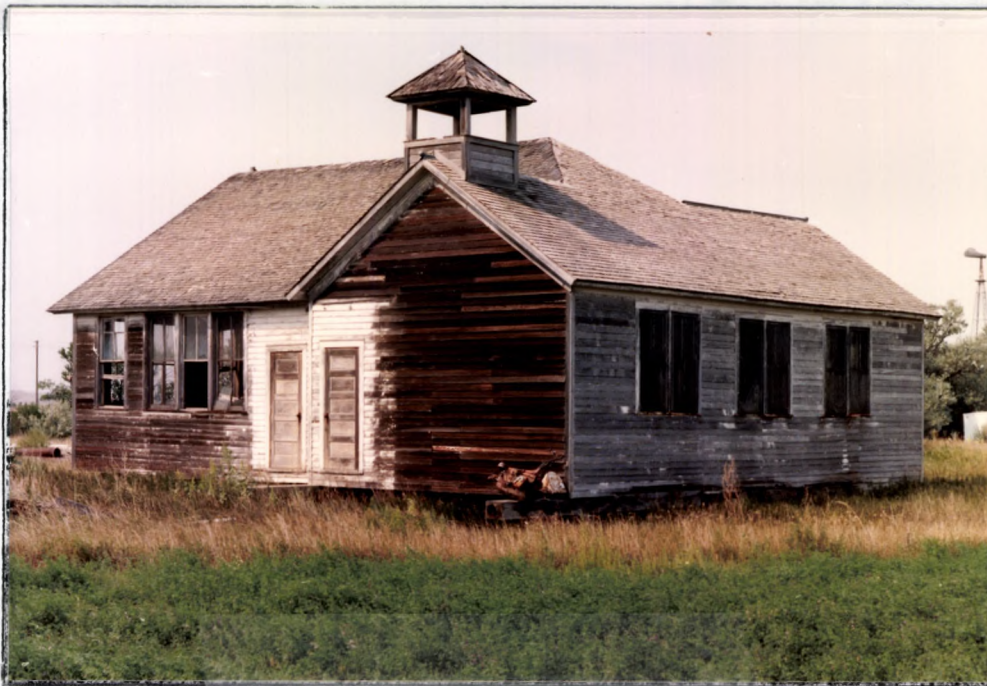
FEATURE DESCRIPTION & STATEMENT OF INTEGRITY Feature no. 1 is a "T" shaped bungalow styled school house with bell tower, and set on railroad ties. The structure consists of seven rooms with three windows in the north wall all covered with a wire mesh guard. The west wall of the "T" section exhibits one window and electrical cord outlet and stove exhaust elbow. The leg portion of the "T"s west wall exhibits a doorway with only a door frame hanging, steps not secured to the south of the room and one small window. The south wall exhibits two small box windows, one large rectangular window and one double window. The east wall "T" leg provides two rectangular windows, one is a single, one a triple with wire screen mesh guard on the 1st and 3rd sections. The door is intact and operational. The east portion of the "T" exhibits one intact operational door. The structure is a reasonable representation of the era yet with the structure having been moved from its original location and some modern alterations (electricity). The bell tower is empty. (See continuation)

Appendix 1. Photographic coverage of site UW#1133: Feature 1. Legal: SW $\frac{1}{4}$ NE $\frac{1}{4}$ NE $\frac{1}{4}$, Section 34, T132N, R103W, Bowman County, ND. Top photo taken facing NE, bottom photo taken facing SW. UW#1133. Field Date: 8/16/88.

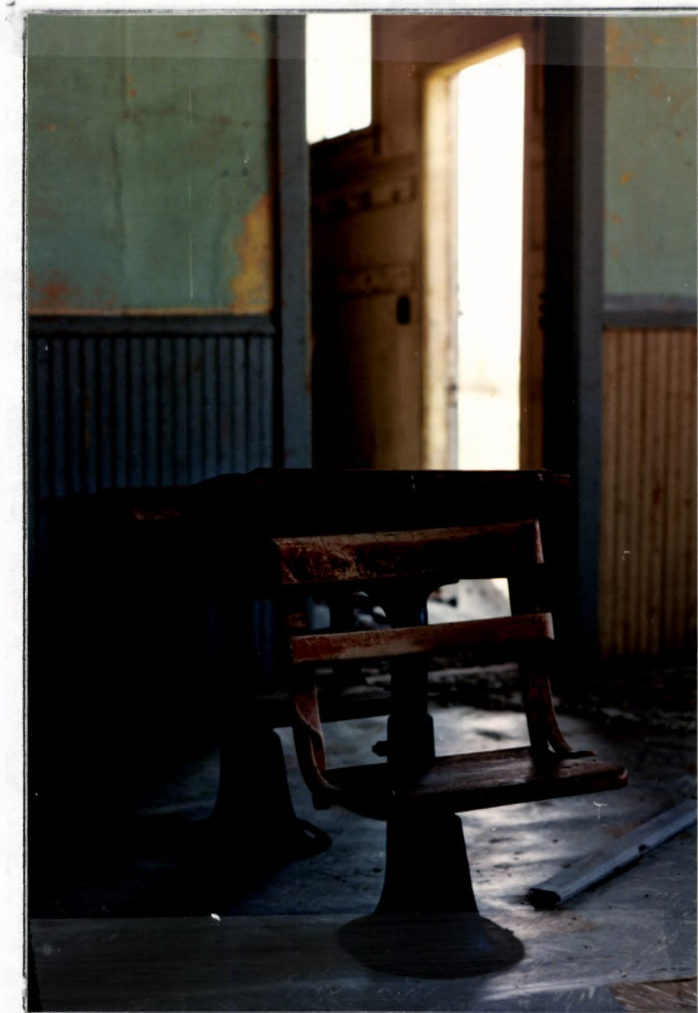
& Integrity Room #1 has two desks in southeast corner of the Sears Roebuck Company style of the era, and bolted to floor. One desk a lift lid with metal hinges. "Cleveland #1" was observed on the desks metal base. Inside the desk was observed the standard graffiti.

Appendix 1a. Photographic coverage of site UW#1133, Feature 1. Legal: SW $\frac{1}{4}$ NE $\frac{1}{4}$ NE $\frac{1}{4}$, Section 34, T132N, R103W, Bowman County, ND. Photo taken facing direction SSW - Room #1, Item A. Field Date: 8/16/88.

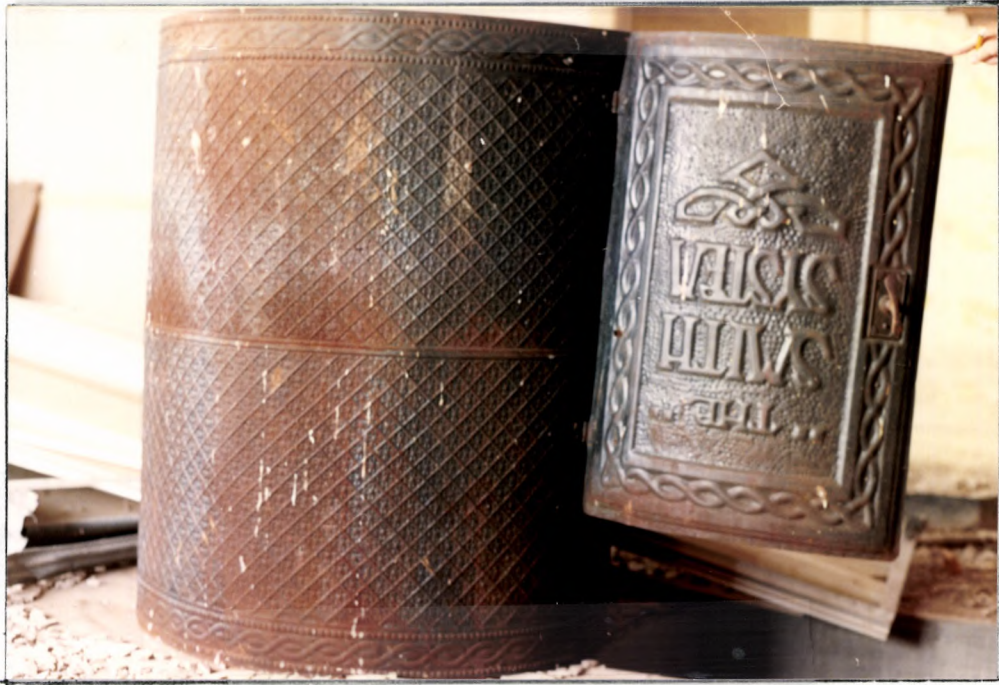
Room #4 contains a floor heat vent along side a rectangular hole suitable to serve as a trap door on an area for a floor mounted furnace, two desks, are by the 3rd section of the triple window. A large cylindrical object with "the Smith System" embossed on door could be the shell of a furnace/stove with the burner missing. A set of five steps is in the doorway to room 6.

Appendix 1b. Photographic coverage of site UW#1133, Feature 1. Legal: SW $\frac{1}{4}$ NE $\frac{1}{4}$ NE $\frac{1}{4}$, Section 34, T132N, R103W, Bowman County, ND. Photo taken facing direction SW, Room #4, Item F. Field Date: 8/16/88.
