NDCRS ARCHITECTURAL SITE FORM
PAGE 1 UPDATE

Field Code N/A SITS# 32 BO 906

Map Quad Site Name Hammond School
Map Quad Site Name

Field Code SU116 Site Name Hammond School No. 2
Field Code _____ Site Name _____

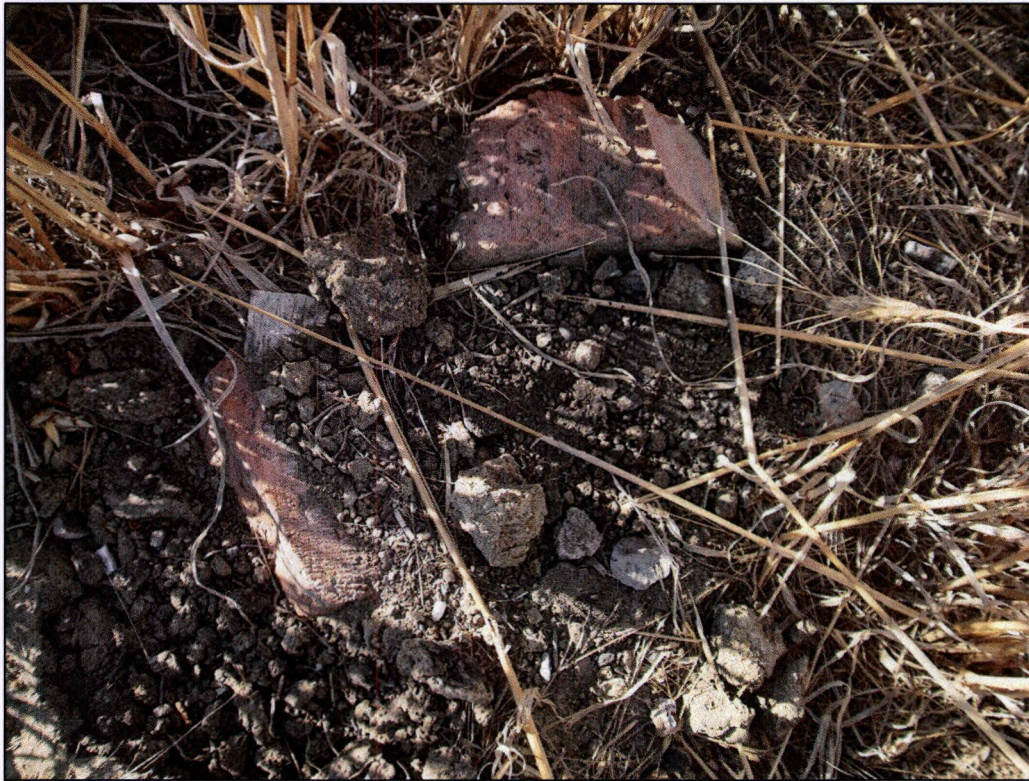
The only cultural material observed at the site were approximately six bricks near the center of the depression.

Figure 3: 32BO906, bricks in the center of depression.

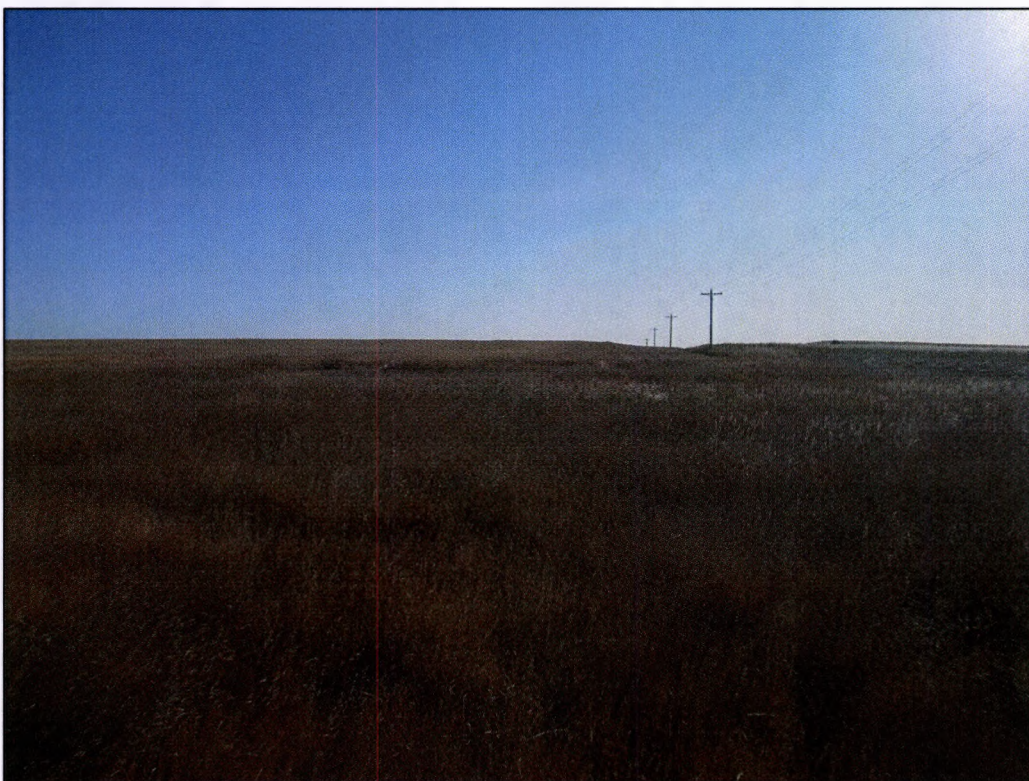
Only a slight, rectangular depression remains and it has been cultivated.

Figure 4: 32BO906, overview to the east, depression in background

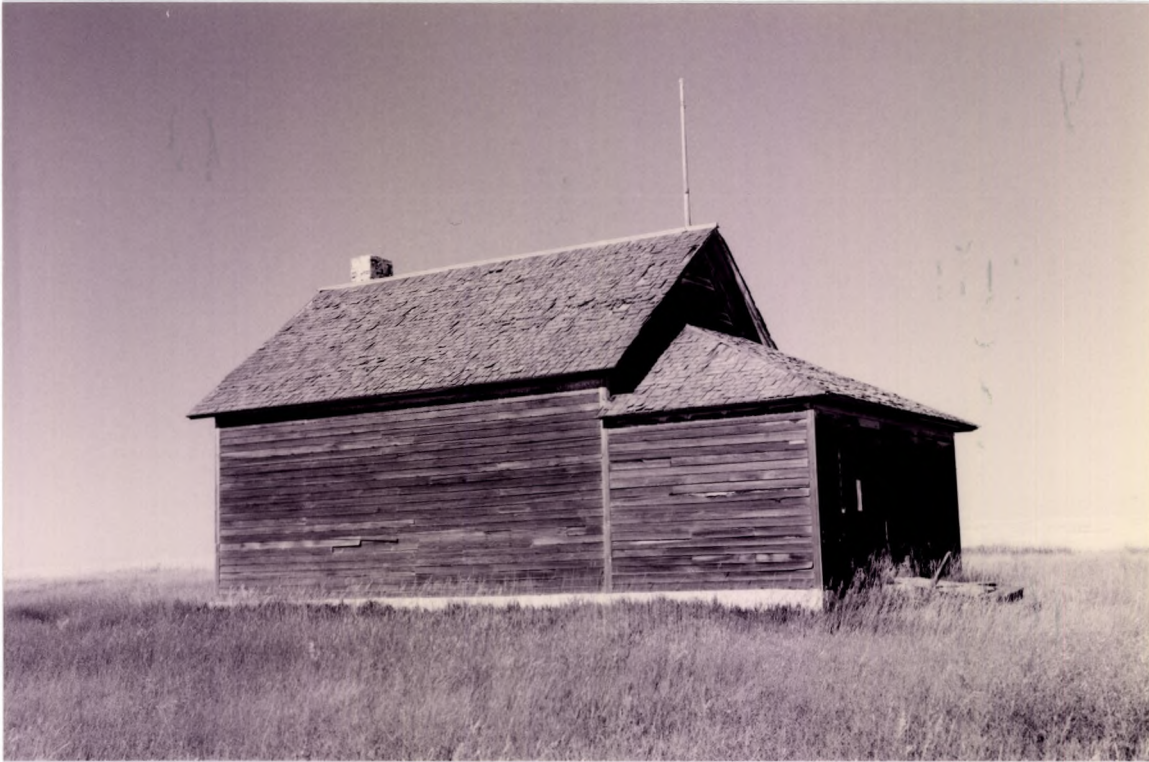
Roll *CC* Frame *4* Site *SU 116* Feature Date *8/3* View from *SW*

This schoolhouse is known as Hammond School No. 2. This one-room school is a wood frame building on a foundation of poured concrete. Its gable roof, aligned north and south, is covered with wood shingles. Its exterior walls are covered with horizontal wood siding. There is a brick chimney at the north end of the gable. Built onto the front (south) side of the school is a hip roof entryway that extends the length of the south side. The school has three tall windows on the north side and three tall windows on the east side. These are in poor condition. There are smaller windows on the east and south side of the entryway. Access to the entrance is on the south side by wooden steps that are collapsing.

Subject: *Schoolhouse*

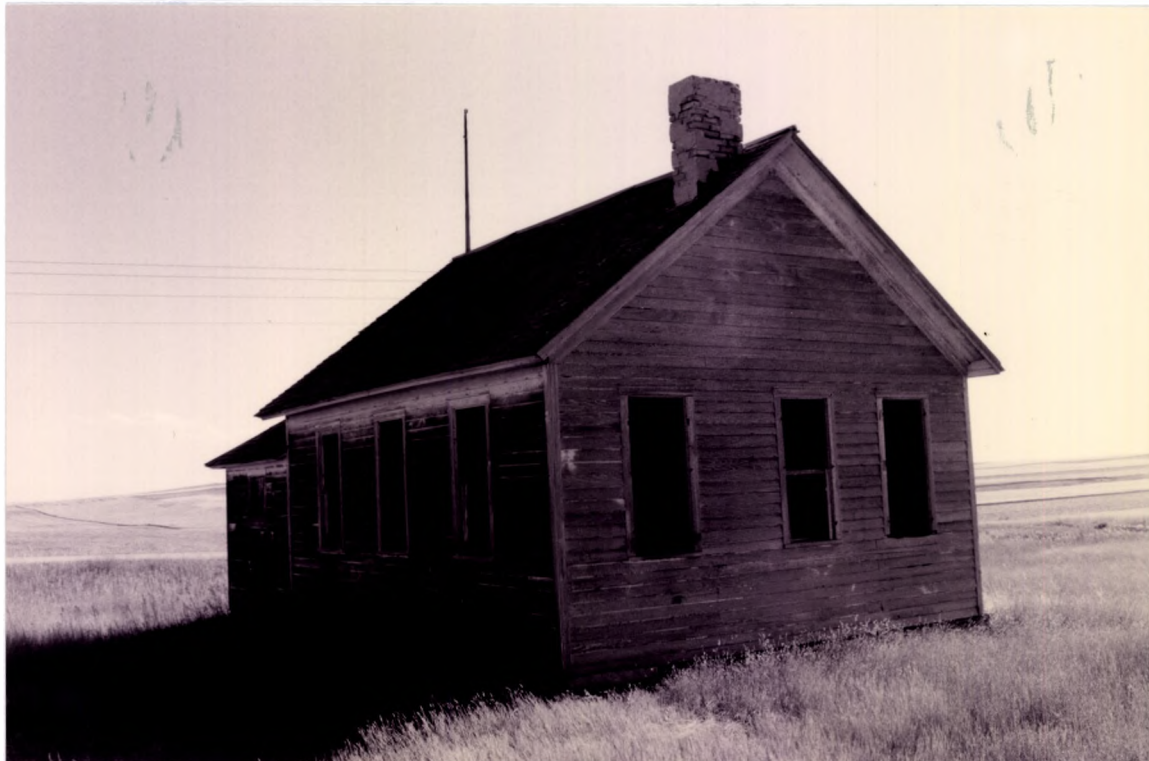
Roll *CC* Frame *5* Site *SU 116* Feature Date *8/3* View from *NE*

Subject: *Schoolhouse*
