NDCRS SITE FORM  
ARCHITECTURAL SITES  
Page 1

Field Code Su. 120 Site Name Schoolhouse  
Field Code \_\_\_\_\_ Site Name \_\_\_\_\_

Manuscript/Report Title: Survey of Bowman County

Photographic Coverage, Historic Architectural Survey of Bowman County, 1997

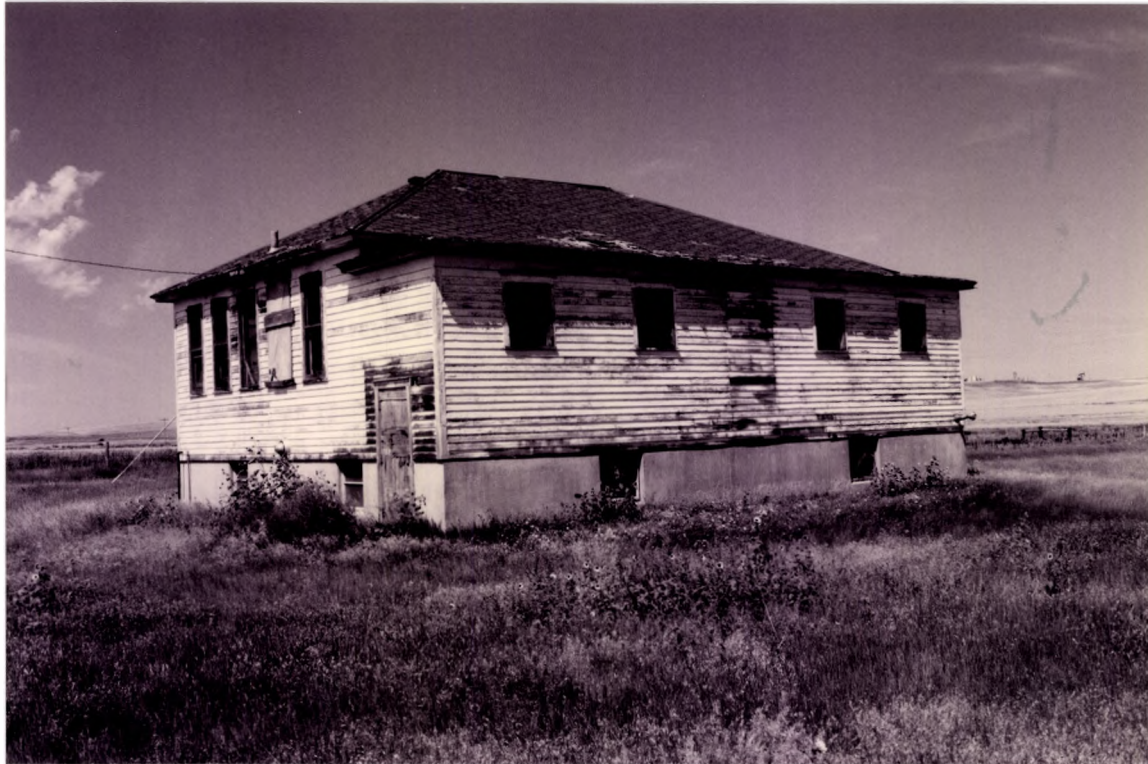
Roll DD Frame 13 Site SU 120 Feature Date 8/4 View from SE

This country schoolhouse sits upon its original school grounds, but it was moved slightly and turned around for positioning on a new foundation (the present foundation is not the original). This is a wood frame building on a foundation of poured concrete. The exterior is horizontal wood siding. The hip roof is covered with asphalt shingles. The school was built in about 1920. A hip roof addition spans the line of the east side of the school. All the walls of the original section of the school have tall, double-hung windows. The new addition has square windows on the east wall only. It appears that the entrance to the school during its active days was in the middle of this east wall, but the doorway has been covered over with siding and the steps removed. There is a small, shed-roofed entry way over a back door on the west side. There is one more door, ground level, on the south side of the new addition, but this door appears to have been a recent addition. The evidence is that after its use as a schoolhouse, this building was begun to be converted to some other use by a subsequent owner.

Subject: Schoolhouse

The modifications to this building make its integrity questionable, and at any rate, it lacks associations or distinction sufficient for National Register consideration.

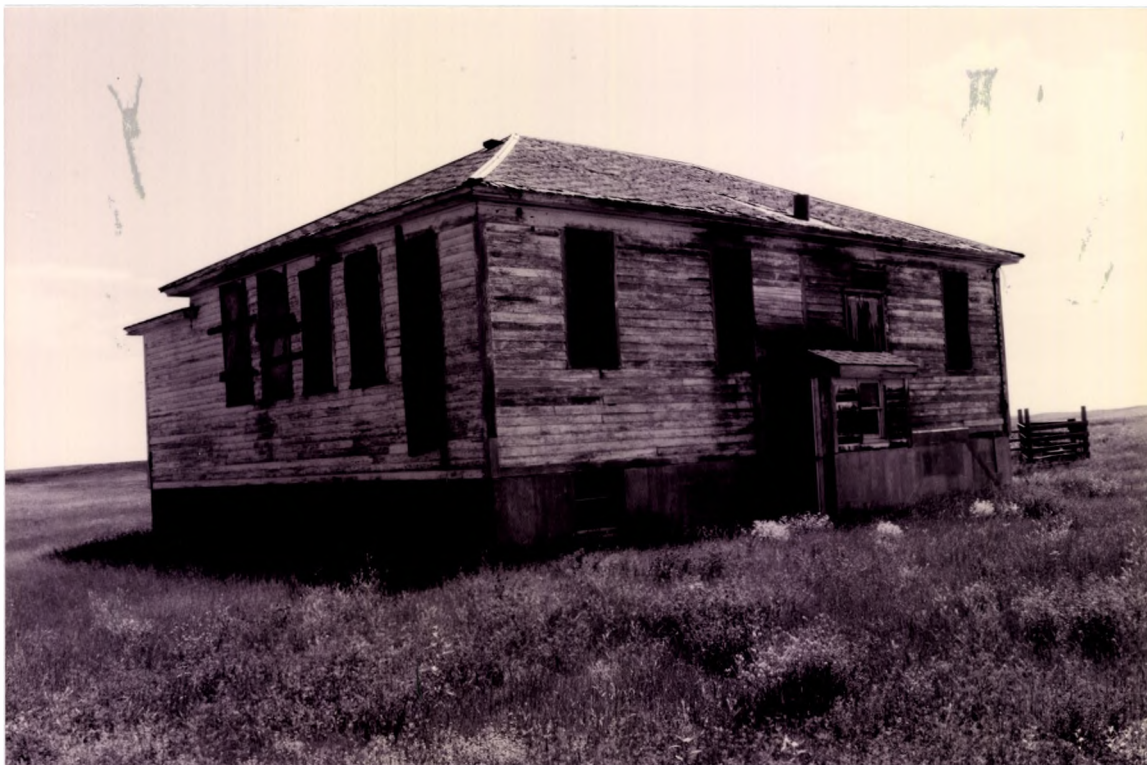
Roll DD Frame 13 Site SU 120 Feature Date 8/4 View from NW

Subject: Schoolhouse
