### NDCRS ARCHITECTURAL SITE FORM

SITS# 32 BO 917

Project: Slope Electric RUS 337; PI: Ed Stine

Report Title: IEA Slope Electric RUS 337: A Class II/III Cultural Resource Inventory in Bowman County, North Dakota; Author: Ed Stine

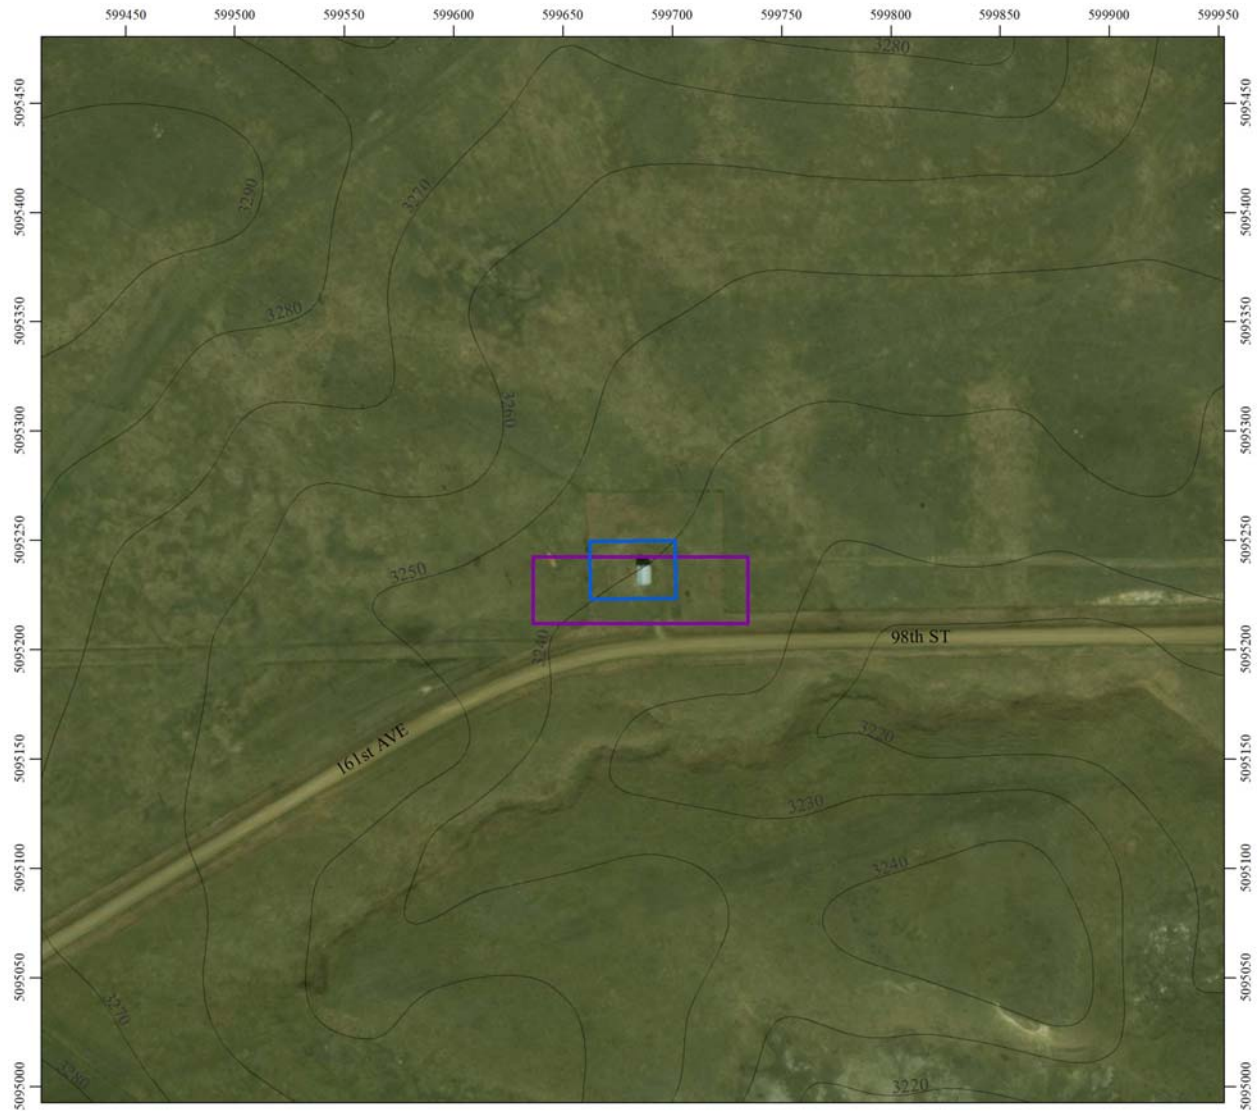
**Figure 1:** Sketch map of 32BO917 depicted on aerial imagery.

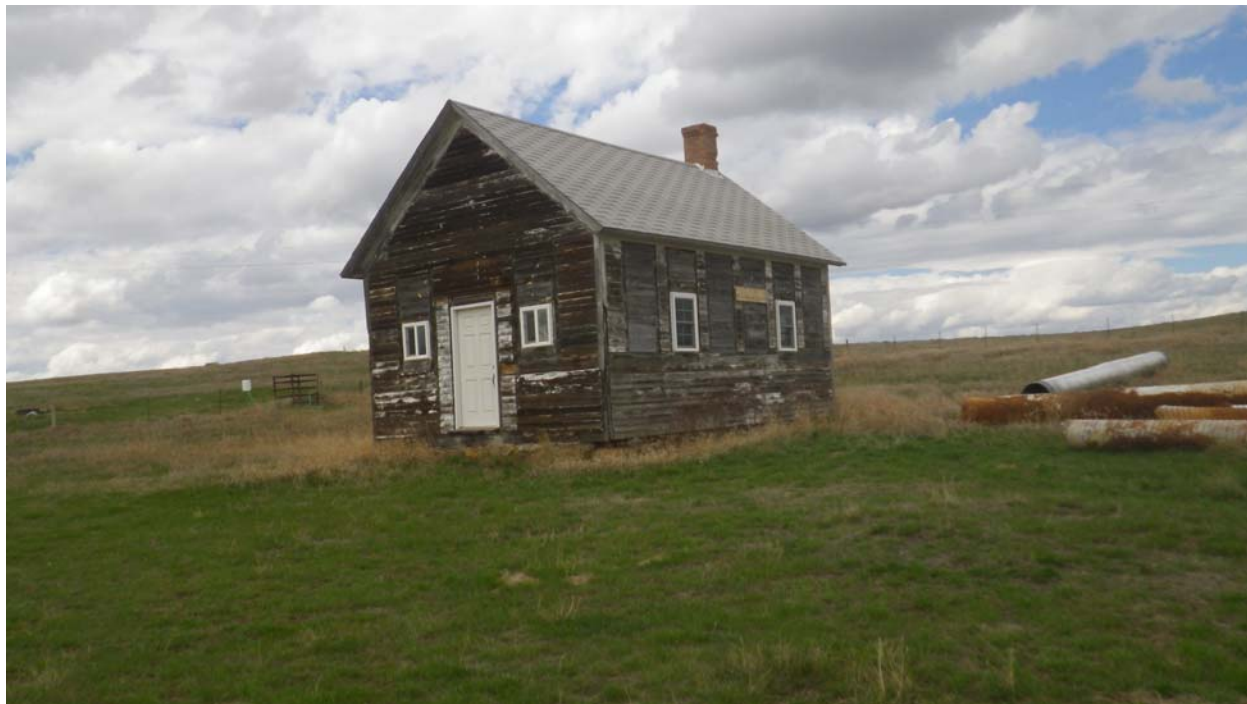
DESCRIPTION: Feature 1 is a single-story wood-framed building, recorded as a one-room school house by Tom Isern in 1997. The feature has since experienced a number of alterations. It has a gabled roof that has recently been covered in asphalt shingles. The primary entrance is centered on the south gable end and consists of a modern, paneled steel door. Flanking the entry are two two-lite sliding windows. Both windows are set within much larger window openings that have been filled in with wood siding. A series of blinded window openings spans the east elevation that have similarly been filled in with horizontal lumber. Two of the formerly large openings currently contain modern four-over-four-lite vinyl windows. The north gable end contains another altered window opening at the east end, with a modern four-over-four-lite vinyl window. To the west is an opening near the base of the building that, in 1997, served as a vent. The vent has since been removed and the opening boarded up with a sheet of plywood. On the west elevation are two large four-over-four-lite vinyl windows and an electrical conduit. The brick chimney that pierces the gabled roof at the north end of the feature shows signs of spalling, particularly on the north side. An electric light, two chests of draws, and a large stack of lumber were visible on the interior.

INTEGRITY: The structure has been subject to a number of changes, including modifications to the window openings, installation of a modern door and windows, and new roofing materials. These changes have compromised integrity of materials, design, feeling, workmanship, association, and setting. Integrity of location is the only aspect retained. This is supported by the presence of a schoolhouse on this location in the 1917 Atlas of Bowman County (George A. Ogle and Co. 1917) .

**Figure 2:** Site 32BO917, Feature 1, view northwest (Image 902).

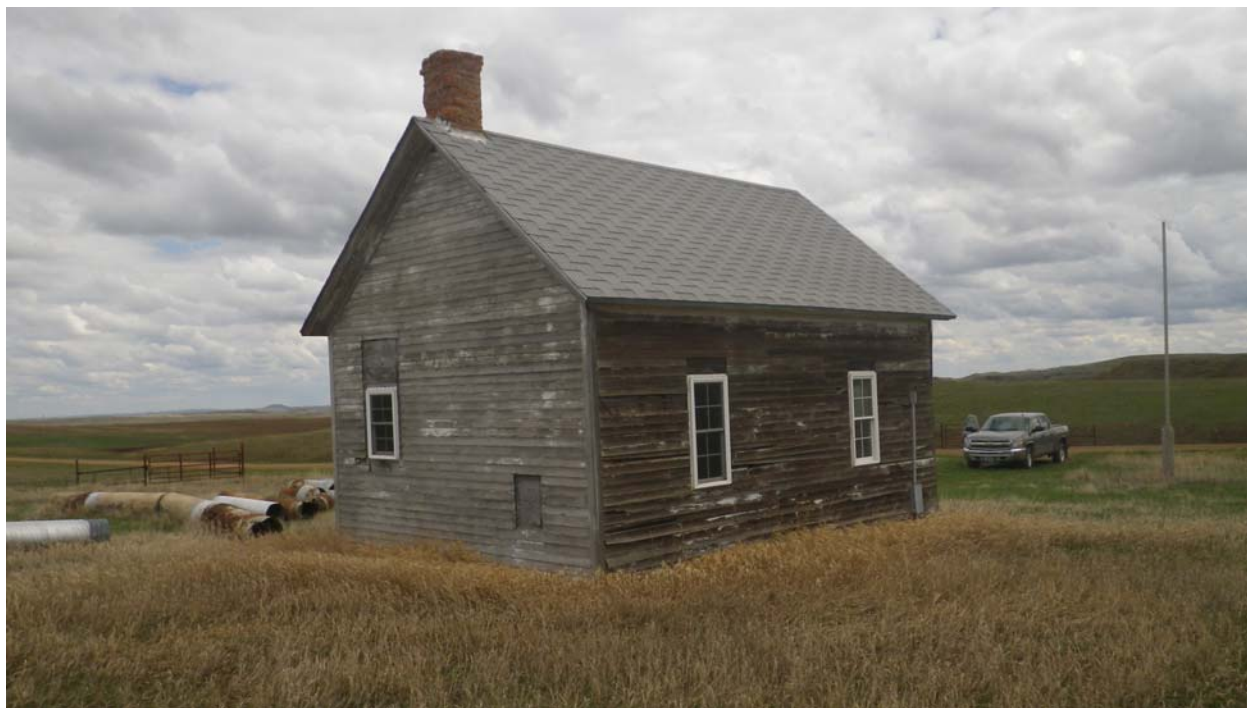
DESCRIPTION: Feature 2 is a wood flag pole set in the ground southwest of Feature 1. It appears unchanged since its original recording.

**Figure 3:** Site 32BO917, Feature 1 and 2, view southeast (Image 906).

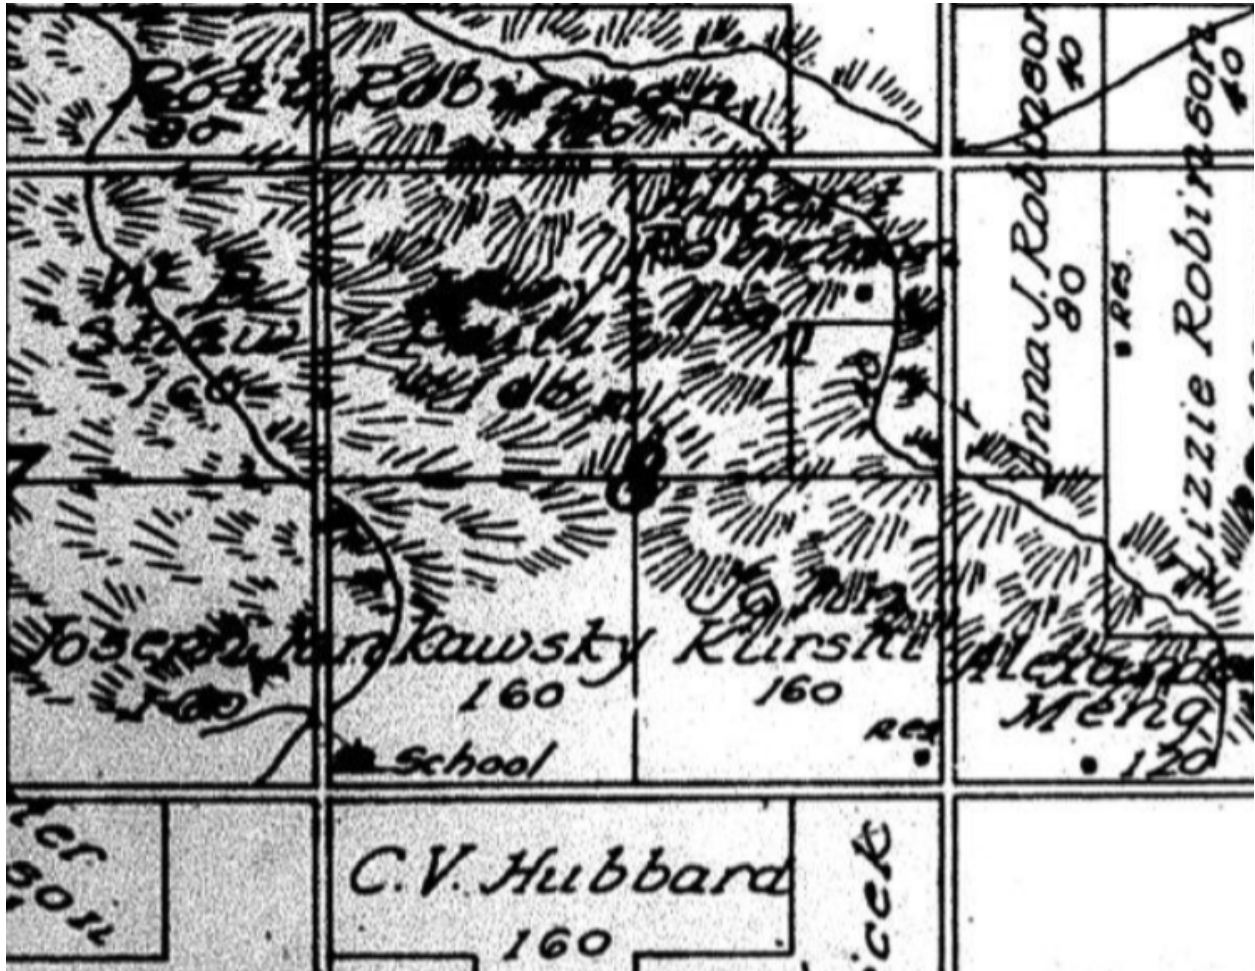
**Figure 4:** Map of Township 129N, Range 104W, Section 8. Excerpt from map by Geo. A. Ogle and Company, in *Standard Atlas of Bowman County, North Dakota* (Chicago, IL: 1917).

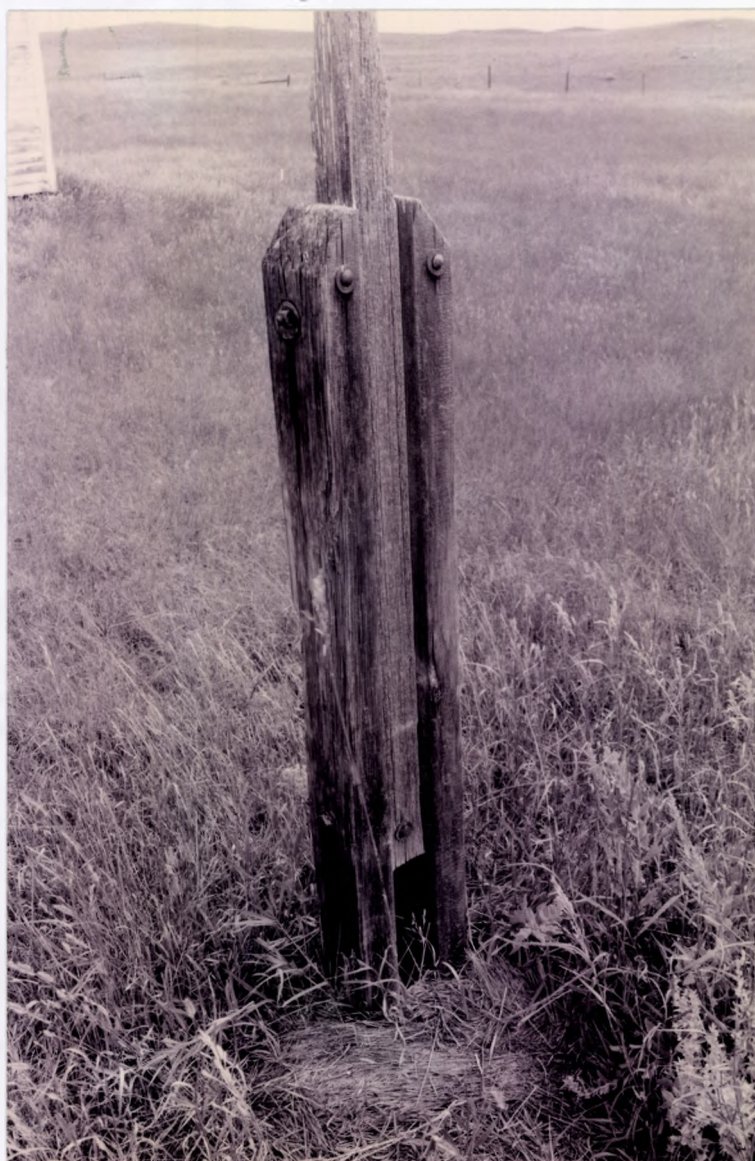
Roll FF Frame 23 Site SU130 Feature 2 Date 8/5 View from SW

This wooden flagpole is southwest of the schoolhouse. It is of interest mainly for the mechanism by which the flag could be raised or lowered by hinging the flagpole. The flagpole could be raised to vertical or lowered to horizontal as it pivoted on the wood frame to which it was bolted.

Subject: Detail of flagpole

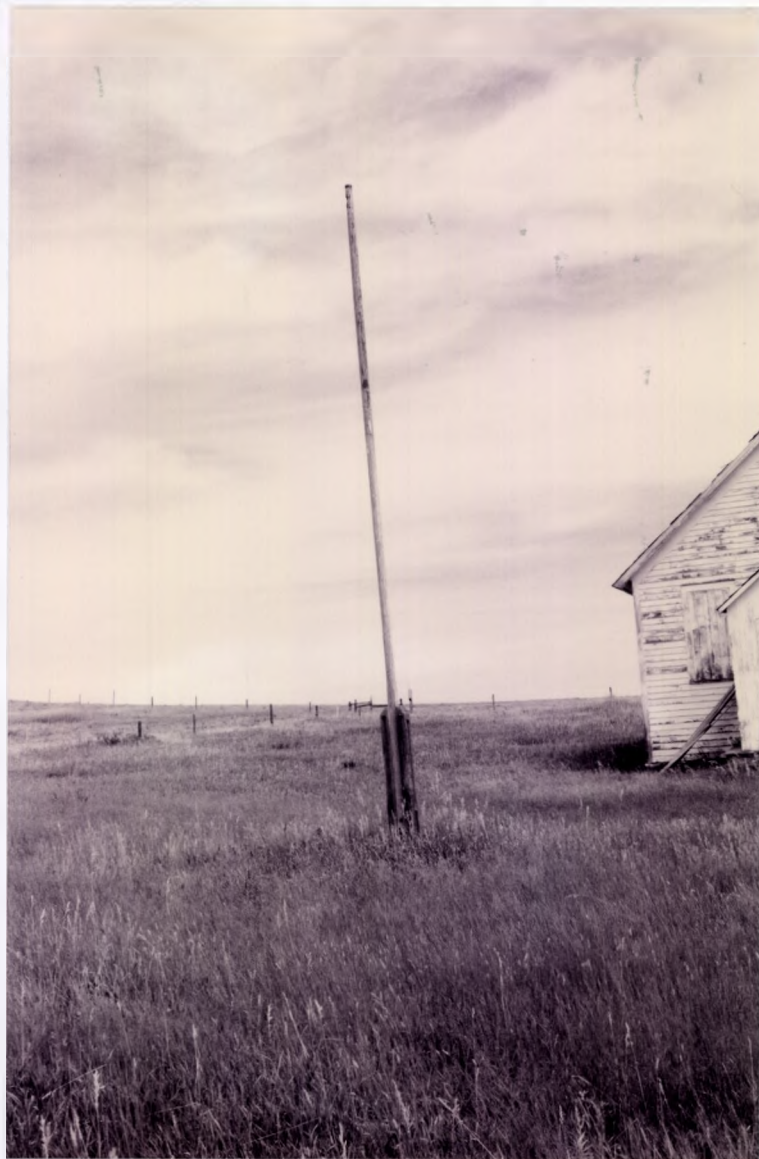
Roll FF Frame 22 Site SU 130 Feature 2 Date 8/5 View from SE

Subject: Flagpole

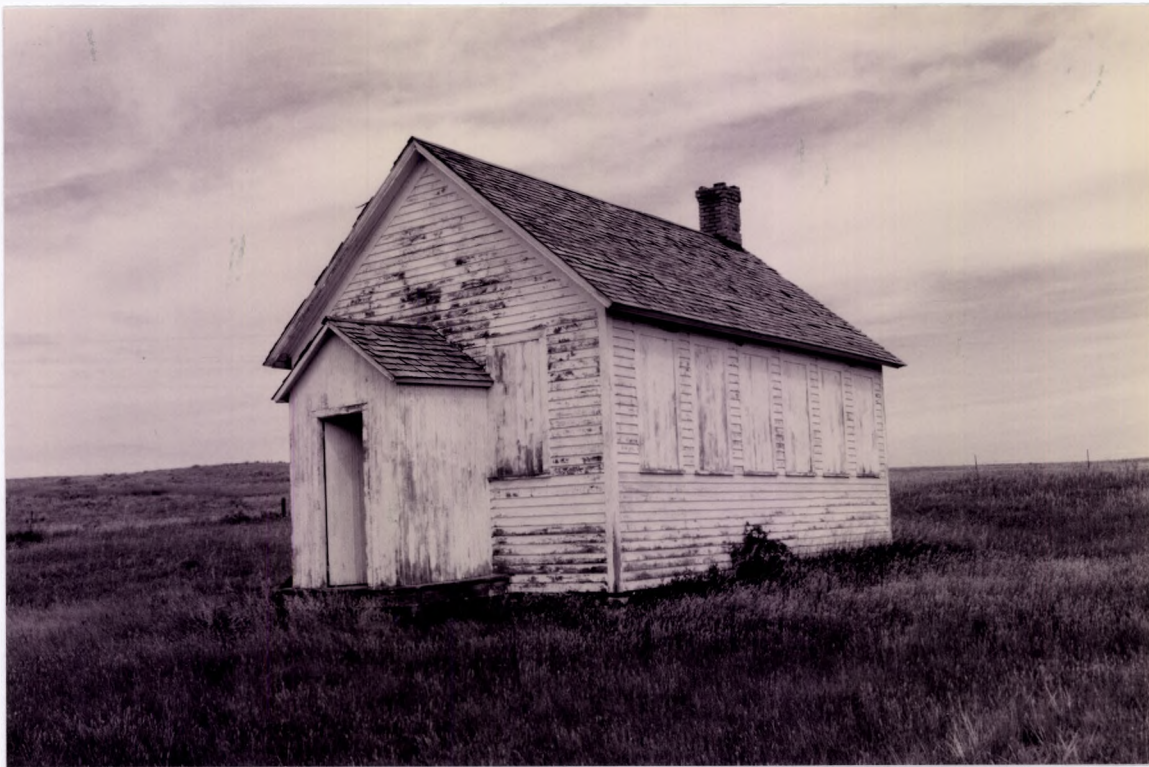
Roll FF Frame 20 Site SU 130 Feature 1 Date 8/5 View from SE

This one-room schoolhouse is a wood frame building on a foundation of uncut stone and likely was constructed in about 1910. Its exterior is horizontal wood siding, and its gable roof is covered with wood shingles. It has a line of six windows on the east side, one window on the north side, and two windows on the south side, all of which have been boarded up but are underneath in an excellent state of preservation. There is a brick chimney near the north end of the gable. Built onto the south end of this schoolhouse is a gable-roofed front entry with a door opening to the south. This front entry has no foundation other than wood pilings, and the steps to the door are gone. Inside, the ceiling has fallen down, creating great mess and clutter, but otherwise the interior of the classroom remains in an excellent state of preservation -- high wood wainscoting, cast iron stove, impressive window sashes and sills, even the window glass intact. Entering from the south, to the left is a cloak room, to the right is a closet accessible only by a door from the classroom.

Subject: Schoolhouse

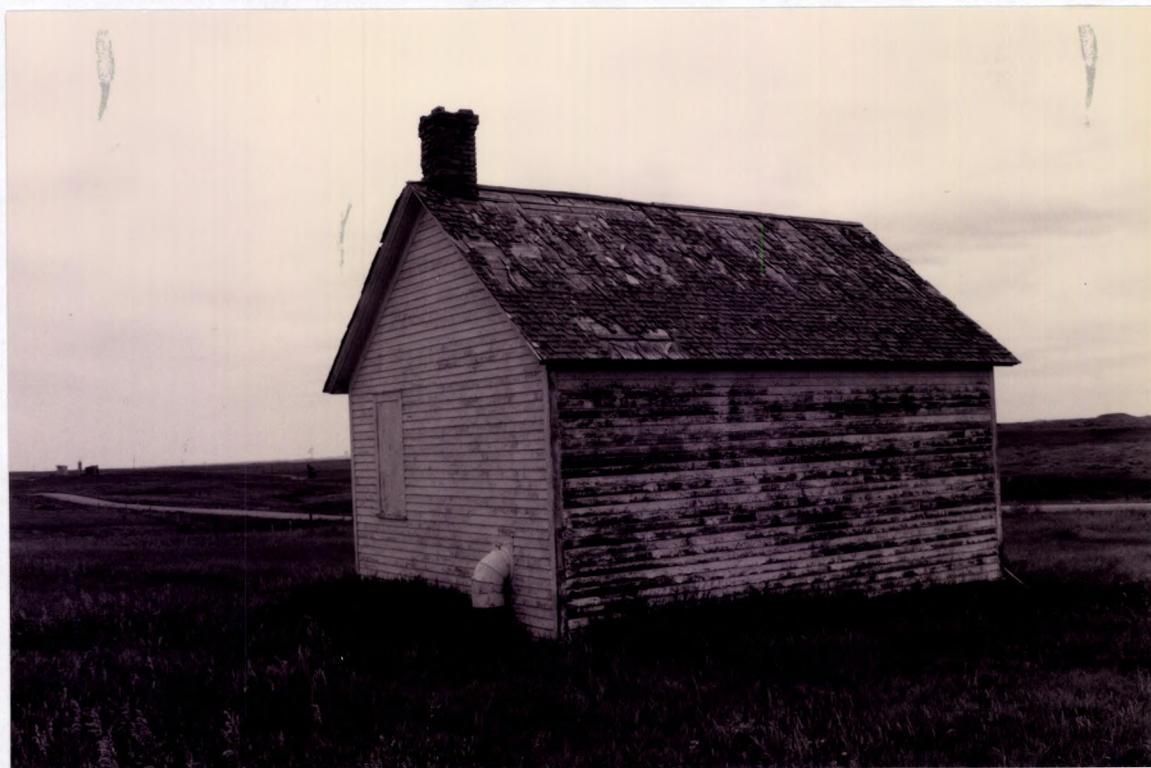
Roll FF Frame 21 Site SU 130 Feature 1 Date 8/5 View from NW

Subject: Schoolhouse
