NDCRS SITE FORM  
ARCHITECTURAL SITES

SITS # 32 BU 969

Field Code SU 185 Site Name Schoolhouse  
Field Code \_\_\_\_\_ Site Name \_\_\_\_\_

Manuscript/Report Title: Survey of Brown County

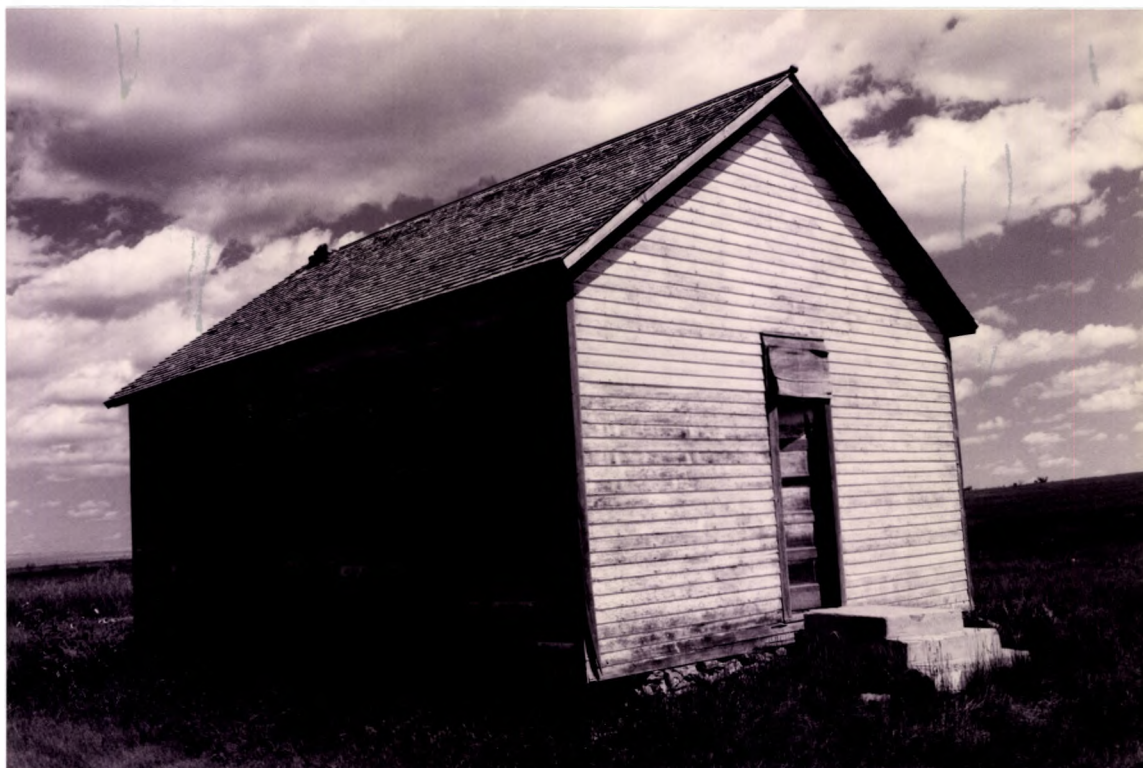
Roll JJJ Frame 12 Site SU 185 Feature Date 8/12 View from SUT

This modest schoolhouse has been converted for use as a granary. This building dating from about 1910 is a wood frame building on a foundation of uncut stone. Its exterior is horizontal wood siding. Its gable roof is covered with wood shingles. The windows of the building have been closed off for its use as a granary.

Subject: Schoolhouse

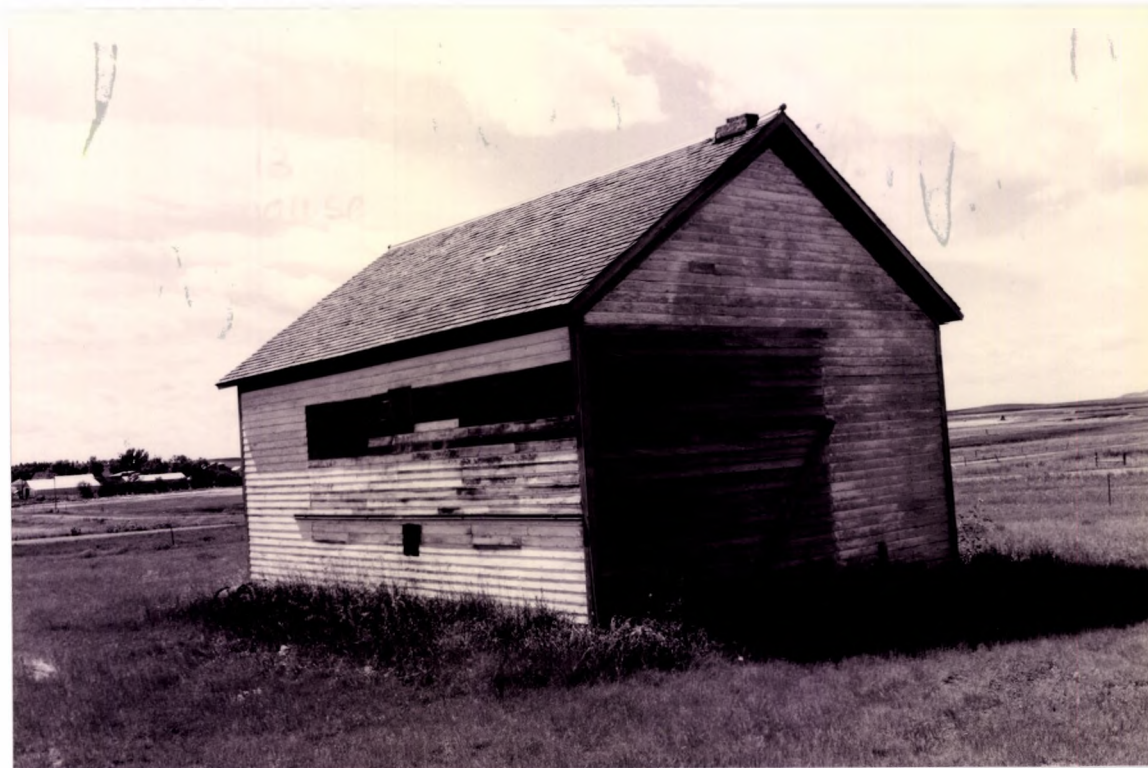
Roll JJJ Frame 13 Site SU 185 Feature Date 8/12 View from NF

Subject: Schoolhouse
