NDCRS SITE FORM
ARCHITECTURAL SITES
Page 1

Field Code SU 190 Site Name Scariona Hills Ranch
Field Code _____ Site Name _____

Photographic Coverage, Historic Architectural Survey of Bowman County, 1997

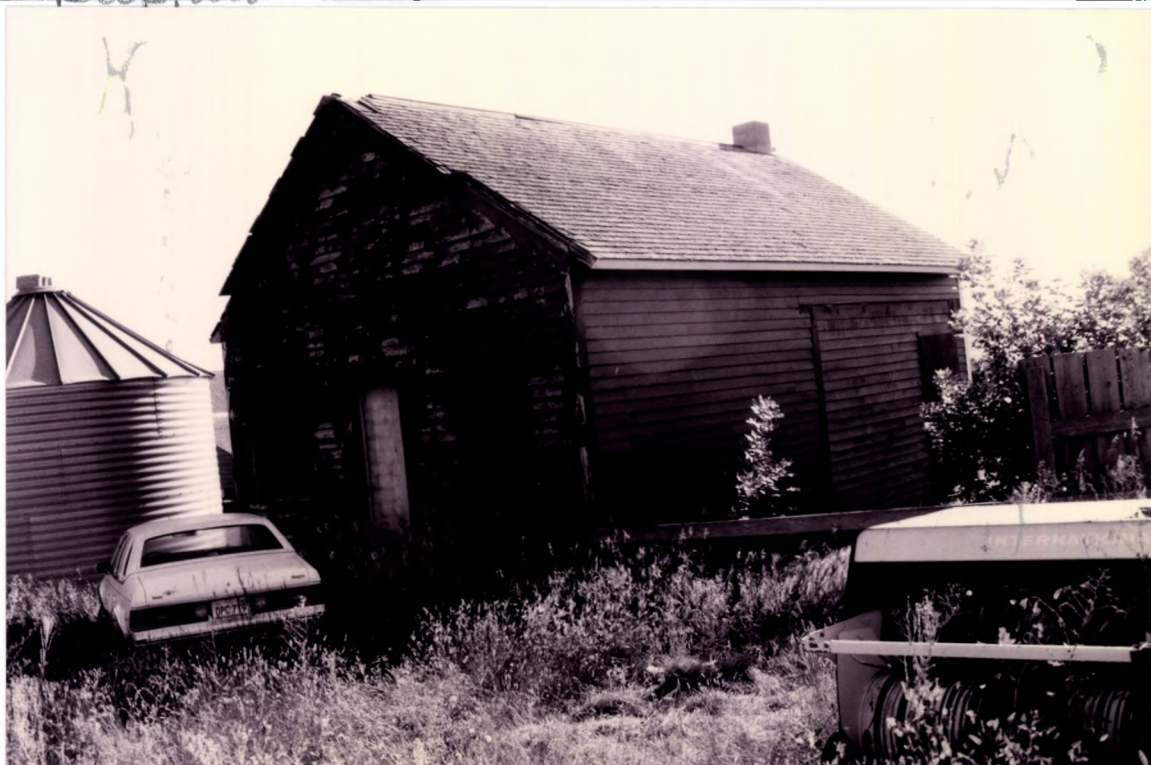
Roll LLL Frame 7 Site SU 190 Feature 2 Date 8/12 View from NE

This schoolhouse is located southeast of the house that is feature 1. Dating from the 1910s, this is a wood frame building on a foundation of poured concrete. Its gable roof is covered with wood shingles, and its exterior is horizontal wood siding. The east end of this schoolhouse originally was the front entry, but the door and two windows on this side have been closed off. On the opposite end, a single door and two windows have been installed. Three new windows also have been installed on the south wall. This school, known as Buffalo School, was relocated to this farmstead.

Subject: Buffalo School

The extensive modifications made to this building make it ineligible for the National Register.
