NDCRS ARCHITECTURAL FORM
PAGE 1

Field Code Richburg School

SITS# 32 BU 777

Country School House Project
Kathy Wilner
366 43rd Ave SE
Bowdon ND 58418

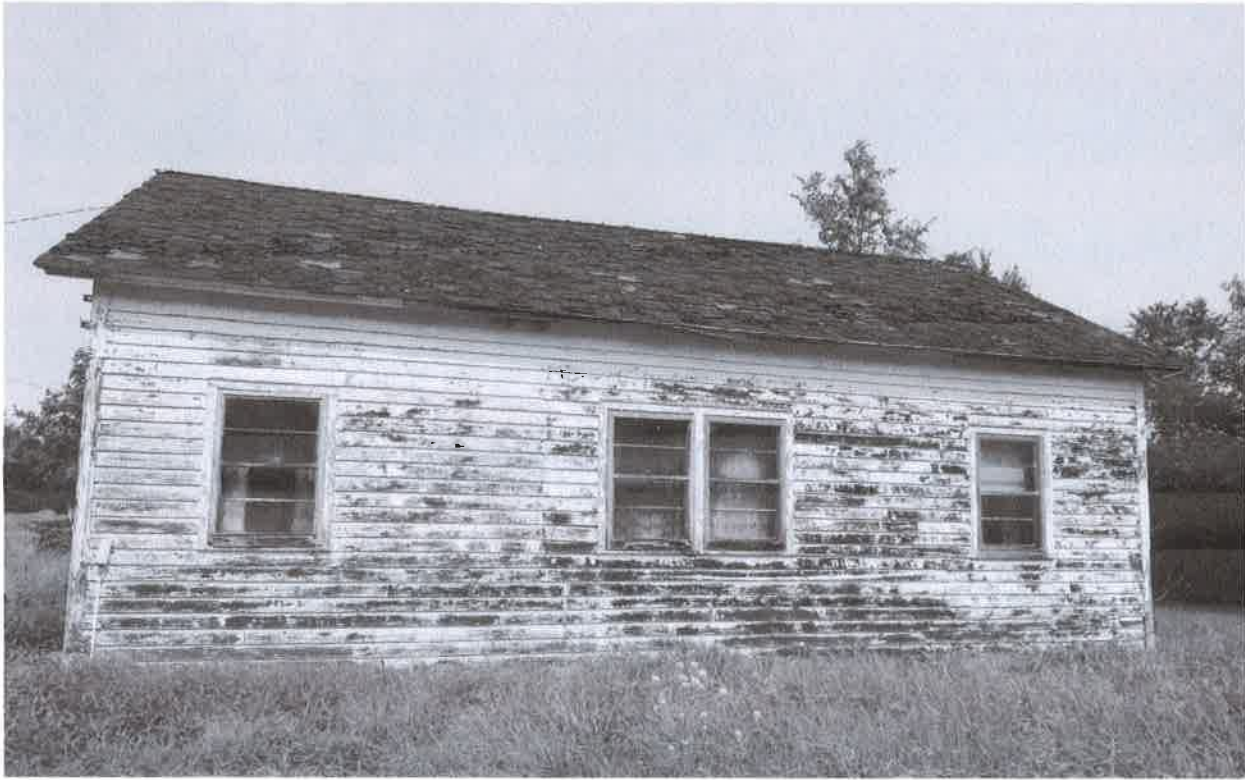
South Side

The siding begins with a rake board at the peak ends of the school. The rest of the siding is 6 inch wood lap with 4 inch wood corner trim. The windows are double hung, 2 over 2, with storm windows to protect the glass and keep in the heat. The glass is intact. There are 4 windows on the south side with one near the west end and the other near the east end and a pair close to the middle. Two more windows are located on the north side. The entry door is 3 panel wood with a window on the top 1/3. A concrete pad leads to the door. The interior walls and ceiling are lathe and plaster with wall paper on the walls. The school had dividing walls inside to make rooms for a bedroom, kitchen and living room area. The floor is hard wood with tile. Exterior wiring indicates electricity was present.

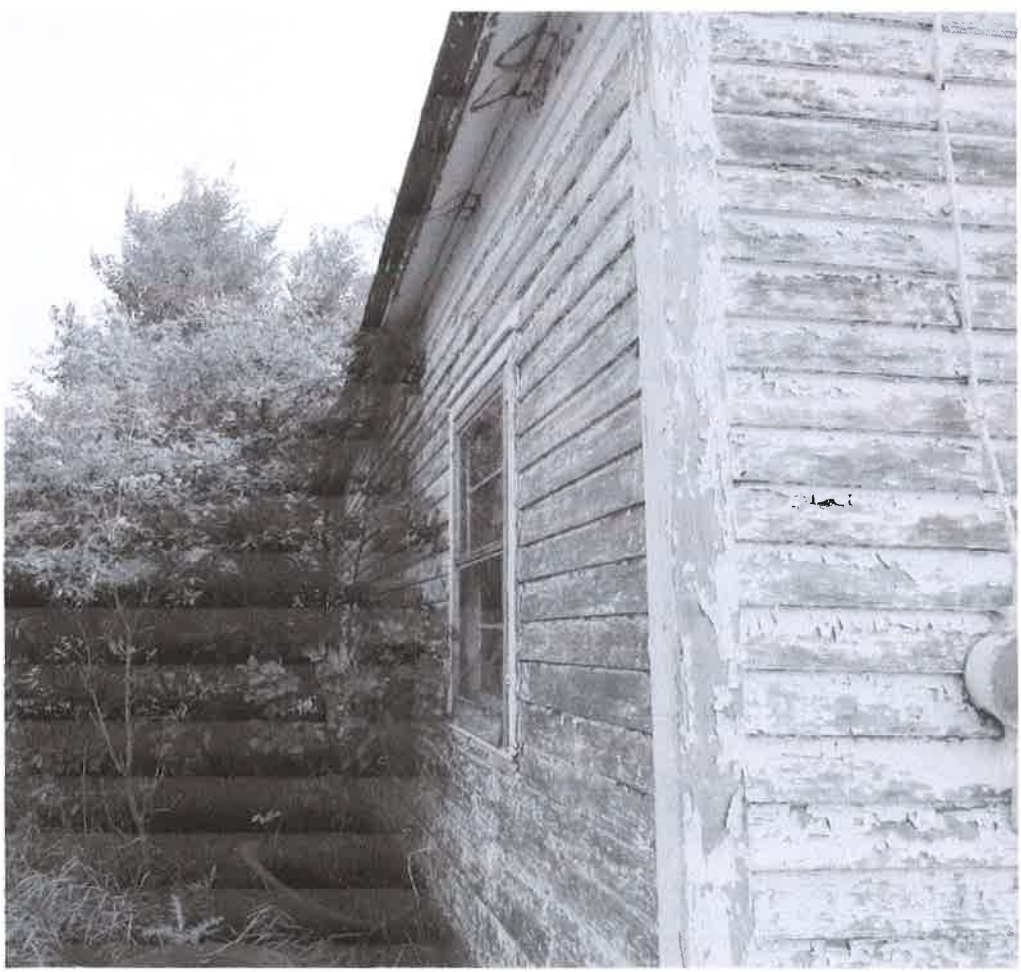
North Side

The feature is a one room prairie school moved to the present location for use as a house. It was placed on a poured concrete foundation. The original location of the school was Brander Township. The gable roof is covered with asphalt shingles with metal capping and finials. There is a red brick chimney on the north slope of the roof. The soffits are closed.
