NDCRS ARCHITECTURAL FORM  
PAGE 1

Field Code Bottineau School #3

Site Name Bottineau School #3

Architectural Feature # 1

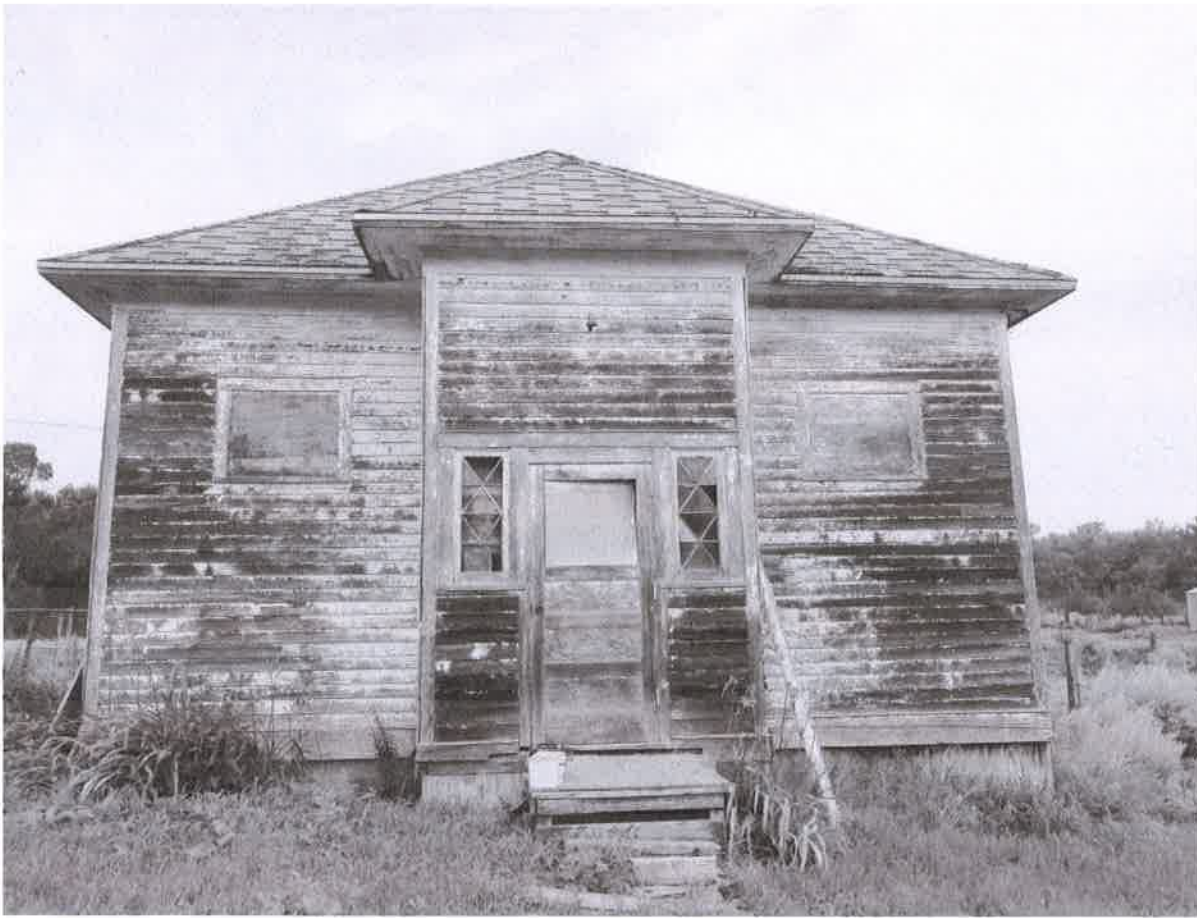
**West Side**

The siding begins with a rake board on all sides under the eaves. The remainder of the siding is 6 inch wood lap with 6 inch wood corner trim. The half hip roofed entry is a bump-out on the west side. Wood steps lead up to a 3 panel wood door with the window opening boarded up. The door from the coat room into the school proper is missing. There is a small, decorative fixed pane window on either side of the door. Also on the west wall are two more covered windows. They are fixed 4 pane windows and these are located in the coat room. On the east side there are 4 windows, three over one, some covered and some with glass. Two similar double hung windows are located on the south side, one covered and one not. The ceiling and about 2 feet at the top of the walls are covered with perforated acoustic tiles. The remainder of the walls are finished with lathe and plaster. There is a small blackboard located on the north wall. The floor is tongue and groove hardwood. Light fixtures are indicative of electricity. The heat was coal.
