NDCRS ARCHITECTURAL SITE FORM

Field Code Bell Township #60

Map Quad Grandin Site Name Bell Township #60

Project & Principal Investigator:
Country Schoolhouse Project

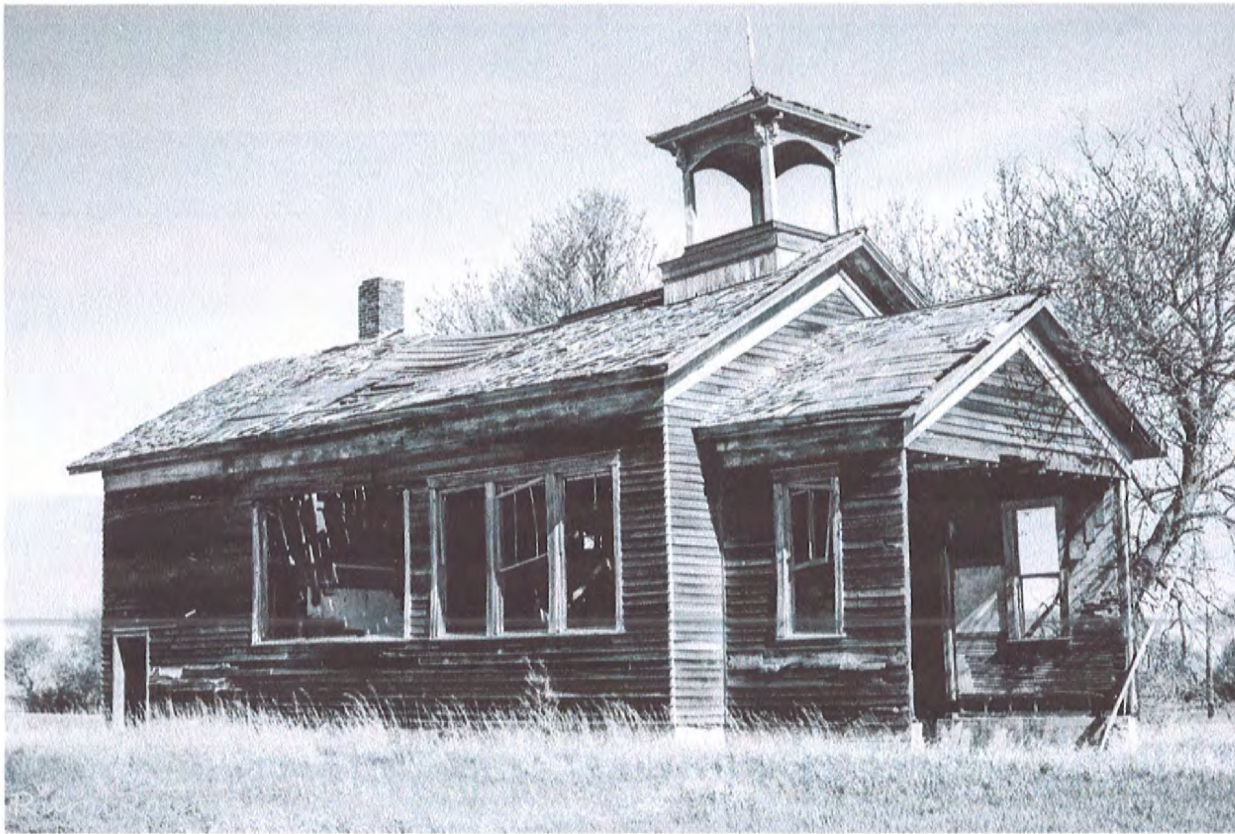
South
Side

There is a wide trim board under the eaves of all side of the school. The siding is 6 inch wood lap with metal corner trim. The window openings on the south side of the school are mostly just large holes. It appears there were two banks of three double hung windows, with little framing and no glass. The entry also had two double hung windows, no glass and a bit of framing. On the west wall there are two mutipane, double hung windows nearer the north wall and another double hung window closer to the south wall, no glass in any of them. One last window opening is under the peak on the west wall. A stairway inside the door located at the southwest corner of the school of the appears to lead up to a small room at the west most end of the school. Perhaps a room for the teacher. Where the stairway turns to go upstairs it also opens into the school proper. The entire east end of the entry was cut away leaving a large opening. Perhaps the building was used for storage of farm equipment. The remaining walls are lathe and plaster with much of the plaster fallen away. Remnants of beadboard hang from some parts of the ceiling as well as failing lathe and plaster other areas. There are old light fixtures attached to the ceiling boards indicating electricity.

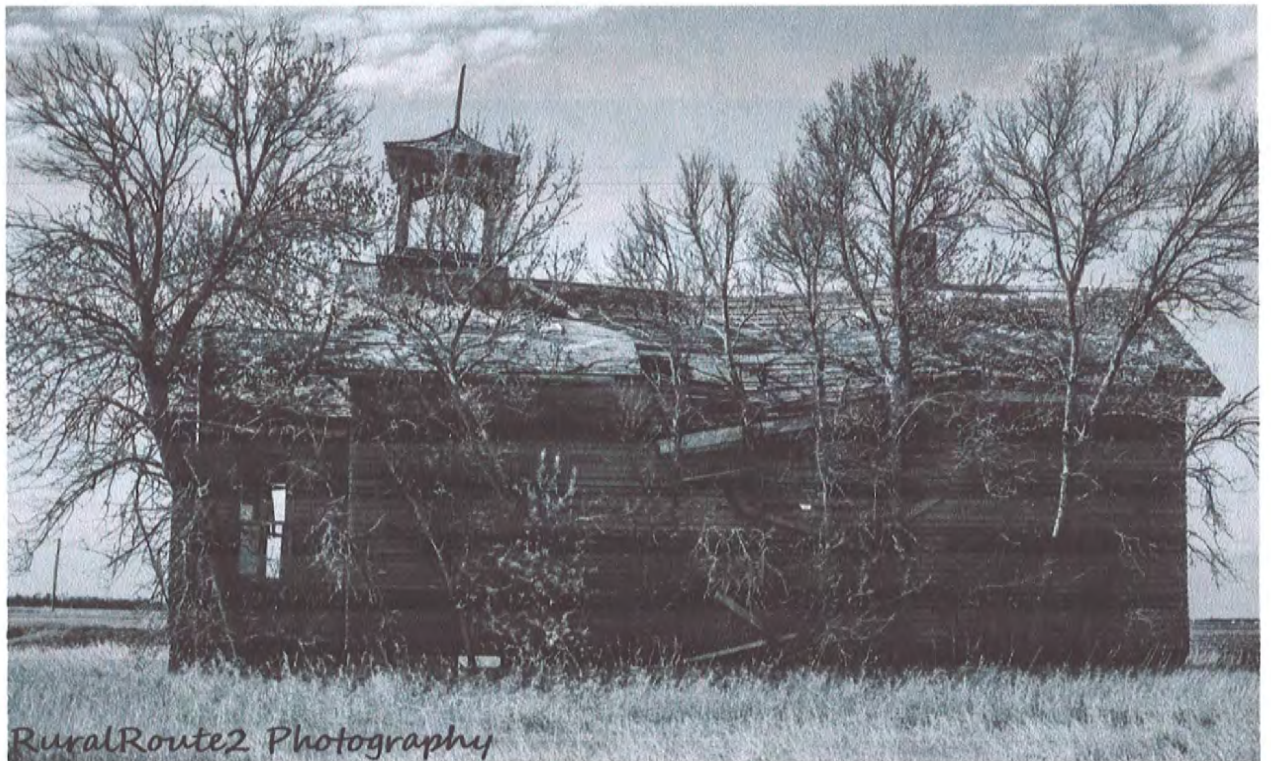
North
Side

There is a bin site to the north of the school and farm fields all other directions. There are some straggly trees growing along the north wall of the school.
