NDCRS ARCHITECTURAL FORM
PAGE 1

Site Name Dep. 25 School
Site Name

Project & Principal Investigator:
Country School House Project
Kathy Wilner
366 43rd Ave SE, Bowdon, ND 58418

Feature Type 9 - School; Church school

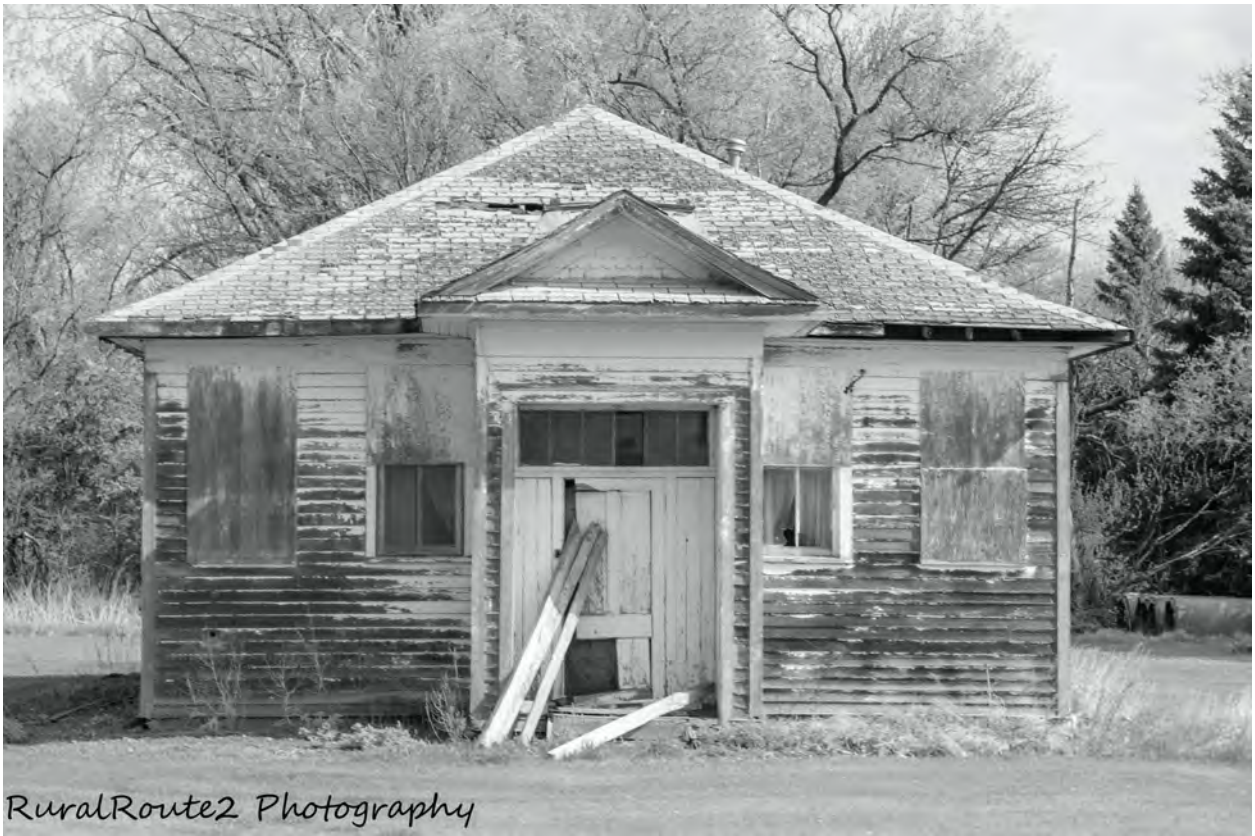
South Side

This feature is a one room prairie school sitting on railroad ties. It was moved to this farmsite for storage. The hip roof is covered with asphalt shingles. A stove pipe is seen sticking out of the roof on the east slope. There is small, gable roofed entry on the south side also covered with asphalt shingles. The soffits were close but are open in many places as the wood rots away. The chimney is gone.

The siding begins with a rake board under the eaves on all sides. The remainder of the siding is 6 inch wood lap with 4 inch wood corner trim. There is an entry on the south side of the school. The roof is gable with decorative shakes above an eave extension. Remnants of the bell tower are seen on this roof. The broken, four panel wood door is recessed. To either side of the door there are verticle 2x4's to finish the wall. A transom opening is covered. There are two double hung windows to either side of the entry, four more similar windows are located on the north side. Most of the windows are either partially or totally covered. There are three more smaller windows on the west side, double hung and covered. One more smaller double hung window is located on the east side. The floor is tongue and groove hardwood. The walls and ceiling are covered with lathe and plaster. There is wainscot but no blackboards. It is wired for electricity.
