NDCRS ARCHITECTURAL SITE FORM
PAGE 2—Feature Data

Field Code SCHOOL #2 Site Name SCHOOL #2  
Field Code \_\_\_\_\_ Site Name \_\_\_\_\_

**FIELD MANUAL  
NDCRS ARCHITECTURAL SITE FORM**

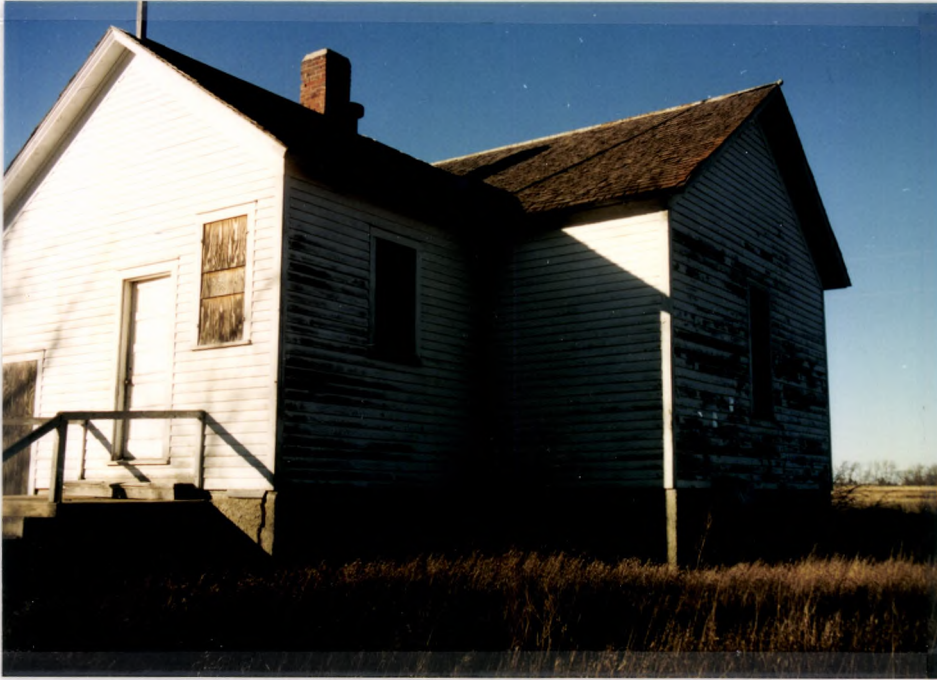
#. 1

1. VIEW FROM SOUTH.

View from the south,.....east-west road in the background....The building looks like it is in a low spot,and it is,water gets in the basement. Originally it was not a low spot,but when the new roads,the one in the background,and the north-south one to the immediate west of the school, were graded up,they were then higher than the level of the school by about four feet.The north-south road is a county road and was raised another two feet when it was graded up and paved about 10 years ago.In wet weather the school basement has three feet of water in it,and access is difficult to get in the building.The furnace (which would not have been useable)is ruined,and some desks that were stored there are beyond restoration.There are others that were stacked one on top of the other, that just the bottom two are ruined.....The steps go to the entry that was constructed in 1925,when the addition was added:The door to the left, (boarded up) goes to the basement.All windows were boarded up,which has helped to preserve the structure.

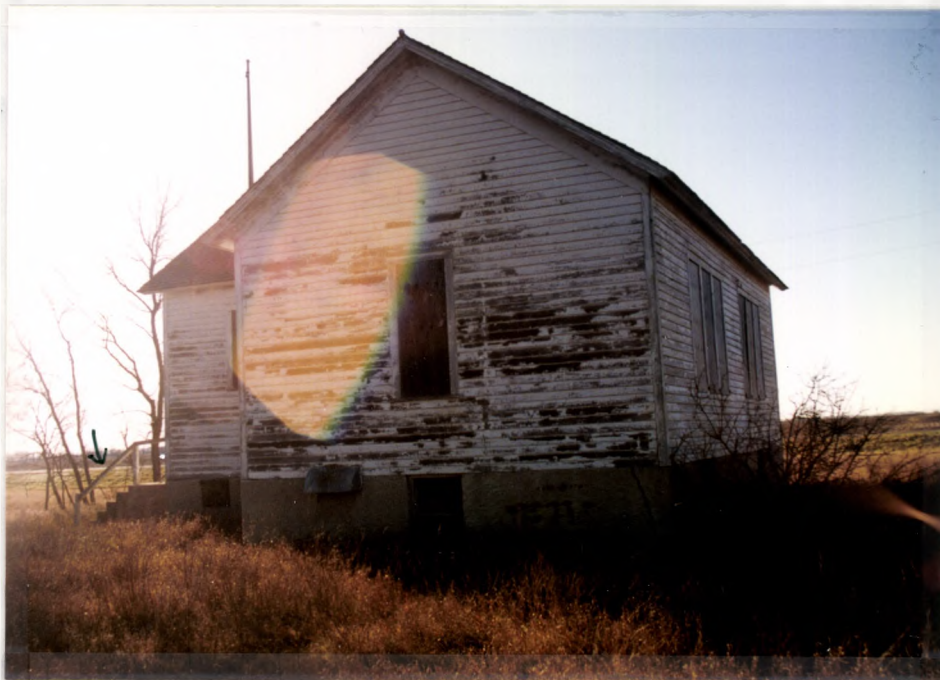
#2

2. EAST ELEV.  
LOOKING SW

East side,looking to the SW..(some sun reflection in lens of camera) Except for paint,the exterior is in excellent condition,considering its age.The height of the grading of the county road in the background gives you some idea of how water will stand around the school.

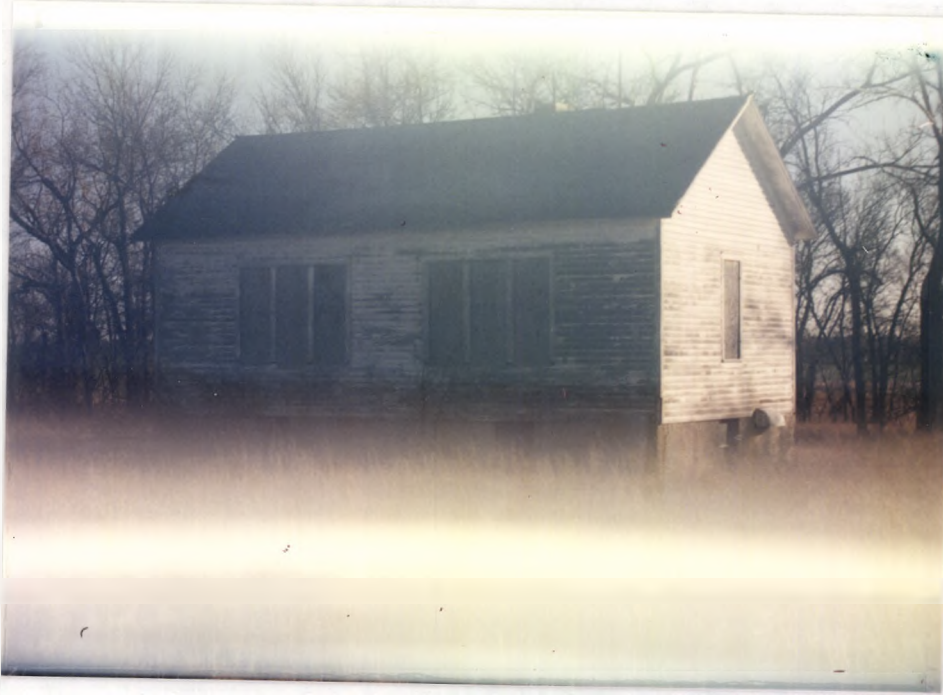
#3

3. N. ELEV.  
TAKEN FROM  
E-W ROAD.

North side of building,taken from the east-west road.I believe the right half is the original part built in 1901.

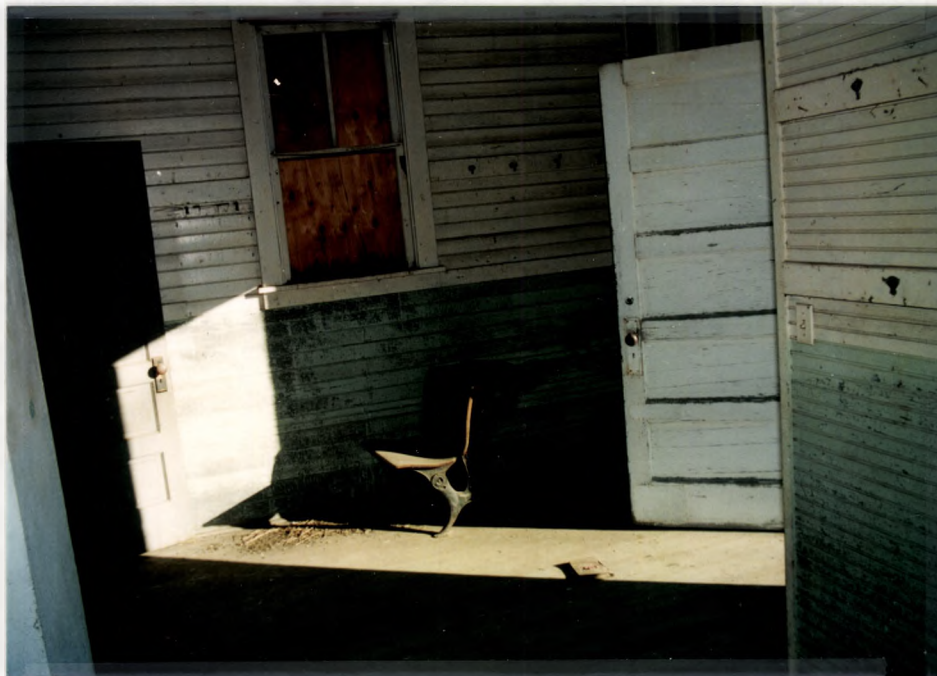
#4

4. 1925 ENTRY.

This is the entry that was added in 1925.(note coat hooks on wall)One of the original??? desks.There are more of these in the basement,some have been in water(as above).

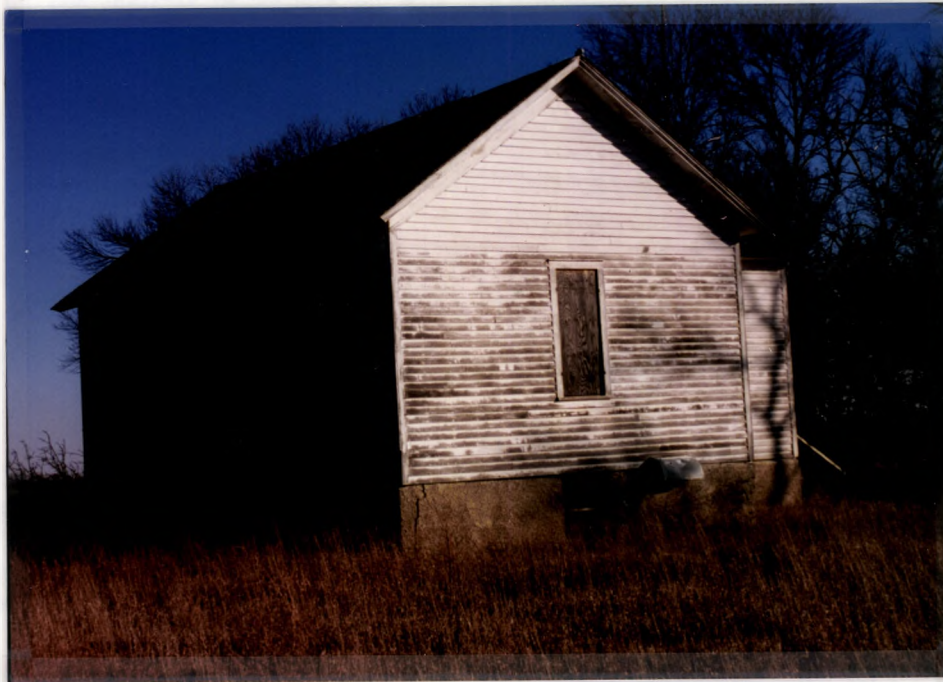
#5

5. LOOKING  
SW.

View from NW looking to SE.I think the metal hood that shows up on both east and west sides of the basement was for venting the basement to dry it out,or air for the furnace.

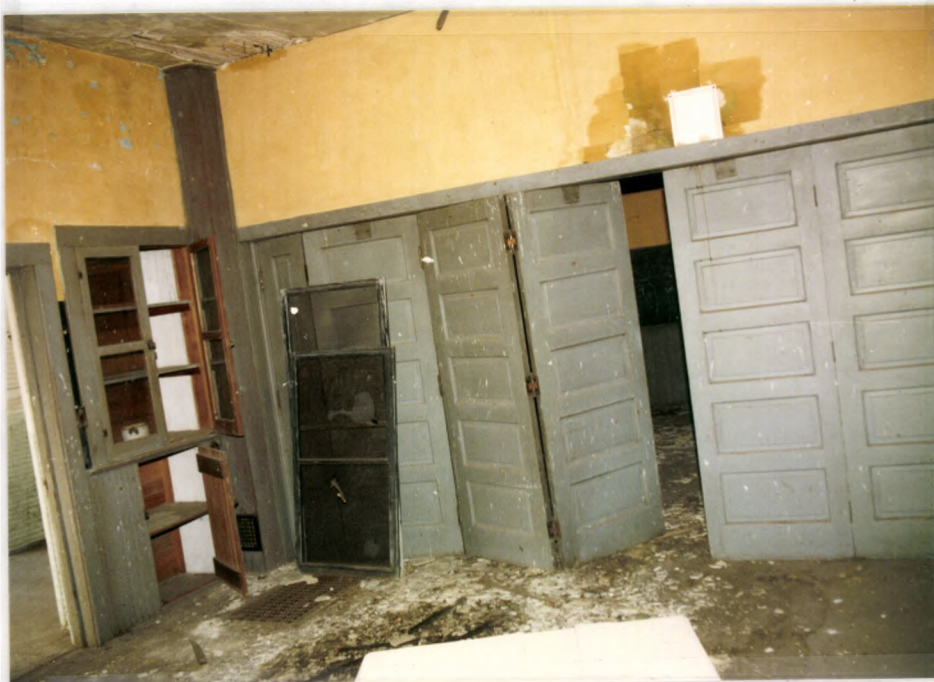
#6

6. FOLDING  
DOORS

Interior view showing the folding doors used to divide the classrooms. The shelving with the doors is part of a series of bookcases .The white stuff on the floor is plaster that has fallen from the ceiling.

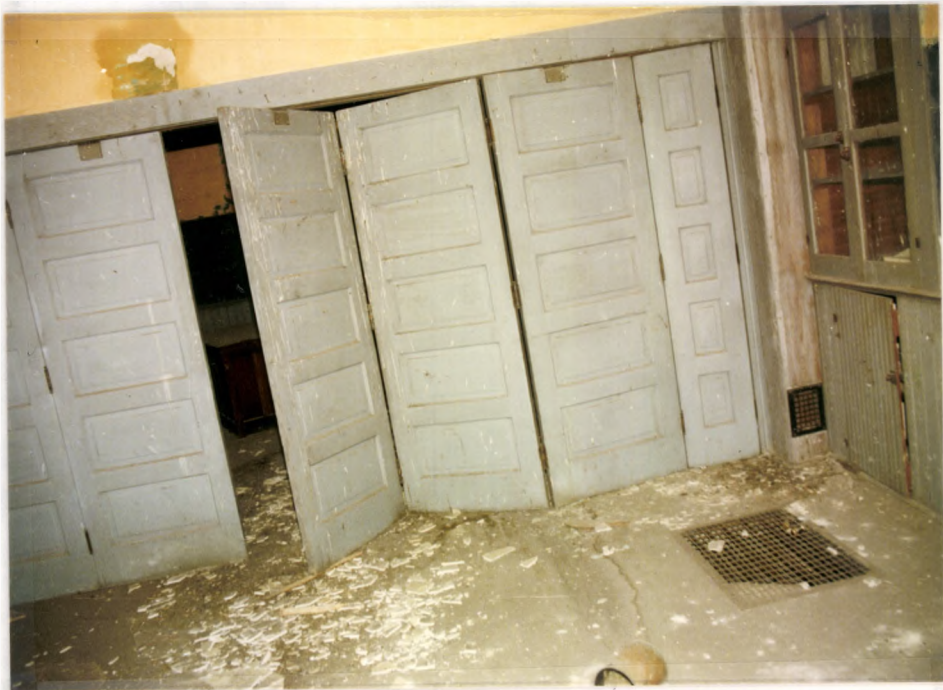
#7

7. FOLDING  
DOORS

View from the other room,again showing bookcase and door over shelves which probably held paper,paste,and other teaching materials.

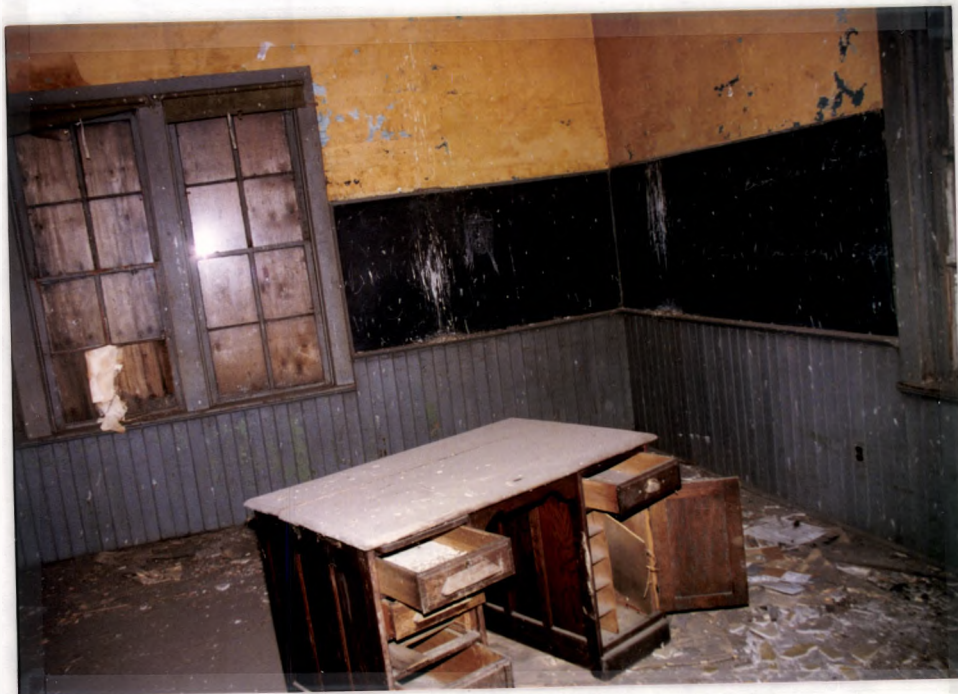
#8

8. INTERIOR

View from east half of interior with teachers desk.Note blackboards, probably installed when school was expanded in 1925.Also note shades over windows.Windows show little signs of rot,and most glass is intact.

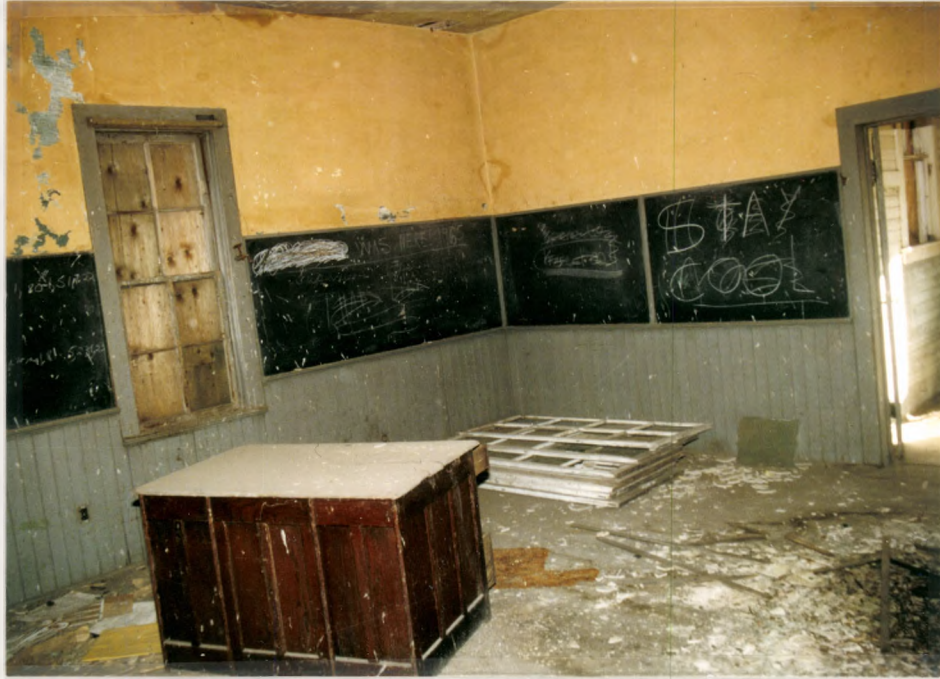
#9

9. VIEW FR. FRONT ROOM TOWARDS  
ENTRY

View from front of room.looking toward entry-way/The windows on the floor were used as storm windows,and were taken off when the plywood was put on.
