NDCRS ARCHITECTURAL FORM

Field Code Wagner School

Site Name Wagner School

NDCRS ARCHITECTURAL SITE FORM PAGE 1 UPDATE

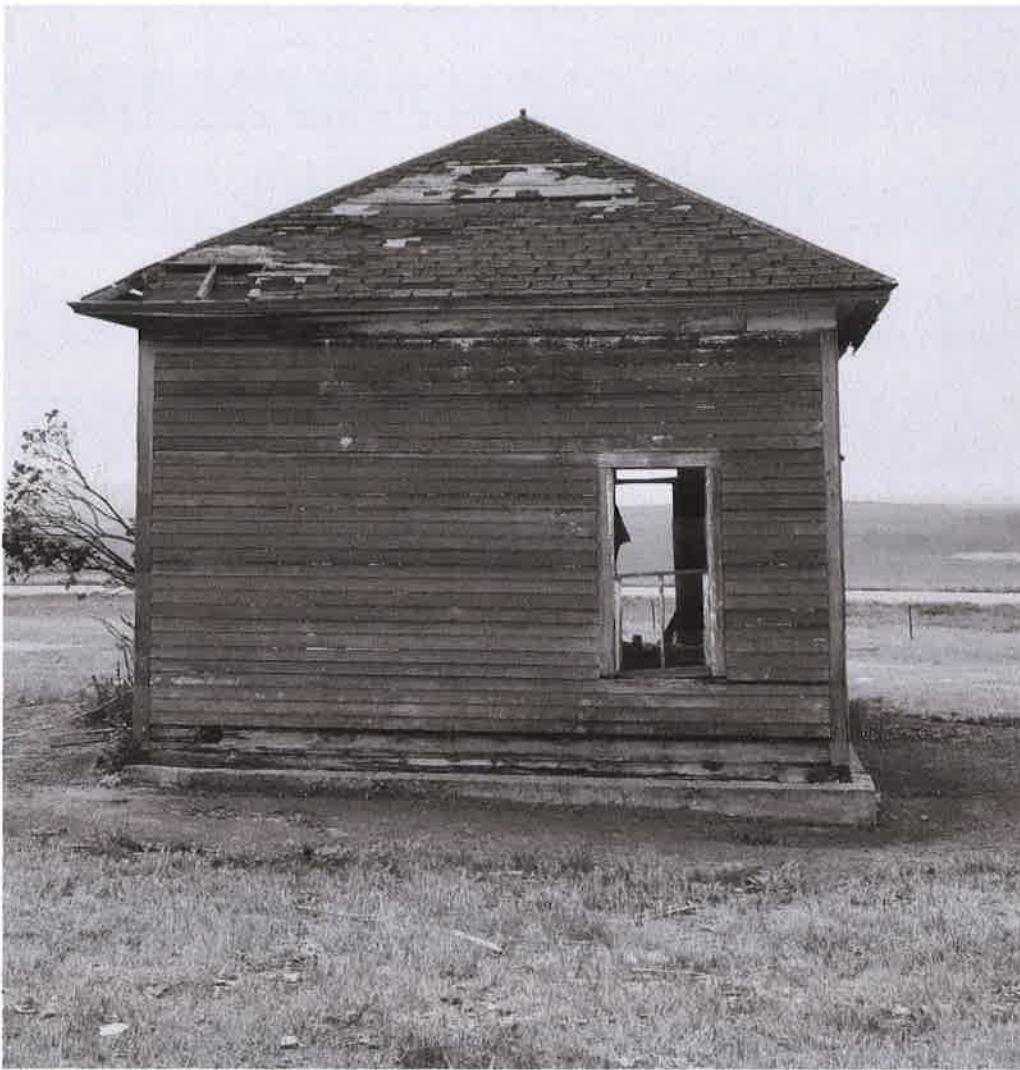
North Side

The feature is a one room prairie school on a poured concrete and rock foundation. The roof has asphalt shingles in very poor condition. There are holes visible in the roof. There is metal capping at the peak with one finial. On the south slope of the roof there is a dormer with an window opening and no glass. Remnants of a red brick chimney are located on the east slope of the roof of the dormer. The soffits were closed and now failing. The building measures 16 feet east to west and 30 feet north to south.

The siding begins with a rake board under the eaves on all side of the school. The rest of the siding is 6 inch wood lap with 6 inch wood corner trim and waterboard at the bottom. The siding is falling away in places. There is no entry but two sides of the school show outlines that there were entries on both the south and east at one point. Pretty unusual to have two entries. There are door openings on both the east and south sides, the door to the south has a transom above it. The door to the east has concrete stairs leading to a concrete porch. There is one boarded up window on the south wall. The west side has four double hung window openings with a bit of framing and no glass. The interior walls were finished with wall board and beadboard with wainscot present in places. The ceiling in the entry was lathe and plaster, the main room has ceiling tiles and most have fallen in. The floor is tongue and groove hardwood. Blackboards are gone and there is no evidence of electricity.

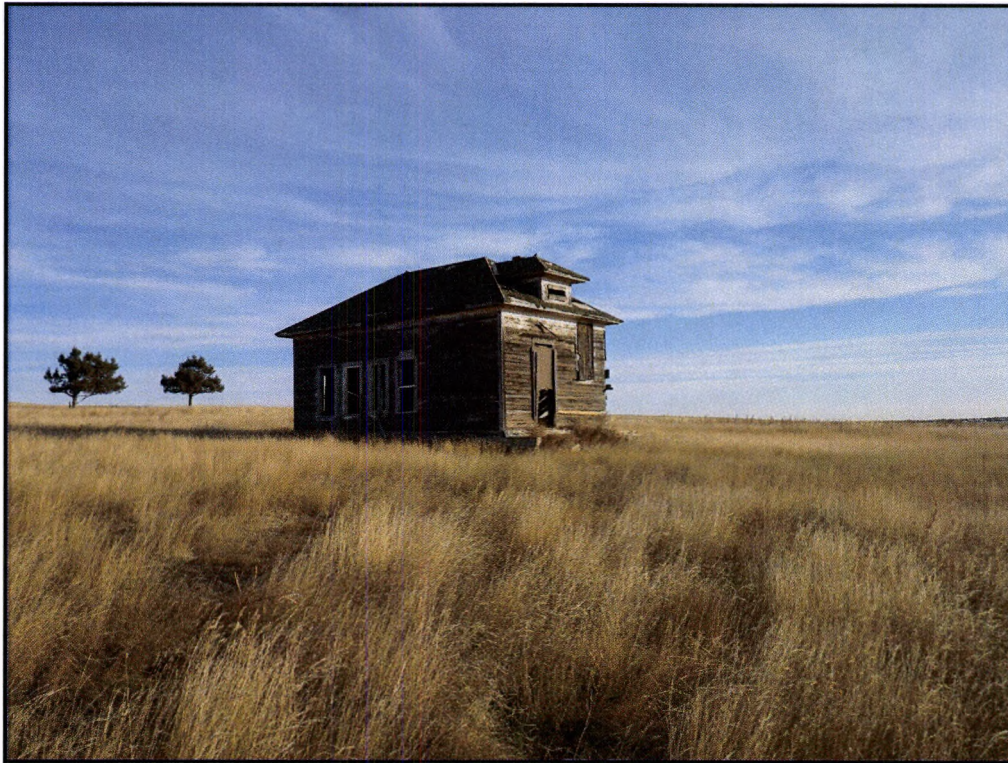
Feature 4 is a hipped one-story wood frame school house. The structure is still standing although it has considerable deterioration. The integrity of this site is compromised. The site retains poor integrity as a rural school. The door and window coverings are gone and the interior is in disarray with parts of the walls and ceiling deteriorated and crumbling. The site has been in existence for more than fifty years yet it lacks integrity due to dieterioration of the building. There is no current use of the site. The property lacks architectural, archaeological, and physical condition to be eligible for nomination to the National Register of Historic Places. Although the property is more than half century old the condition of the school is lacking and no further preservation or cultural research is recommended.

Figure 3: 32DU885, school house, looking northeast.

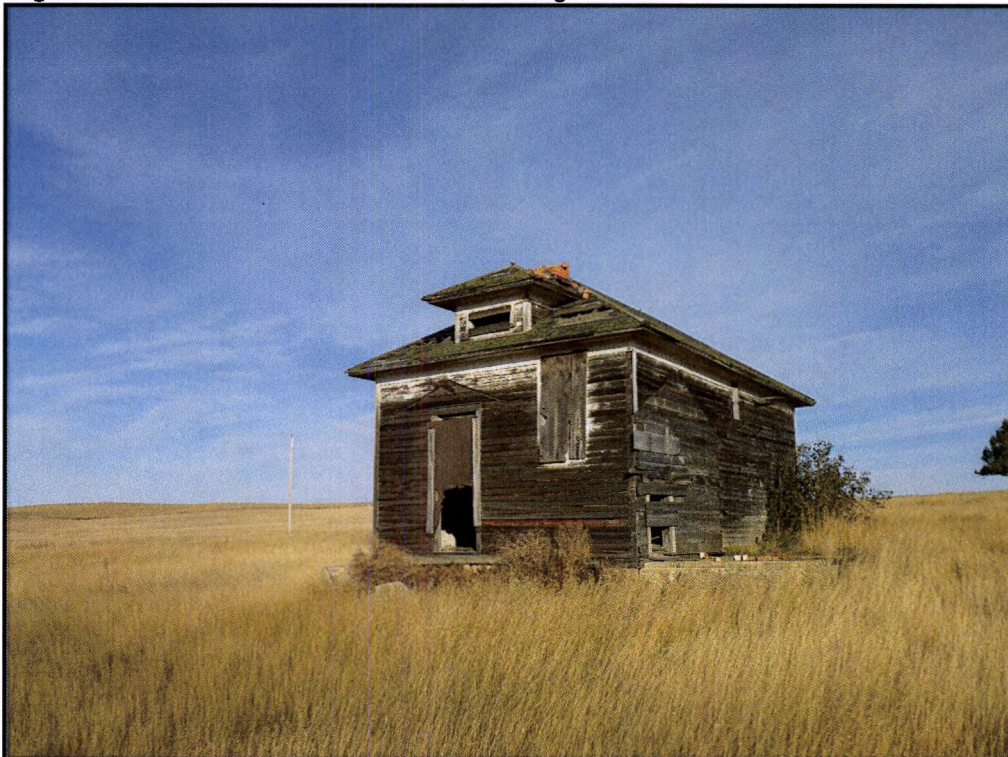
Figure 4: 32DU885, school house, looking northwest.

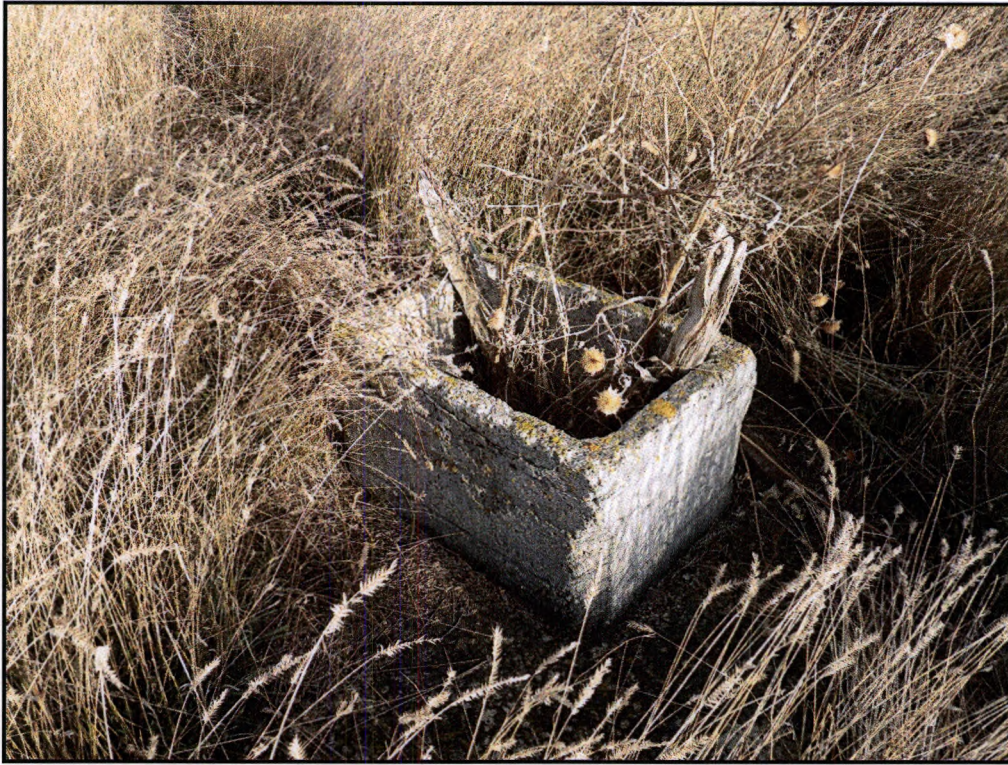
Feature 3, a toilet vault, is still intact with wood debris and grass/plants growing out of it.

Figure 5: 32DU885, privy base.

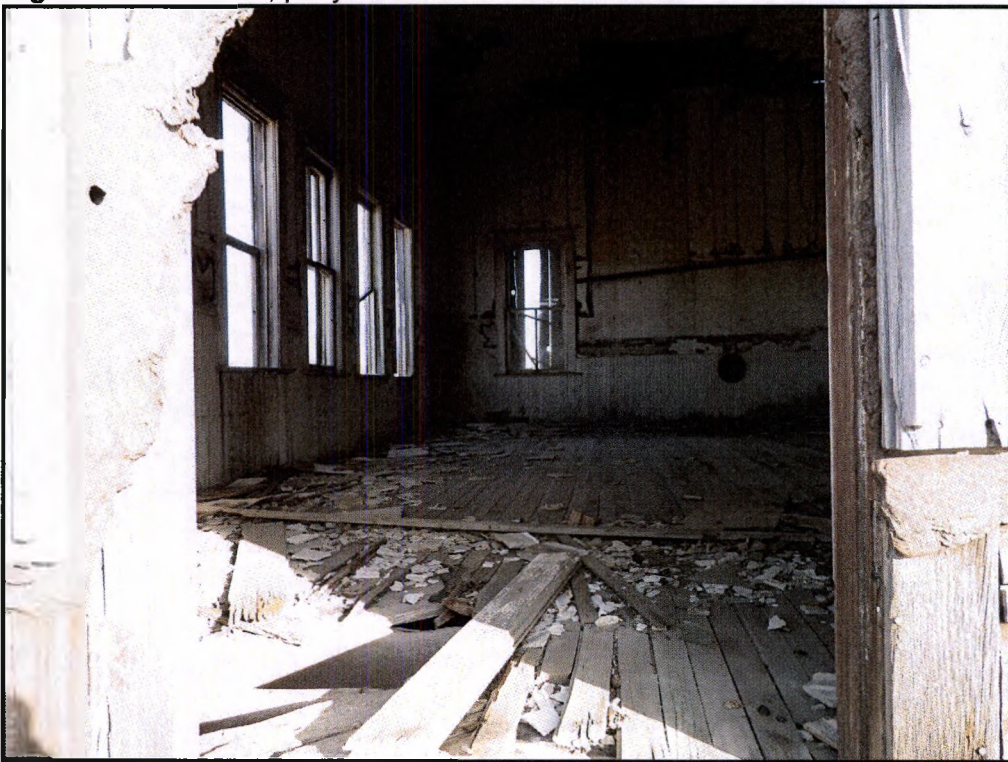
Figure 6: 32DU885, school house interior.

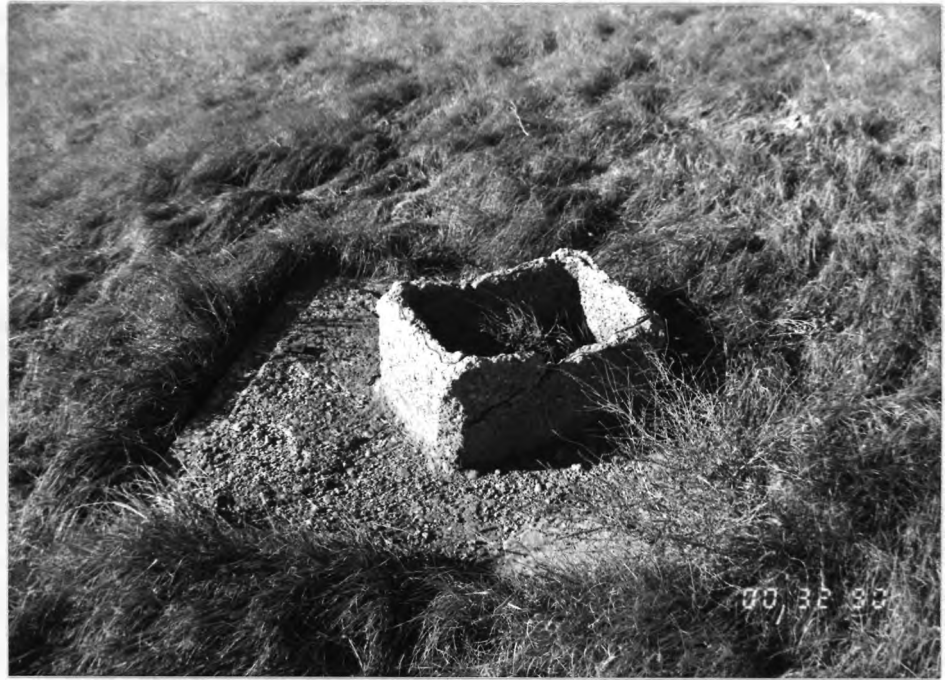
Features 1 and 3 are concrete toilet vaults about 4.7 feet square. The vaults have been filled with earth. Photos: 3290, Feature 1 from east; 3292 Feature 3 from west.

00-32-90: Feature 1
From East

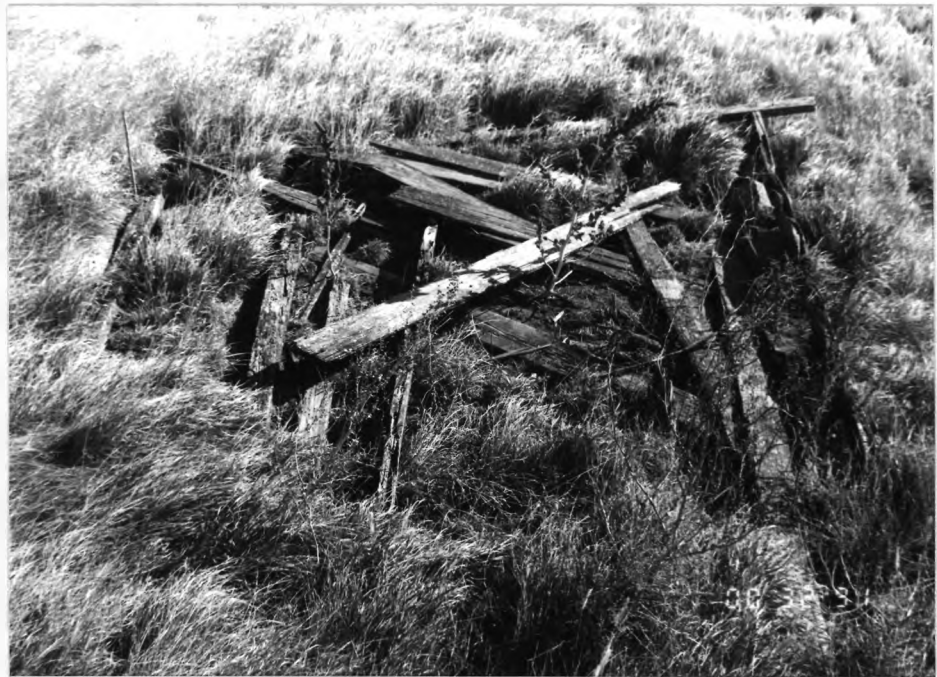
Feature 2 is the wood remains of a shed outbuilding of unknown function. Only 2"x4" sills and probable floor boards remain. Several unmortared stones may have supported the structure on the downslope south side. Building was roughly 8.4 feet square. Photo: 3291 from east.

00-32-91: Feature 2
From East

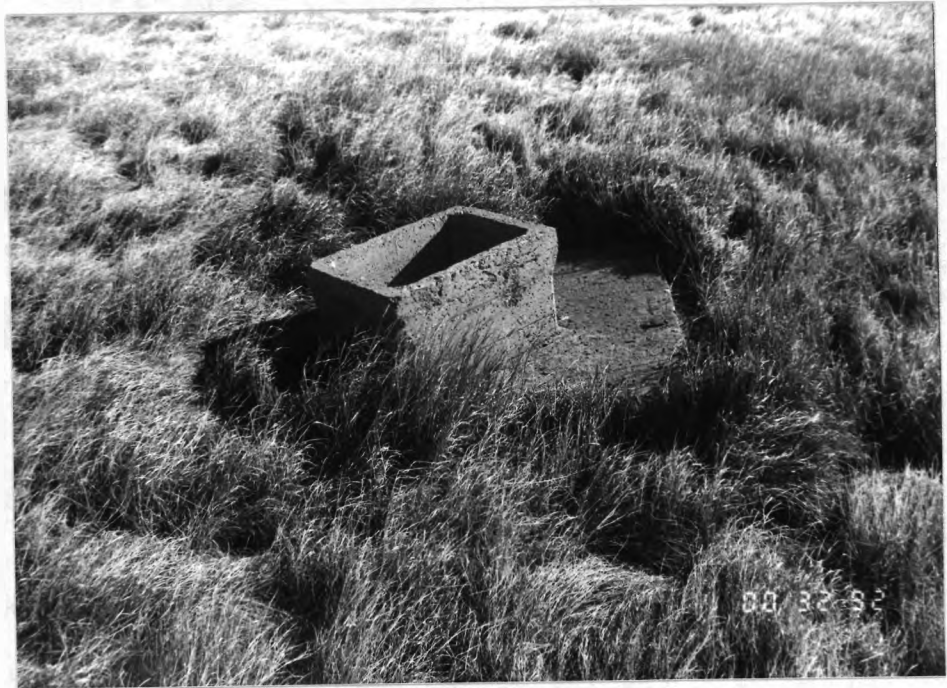
00-32-92: Feature 3
From West

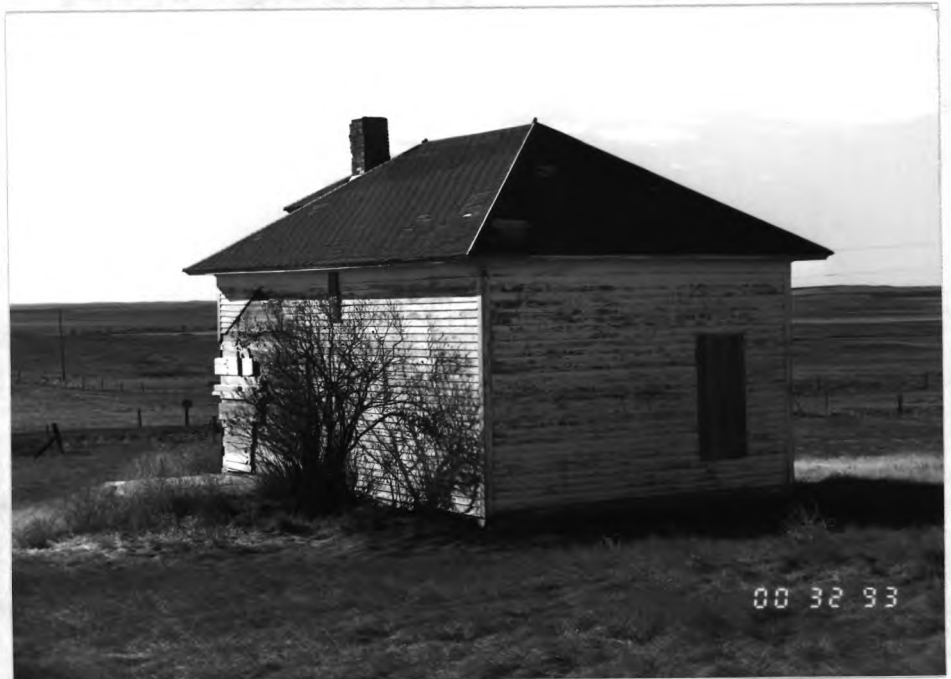
Feature 4 is a hipped one-story wood frame school house. The building has a poured concrete foundation, horizontal wooden lap siding on walls, and asphalt shingles on the roof. Windows are blinded with a variety of materials. On the south end of the east side is a poured concrete stoop or cistern. An addition over the cistern has been removed. A porch or other addition also once existed at the west end of the south side, now evident as a remnant of concrete foundation. Building is 18.3 feet east to west, 30.0 feet north-to-south; concrete cistern is 12.0 feet north-south, 8.2 feet east-west. Photos: 3293 from NE, 3294 from SW; 3295 site area from SW.

00-32-93: Feature 4
From NE

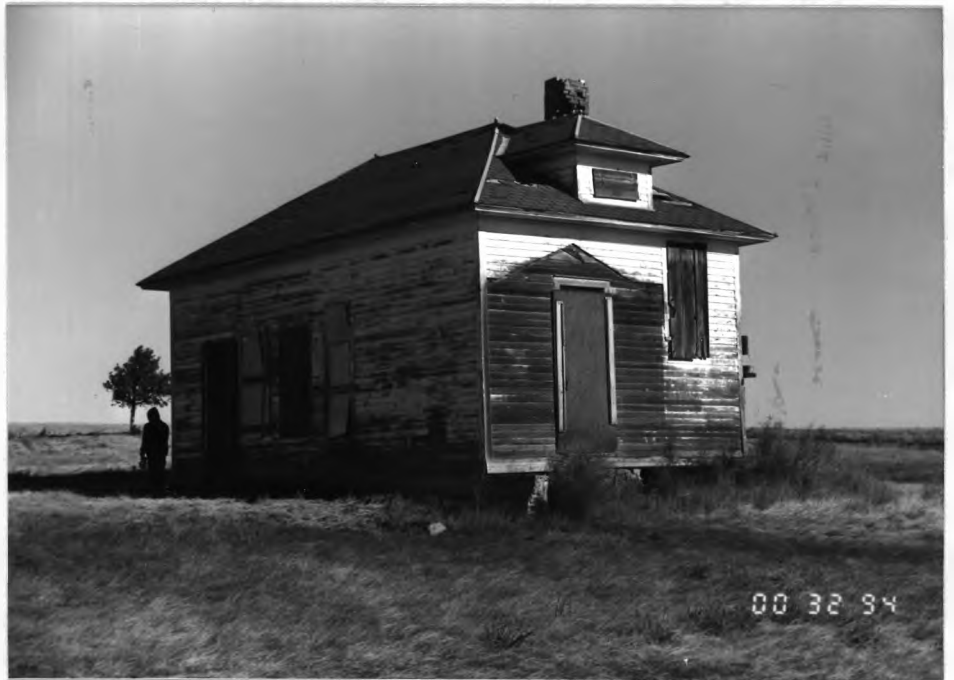
00-32-94: Feature 4
From SW

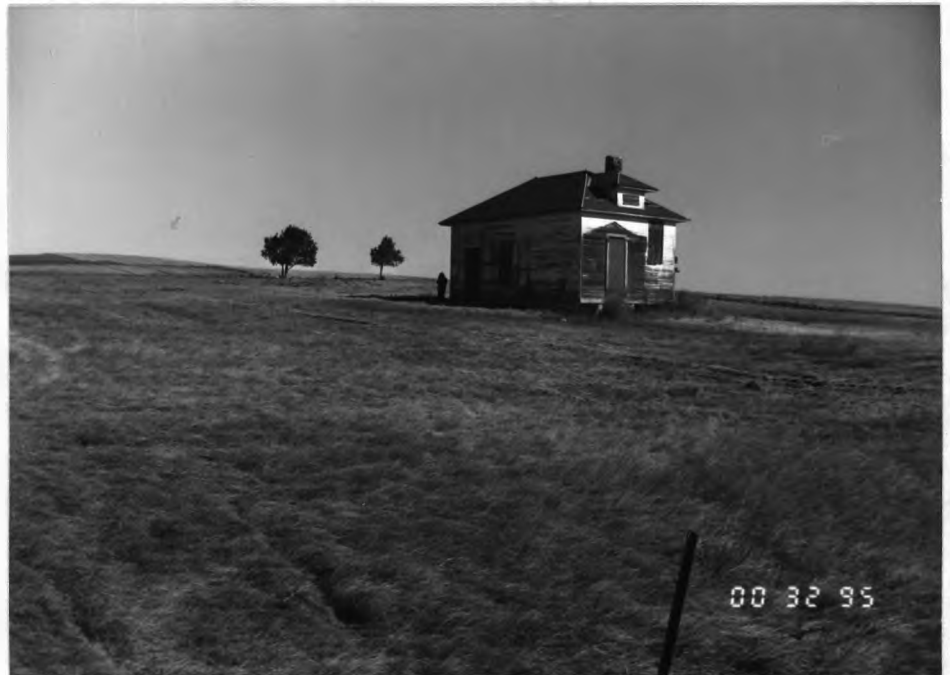
00-32-95: Site Area
From SW

This site is an old school house. The front door and windows are missing. Boards were places over the doors and windows at some point in the past. These coverings are now deteriorated and/or destroyed. The site is in poor condition. Feature 1 (toilet vault) and 2 (wood remains of a shed) are no longer present at site. Feature 3 (toilet vault) is still intact with wood debris and grass/plants growing out of it. Feature 4 (hipped one-story wood frame school house) is still present although considerably deteriorated. There are no cultural materials or artifacts present at the site. Any materials that were previously recorded have been removed from the property.

This property lacks architectural, archaeological and physical condition to be eligible for nomination to the National Register of Historic Places. Although the property is more than fifty years old the condition of the school is lacking and no further preservation or cultural research is recommended.
