NDCRS ARCHITECTURAL SITE FORM PAGE 1

Field Code Hope School #1

Project Title & Supervisor:
Country Schoolhouse Project

The feature is a one room prairie school on a concrete foundation. The hip roof of the school, the half hip roof of the porch and the gable roof of the dormer are all covered with asphalt shingles with some metal capping at the hips and on the dormer. The south slope of the roof has wood shakes. The soffits were closed, much of the material has fallen away. There is not chimney. There is a dormer on the west facing slope of the roof with two window openings, no glass. At the peak there is a flag pole. The building measures 38 feet east to west and 32 feet north to south with a porch that measures 20 feet north to south and 8 feet east to west.

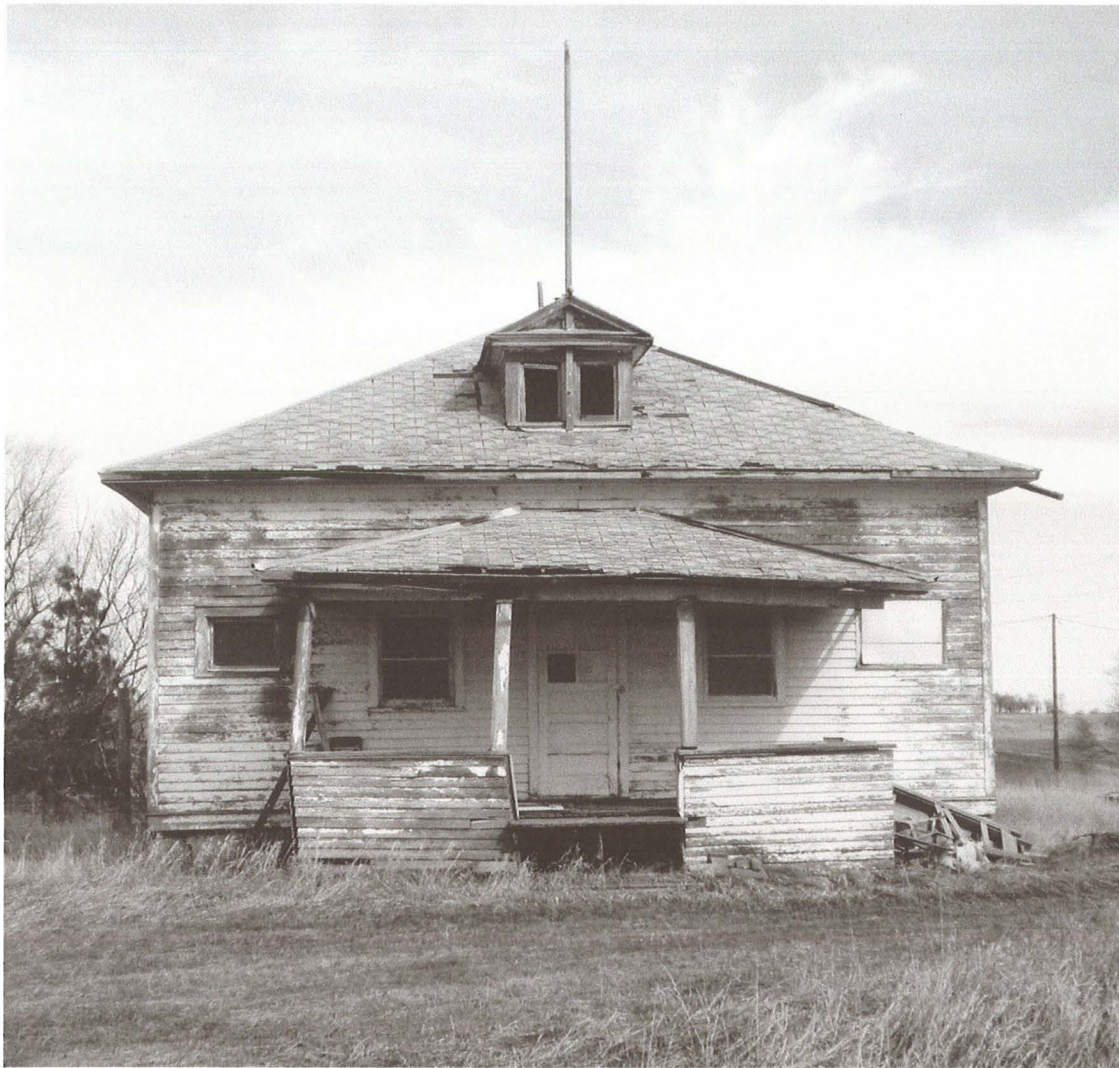
West Side

There is a wide trim board under the soffits on all four sides of the school. The remainder of the siding is 6 inch wood lap with 6 inch wood corner trim with waterboard and a wide trim board at the bottom of the walls. The porch on the west wall of the school has three of four posts remaining, the floor is wood and the roof is sagging at the southwest corner. There are no steps to the porch and the entire south half wall has fallen to the ground. There is as 3 panel wood door with 4 pane window at the top. To either side of the entry door are two smaller double hung windows with glass. Beyond the porch, on the west wall, are two smaller fixed pane windows, one is covered. An opening on the south side is covered. The east wall has a bank of 6 double hung, two over two, windows with all but one covered and some framing and no glass in that uncovered window. There is a locked 3 panel wood door on the north wall near the west end, 4 pane fixed window at the top, that is at ground level and leads to the basement. The concrete basement is cracking in places, has a window on the north and east sides and a fuel door near the east end of the north wall.
